Forest Service

SAFECOM Summary August 2007

Interagency Aviation Safety Alert

Subject: Retardant Dip Tanks

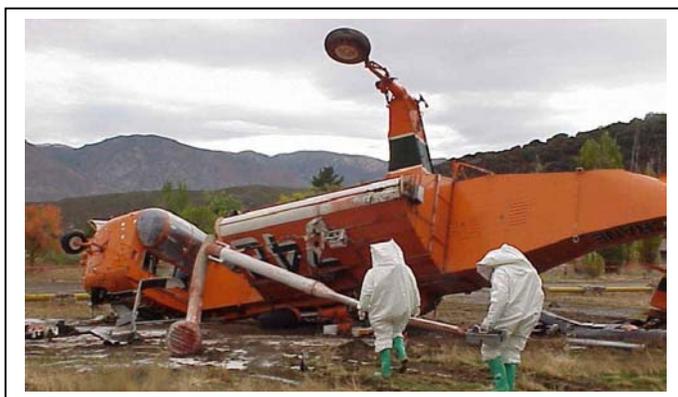
No. IA 07-02

In October 2006 a Type-1 helitanker was severely damaged while attempting to hover-dip from a 5000-gallon portable retardant tank (PRT) when the snorkel inadvertently became lodged on the lip (ring) that surrounds the tank’s frame.

Portable Retardant Tanks. The frame of portable retardant tanks (PRT) may have lift rings, tank bands (aka collars), or other structural components that can “catch” snorkels and water buckets. All PRTs should be inspected, and any structural hazards mitigated, prior to use.

- 1) Inform all helicopter flight crews and Incident Command Teams of the snagging hazard presented by certain dip tank frames.
- 2) Inspect all portable retardant tanks prior to use for protrusions and snagging hazards.

- 3) Ensure that there are NO rings or protrusions around the perimeter of the tank that a snorkel or bucket can “catch”. Remove the hazard or shield it from the snorkel/bucket assembly.

- 5) **If hazardous tank assemblies are found**, require the vendor or the appropriate authority (if government owned) to provide appropriate modifications before use.

- 6) If the parts can't be removed or the hazard can't be otherwise mitigated by shielding/wrapping, **remove the tank from service**.
- 7) If contracted, **ensure that the contracting officer is informed** of tanks that are removed from service.

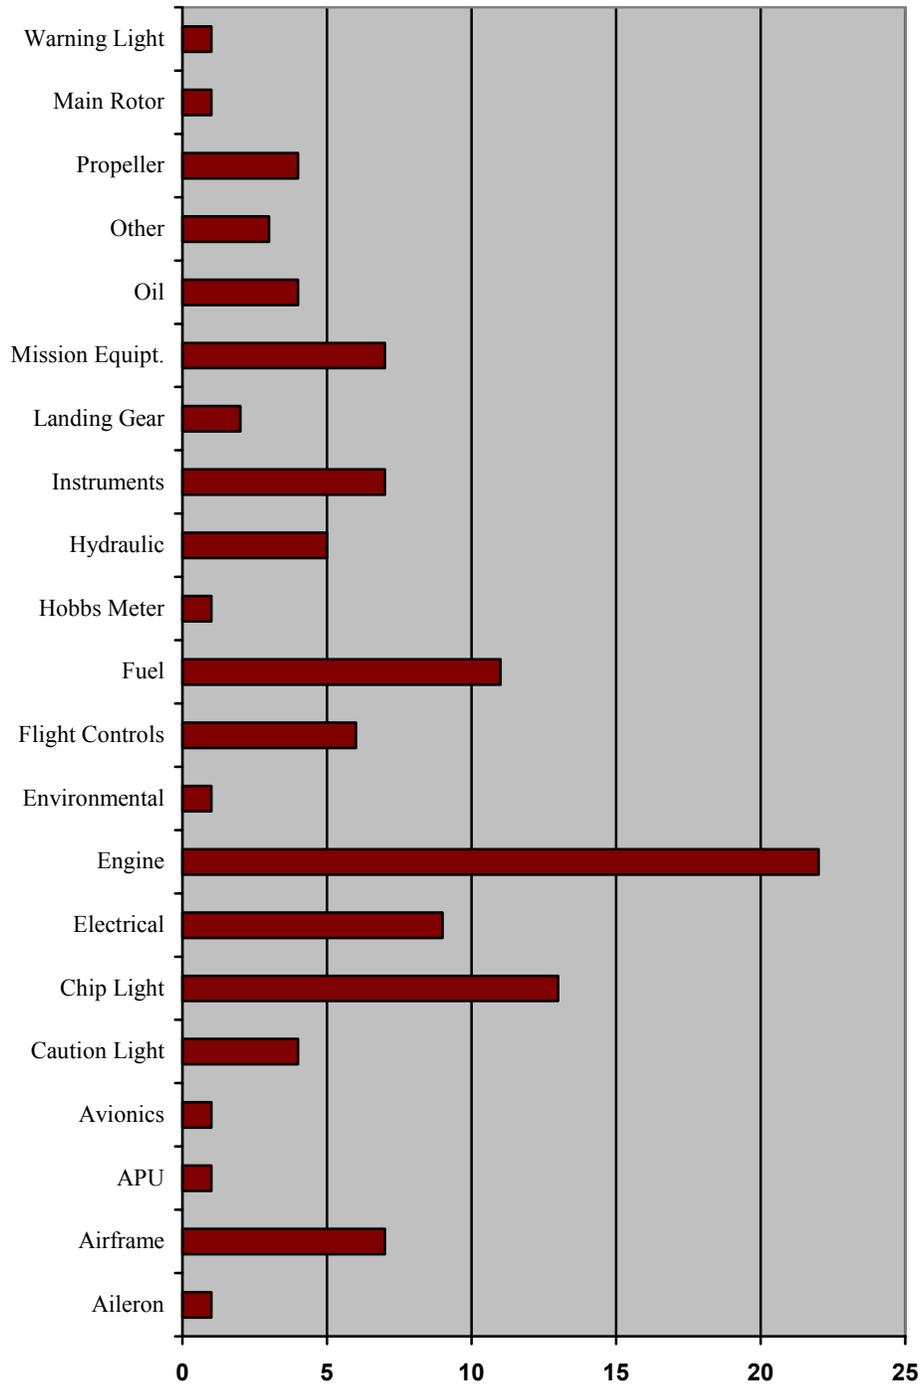
And the other 45% of the SAFECOMS were maintenance issues; the most reported were engine followed by chip lights, which is the norm. A mechanic is commended for detecting a 3-inch crack in the helicopter transmission mount during hot fueling while conducting cargo missions.

SAFECOM 07-0774 Narrative: A planned mission to deliver cargo from helibase to fire, return to helibase, hot fuel, and deliver a second load of cargo to fire was interrupted during the hot fueling stage when the mechanic detected a three inch crack in the helicopter transmission mount. The helicopter was shut down, and determined to be out of service. **Corrective Action:** After the mechanic on site completed his inspection, he contacted another company mechanic, and requested that he come to the helibase and also inspected the aircraft. After both mechanics had inspected the helicopter, it was determined that the helicopter was flight worthy for a ferry flight to Pendleton, Oregon, so that it could be repaired in an environment without heavy helicopter traffic, and the associated rotor wash and dust. The Contractor estimated that the repair would require about four days of work. The helicopter manager contacted the Regional Aircraft Maintenance Inspector and advised him of the situation. The maintenance inspector requested that he be notified when the helicopter was ready to return to service. UAO Comments: Manager was following up with R-6 Maintenance Inspector with Maintenance Log. RAMI comments: (8/6/07) I was contacted 8/3/07 @ 13:00 that xxxx would be unavailable for four (4) days to repair a crack in the transmission mount. When the repair is complete I will be contacted. RAMI Comments: Work was completed, received paper work from mechanic stating all work was complied with, he returned the aircraft back to service, and I returned the ac back to availability at 8am on 8/9/07.
