# **EVALUATION OF MIKE HORSE DAM**

January 2005

Stephen Romero, P.E.  
Regional Geotechnical and Dams Safety Engineer  
U.S. Forest Service

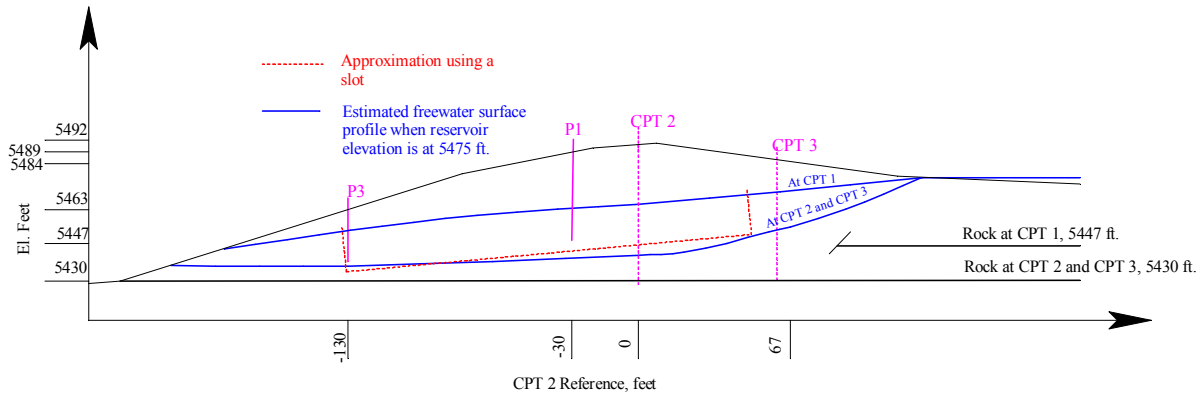
The same basic approach can be used with a two-dimensional finite element model. Approximating the geometry of the free groundwater surface as a slot, or series of wells, an estimate of total head in the sink can be obtained as well as the general shape of the groundwater surface in three dimensions. Total flow into the slot can be approximated by a two dimensional model with verification using well equations. In the case of the Mike Horse the depression appears to lend itself to characterization using a single slot as depicted in Figure 12.

**Figure 12:** Approximation of groundwater drawdown using a slot created by a series of wells.

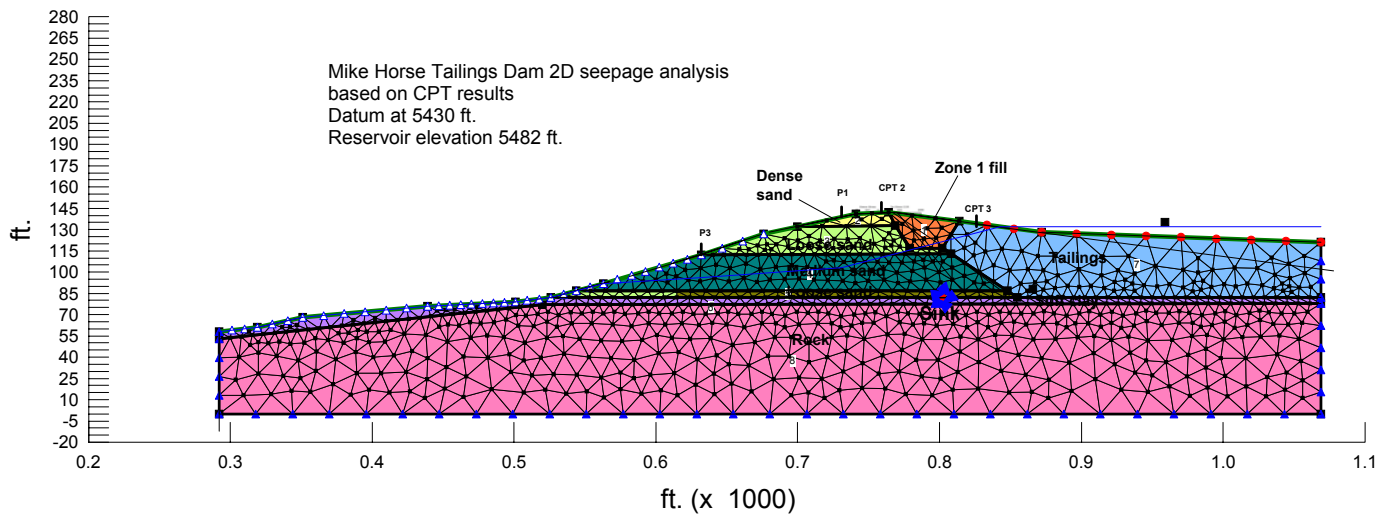
The soil profile developed in SEEP/W for the two dimensional seepage analysis is displayed in Figures 13 and 14.

**Figure 13:** Representation of finite element seepage model derived from CPT data perpendicular to dam crest.

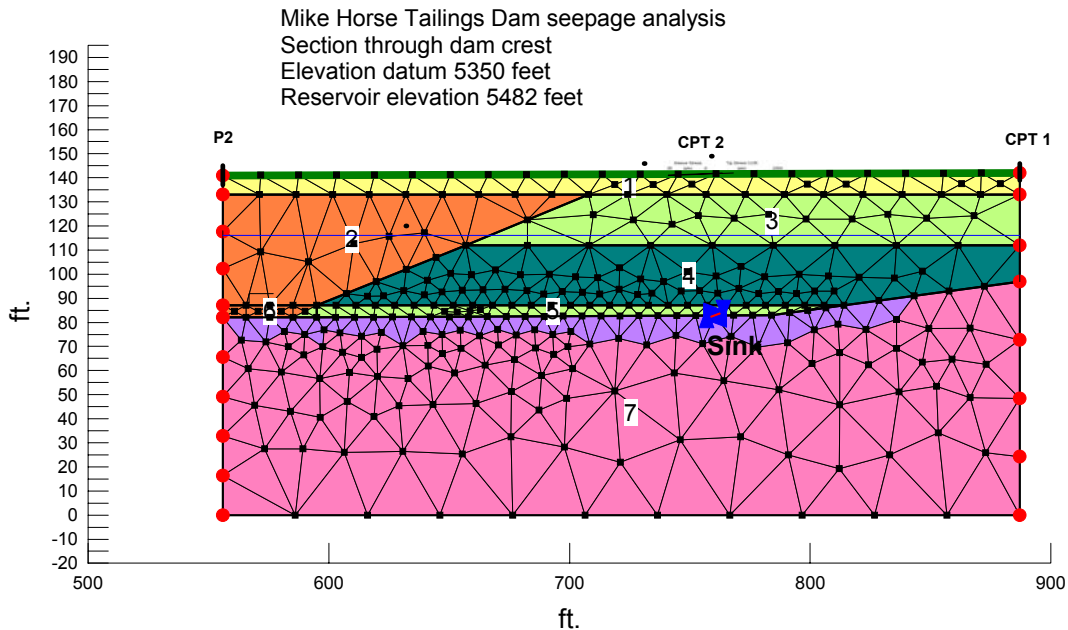
The reservoir elevation was assumed to be at the invert (5482 feet) of the primary spillway for this analysis. The boundary conditions in the section parallel to the dam axis were set at a total head of 5470 feet, 12 below the reservoir level in line with trends observed on P2 and CPT 1 (Figure 14). Total head was adjusted at different locations (sinks) in the model to establish an observed gradient in a particular direction. Super position was then used to sum the flows into the sink.

**Figure 14:** Representation of finite element seepage model derived from CPT data through dam crest between CPT 1 and P2 - approximately.
