**RESURRECTION CREEK RESTORATION  
2006-2007 Channel Morphology and  
Vegetation Monitoring Report**

**Bill MacFarlane, Hydrologist  
Chugach National Forest  
Anchorage, Alaska**

**October 2007**

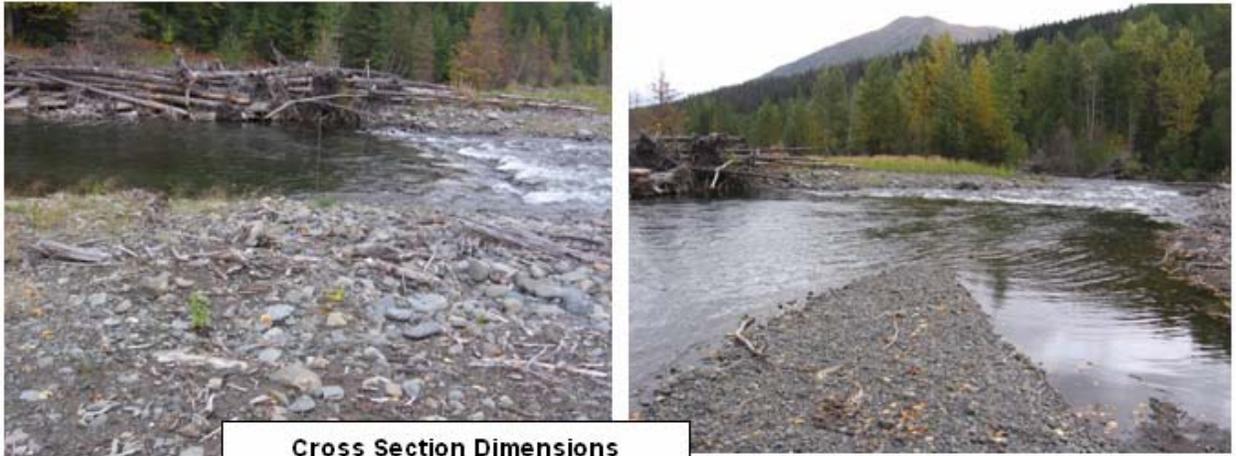
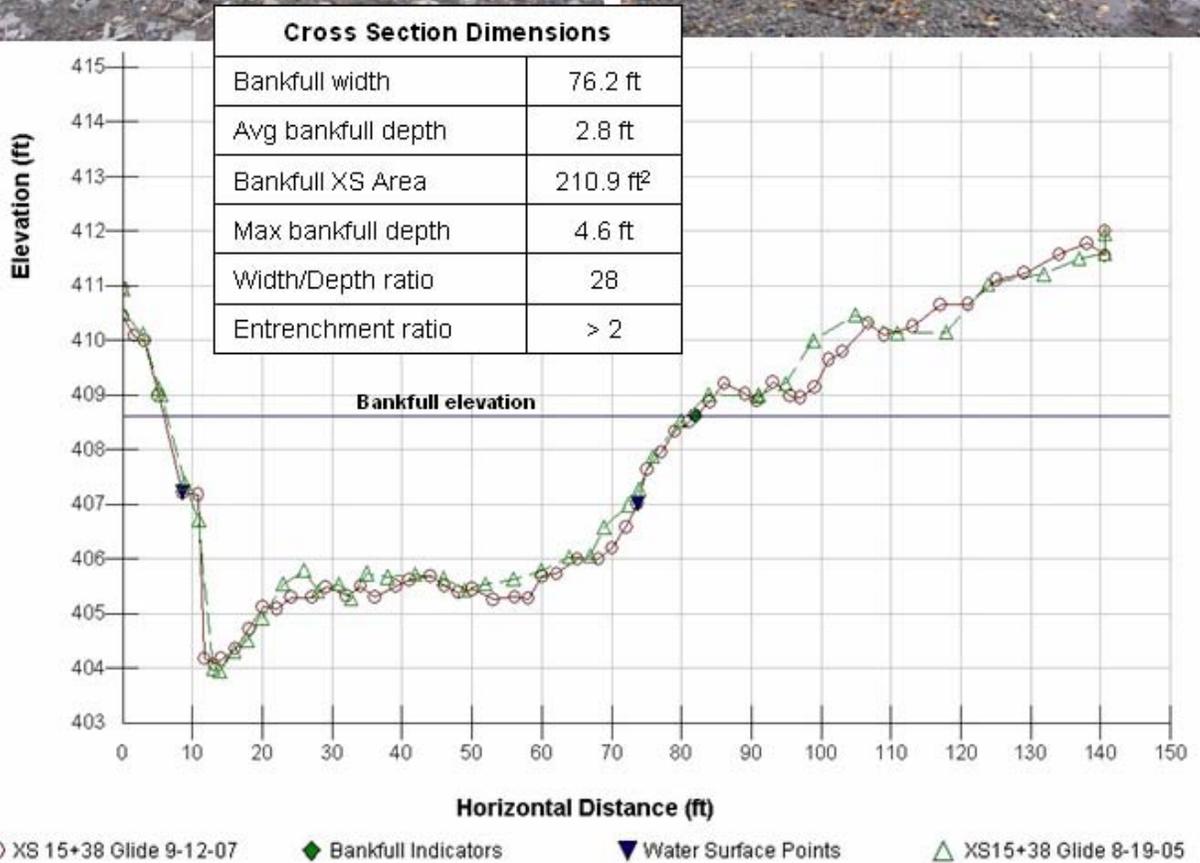
**Resurrection Creek Cross Section 15+38 - Glide**  
**Surveyed 8/19/05 and 9/12/07**

Some channel changes have also occurred in the Meander 3 area. The riffle on the downstream end of Meander 3 has changed little. Cross Section 14+82 has shown up to about 1 foot of degradation on the riffle bed surface, with no major changes occurring along the banks (**figure 23**). The glide at Cross Section 15+38 showed very little change between its initial survey on 8/19/05 and re-survey on 9/12/07 (**figure 24**). This is a glide with a logjam on the left bank. Observed changes on the right floodplain in both of these cross sections are the result of construction work to build the Meander 3 eastern side channel in 2006.

**Figure 24:** Changes in Resurrection Creek Cross Section 15+38 from 2005 to 2007.

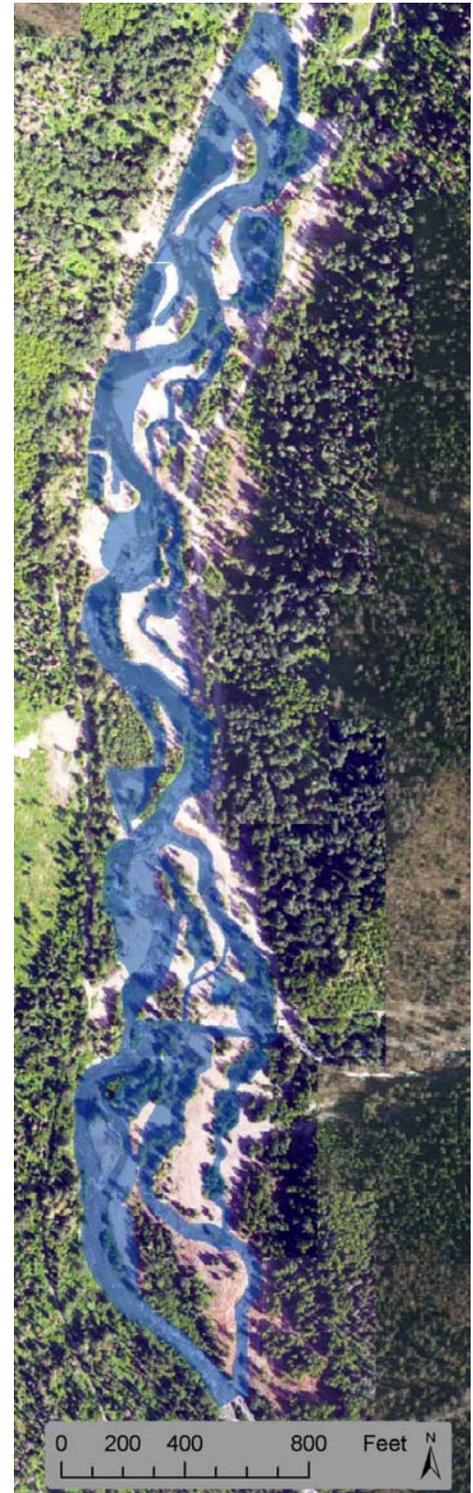
Ice in the project reach was able to spread out onto the floodplain, and much of the floodplain was covered by ice during the winter (**figure 28**). Ice built up in mid-November as overflow conditions existed, with much of the flow of Resurrection Creek running over the anchor ice attached to the bed surface (**figure 29**). Ice thickness in the channel ranged from about 3 to 6 feet. Although flows were relatively low, anchor ice in the channel caused flows to reach elevations considerably higher than the bankfull elevation, and ice conditions pushed much of the water into the side channels. By the end of November, the flows on top of the ice began to incise into the ice, and most of the water generally remained in the main channel during the remainder of the winter (**figure 30**).

**Figure 28:** Approximate extent of ice in the Resurrection Creek project reach, November 2006.

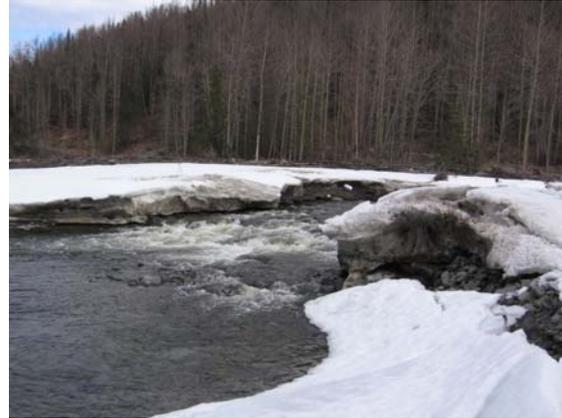
**Figure 30:** Incised flows with remnants of ice along banks, lower Meander 5 riffle, April 28, 2006.  
→

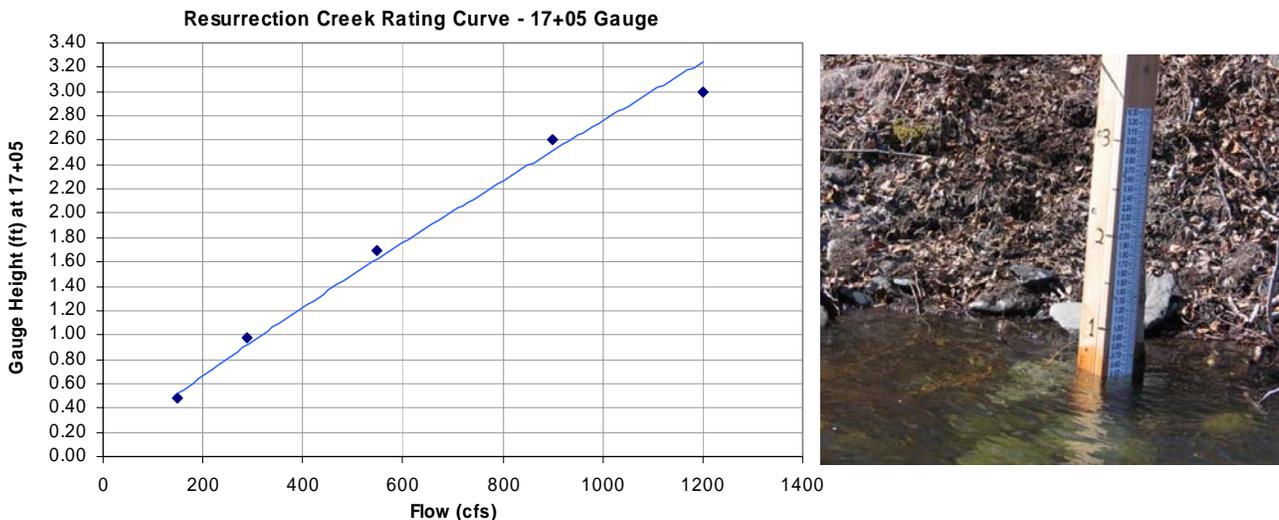
A staff gauge was set up on the main channel of Resurrection Creek on May 12, 2006 at station 17+05. A cross section was measured (**figure 27**), and flows at several gauge heights were measured to develop a rudimentary rating curve for the staff gauge (**figure 32**). The two highest discharge measurements in the rating curve were visually estimated, as it was not possible to wade across the channel.

**Figure 32:** Rating curve for Resurrection Creek 17+05 staff gauge. The estimated bankfull stage is at about 2.8 feet on the gauge.

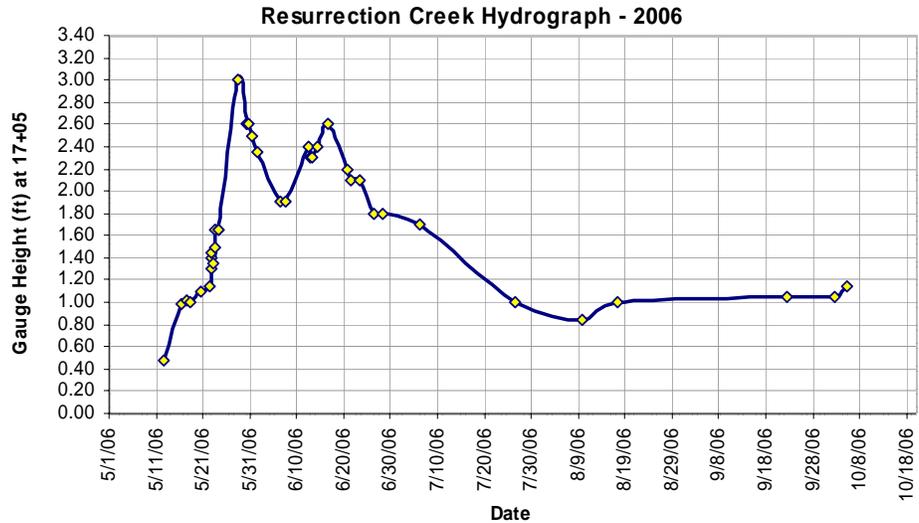
The staff gauge at station 17+05 was visually monitored periodically throughout the 2006 season. Although measurements were not frequent enough to produce an accurate hydrograph, the data give a sense of what the flows were over the course of the summer (**figure 33**).

**Figure 33:** 2006 hydrograph for Resurrection Creek at the 17+05 gauge, based on visual observations during the summer of 2006.

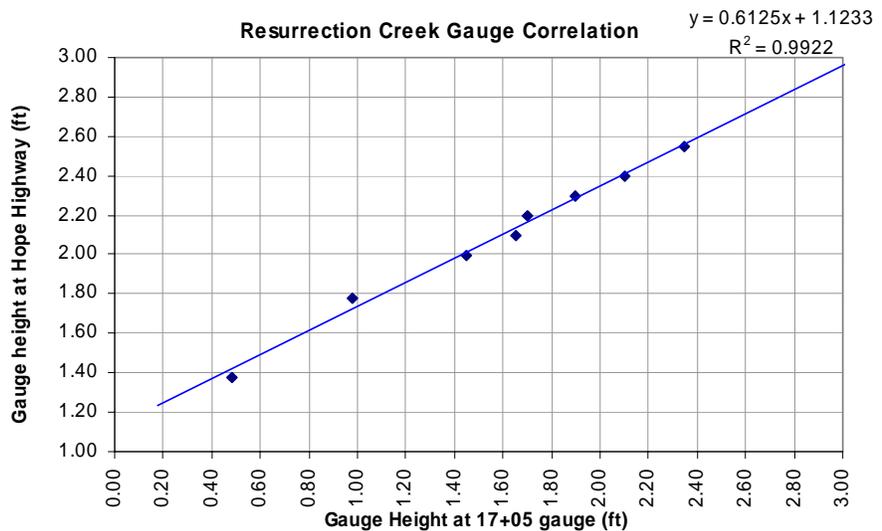
The existing staff gauge on Resurrection Creek at the Hope Highway Bridge near Hope was also monitored periodically throughout the 2006 season. A linear correlation was observed between the gauge heights at station 17+05 and the Hope Highway Bridge (**figure 34**). This correlation allows flows to be estimated based on readings from the Hope Highway Bridge staff gauge, provided that channel changes do not occur at either cross section.

**Figure 34:** Correlation between staff gauges at the 17+05 gauge and the Hope Highway Bridge gauge.

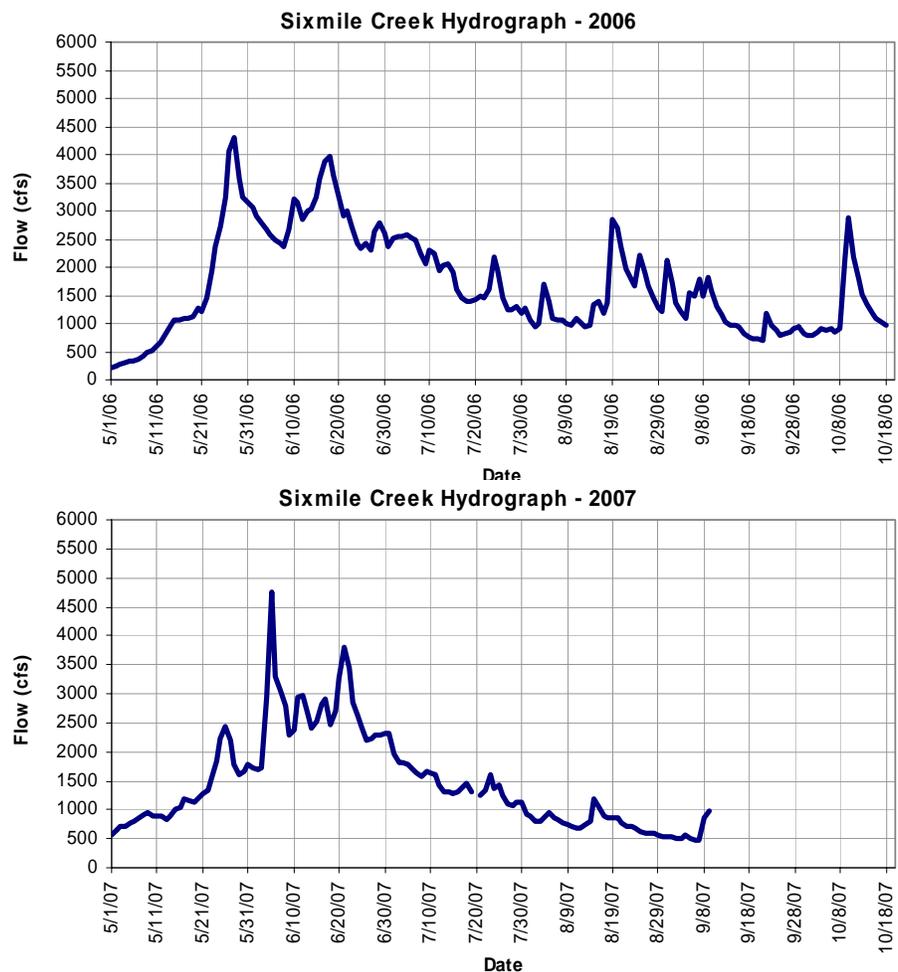
The 2006 hydrograph for Sixmile Creek roughly mirrors the 2006 hydrograph for Resurrection Creek, with the snowmelt peak also occurring on May 28, 2006 (**figure 35**). The instantaneous peak flow of 5020 cfs on Sixmile Creek was between the 2-year and 5-year flow (Curran et al., 2003; US Geological Survey, 2007). It is likely that the May 28 flow on Resurrection Creek was also a 2 to 5-year flood event. The Sixmile Creek real-time gauge data can be used as a rough surrogate for flows on Resurrection Creek. However, it must be noted that although they are in close proximity, the Sixmile Creek watershed has differing climatic and watershed conditions than the Resurrection Creek watershed.

The Resurrection Creek staff gauges were not monitored during the summer of 2007. However, the Sixmile Creek hydrograph for 2007 shows that Sixmile Creek experienced a similar summer snowmelt peak flow as in 2006, but in general, flows were considerably less in 2007 than they were in 2006 (**figure 35**). Resurrection Creek likely experienced similar conditions in 2007, with a similar peak, but overall lower flows than in 2006.

**Figure 35:** Sixmile Creek hydrographs for 2006 and 2007. Data from US Geological Survey (2007).

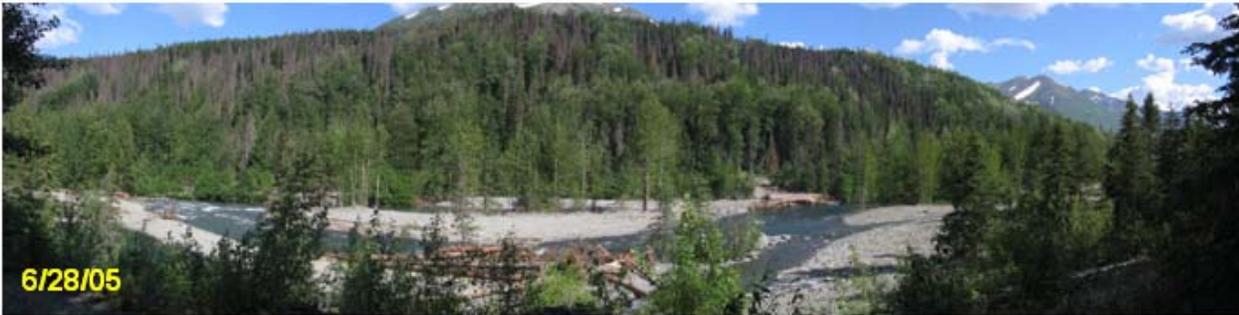
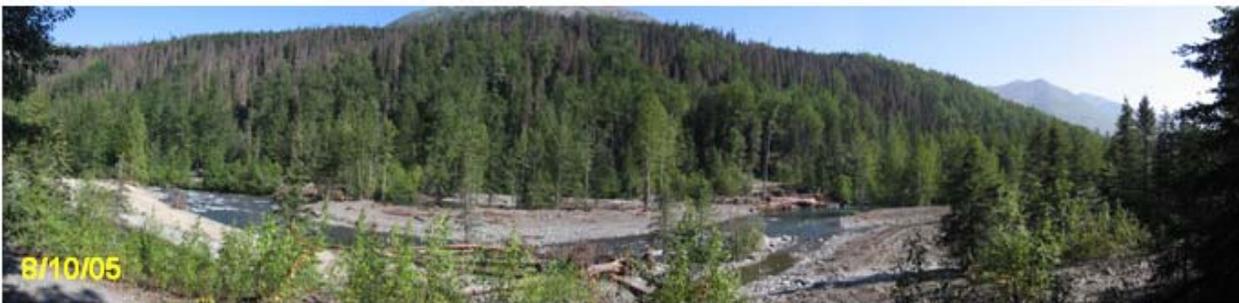
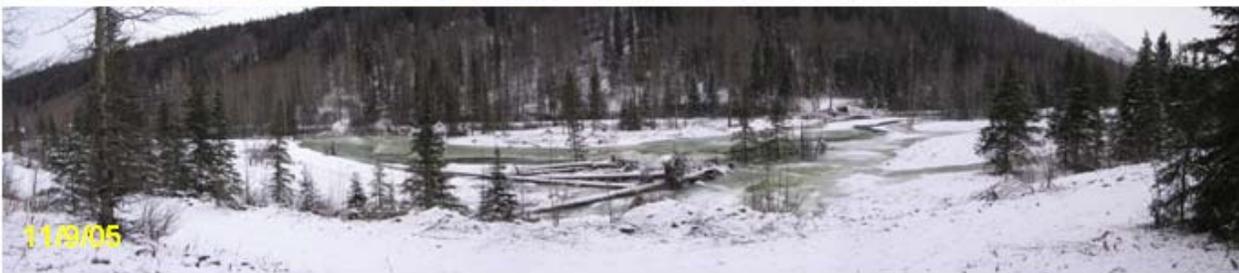
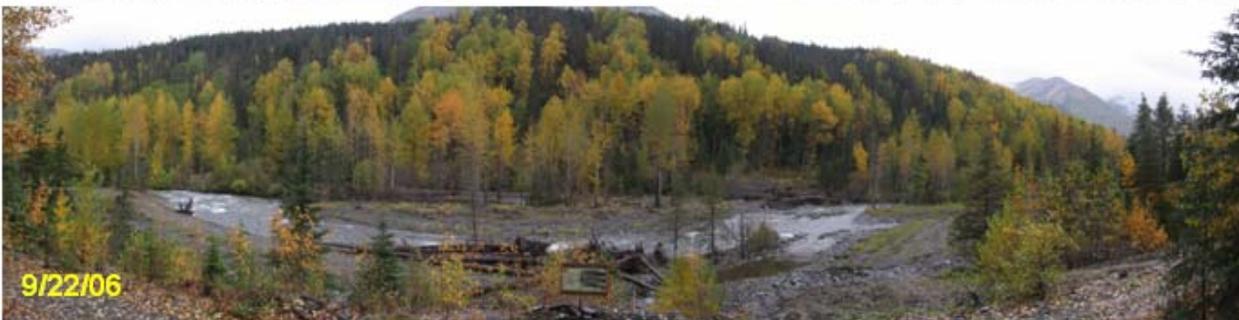
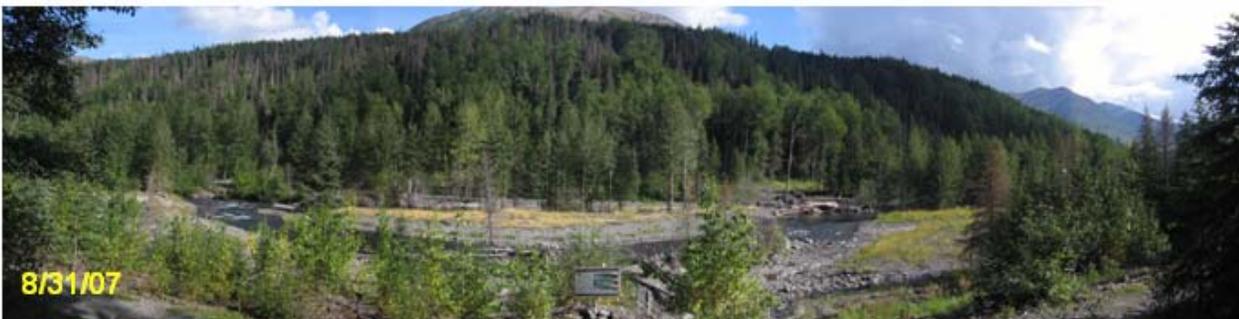
- The photo point 5a sequence shown in **figure 38** shows floodplain revegetation that has occurred in the 2 years since restoration occurred. Natural regeneration is occurring especially well on the west (near) side of the channel. This photo point also shows ice spreading across much of the floodplain, above the high water levels that are typical in the summer. The side channels at Meander 2 have no inflow during low water conditions.

**Figure 38:** Photo point 5 (panorama) progression from June 2005 to August 2007, showing revegetation at Meander 2.

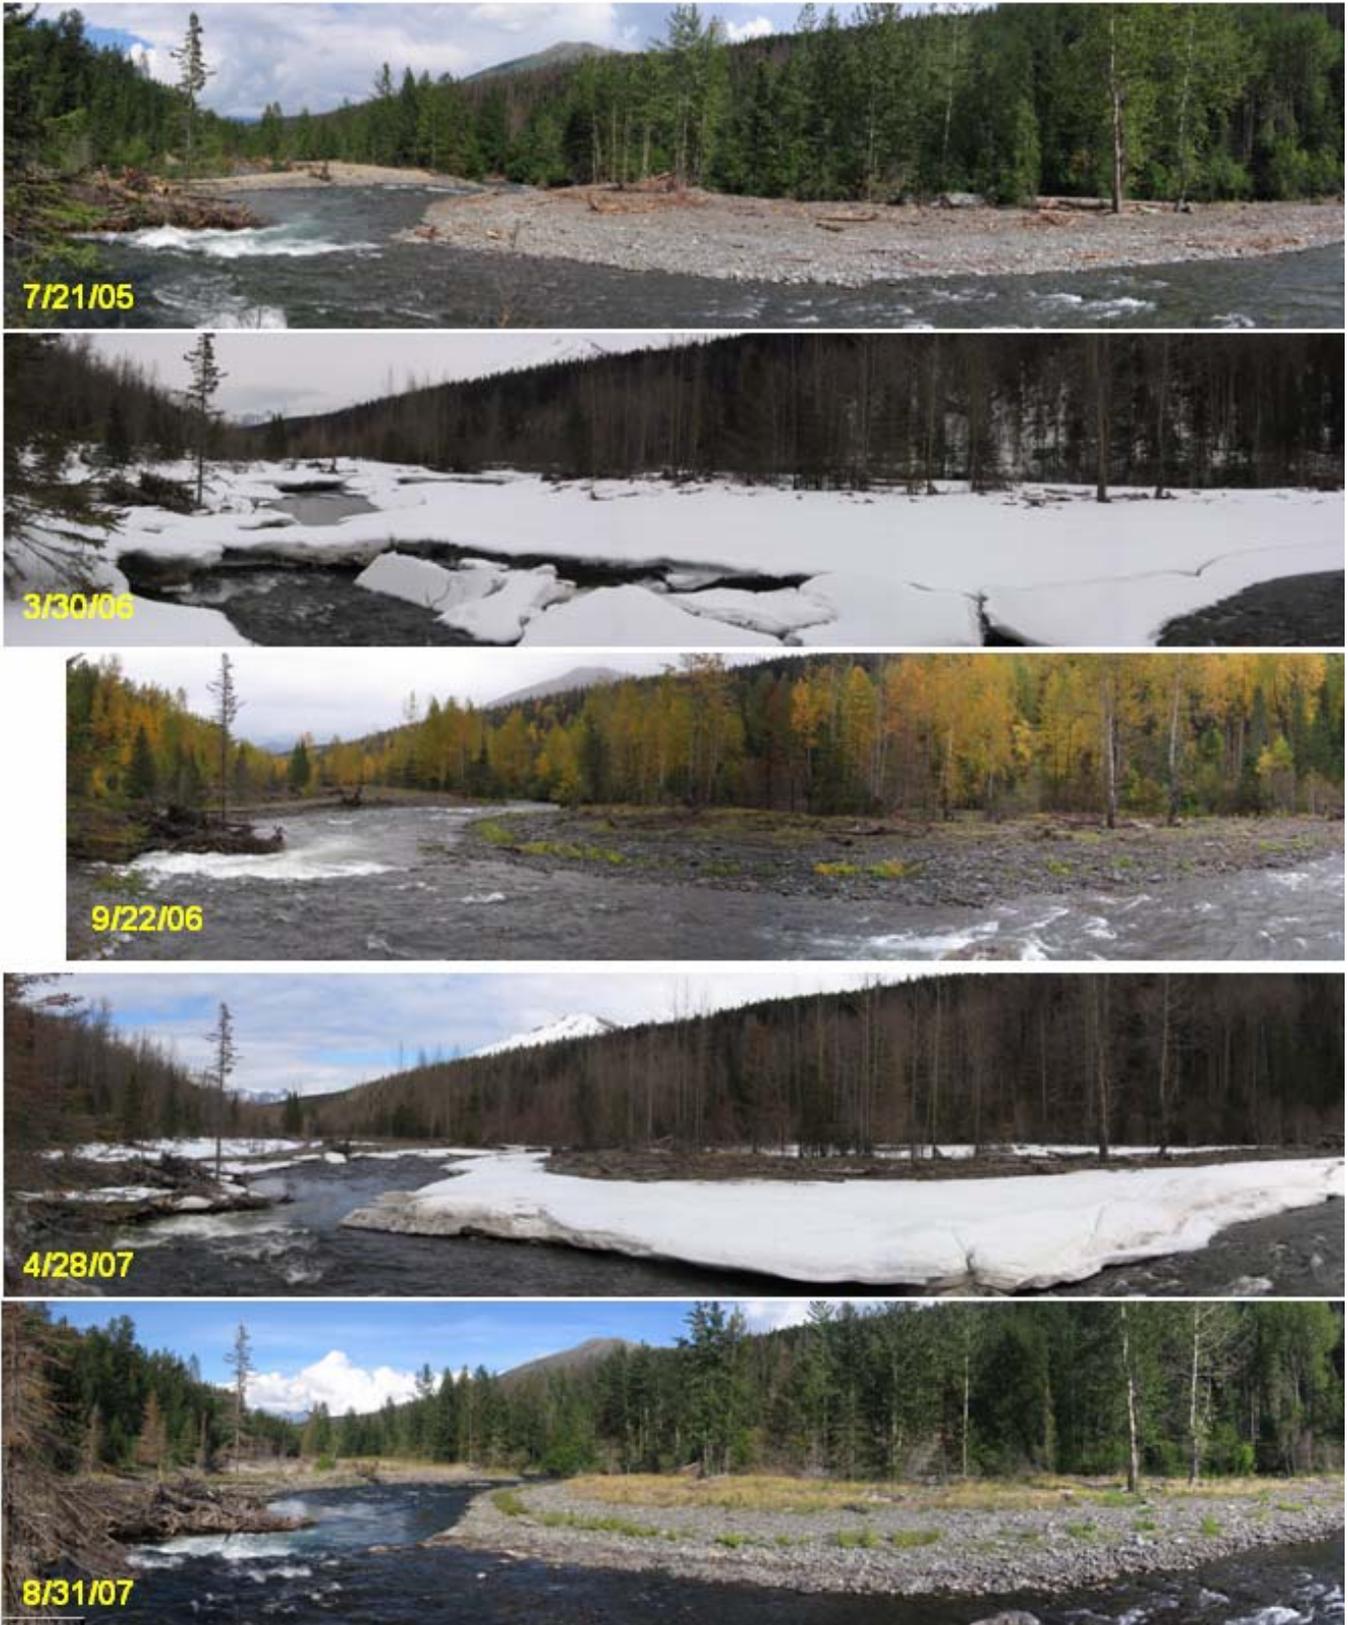
- The photo point 15a sequence shown in **figure 39** shows floodplain revegetation that has occurred in the 2 years since restoration on the east side of the channel, an area where natural soils were not spread. Willow plantings along the right bank are shown to be growing. The lower floodplain, where soil was not spread, has little or no natural regeneration.

**Figure 39:** Photo point 15a (panorama) progression from July 2005 to August 2007, showing seasonal variations and revegetation at Meander 2.

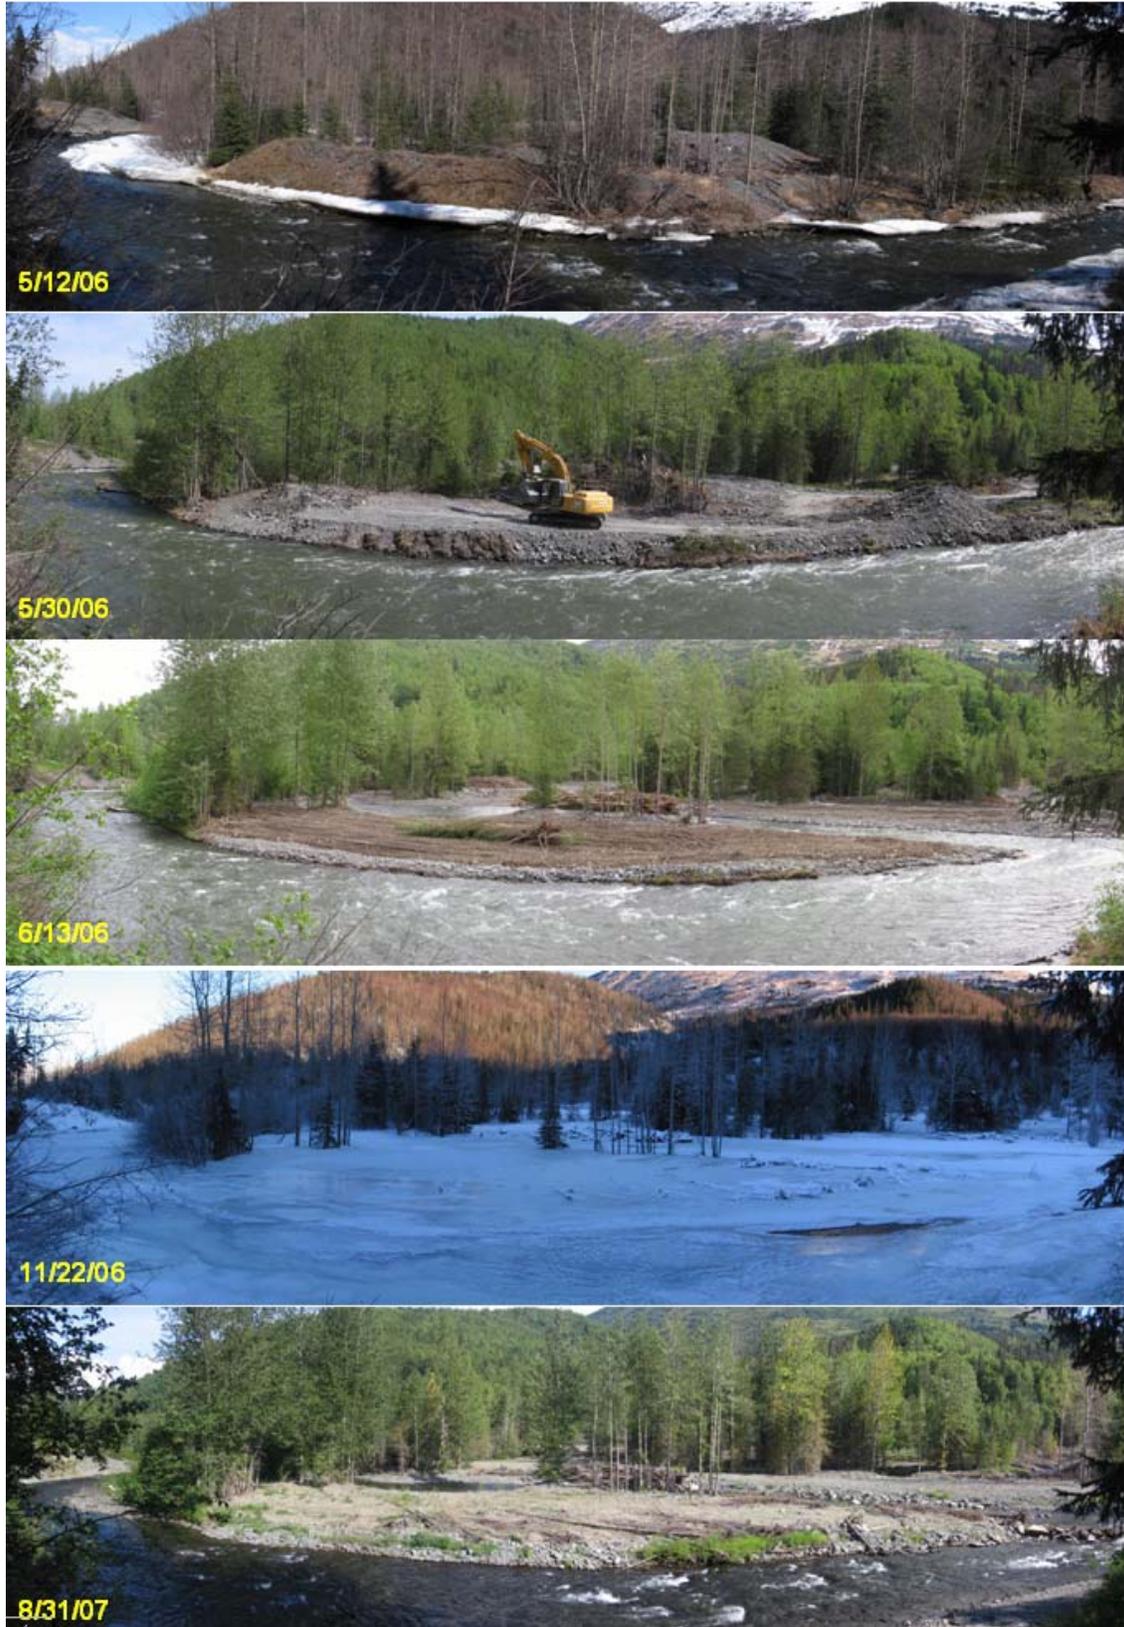
- The photo point 29 sequence shown in **figure 40** shows the construction of the upper reach split channel and one year of floodplain revegetation. Natural revegetation is occurring in this area. High ice levels in November 2006 covered the channels and floodplains in most of this area.

**Figure 40:** Photo point 29 (panorama) progression from May 2006 to August 2007, showing construction of side channels in the upper project reach.

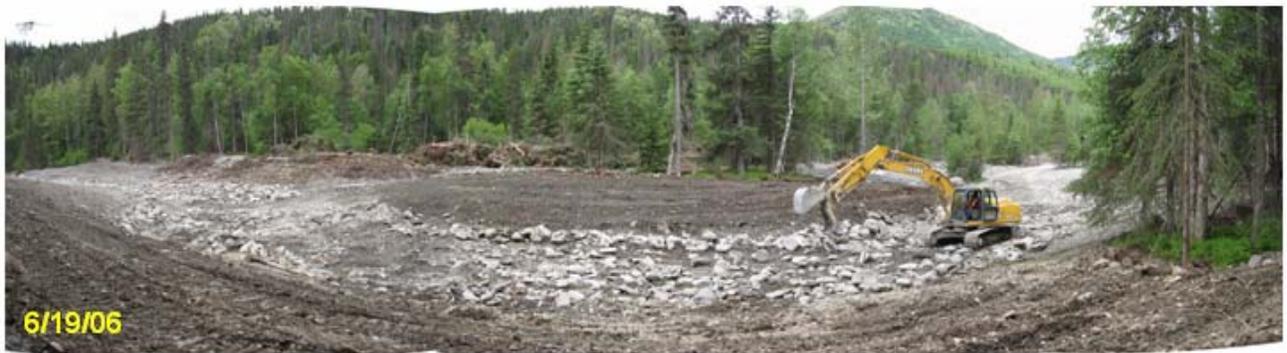
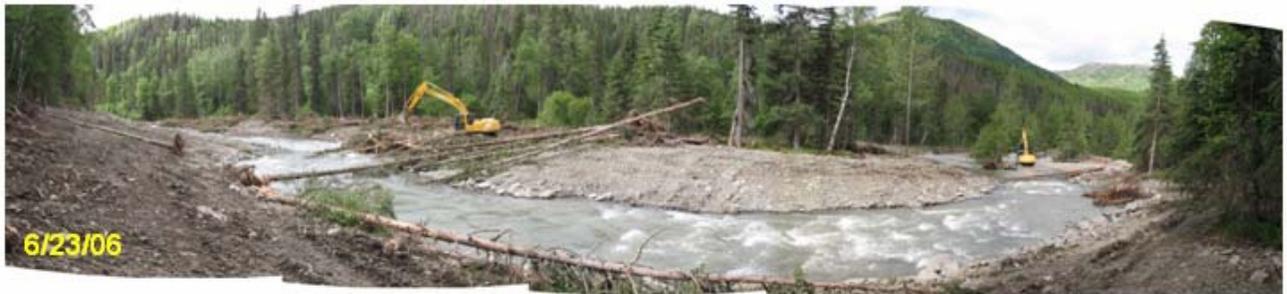
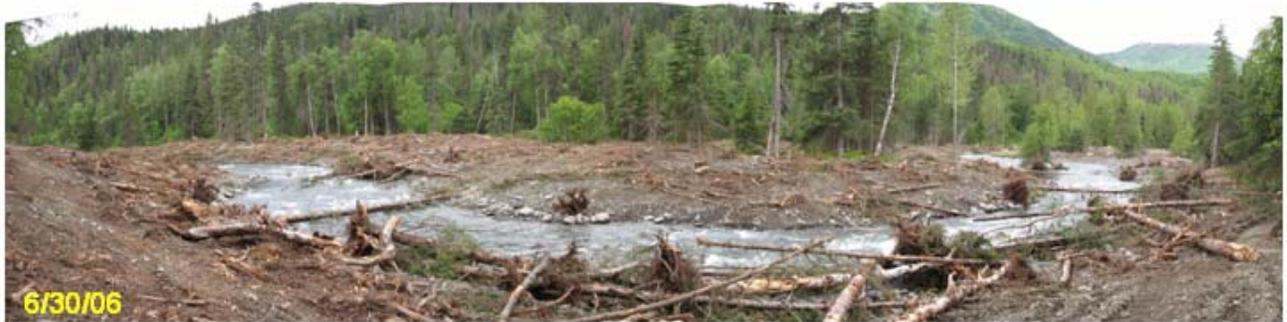
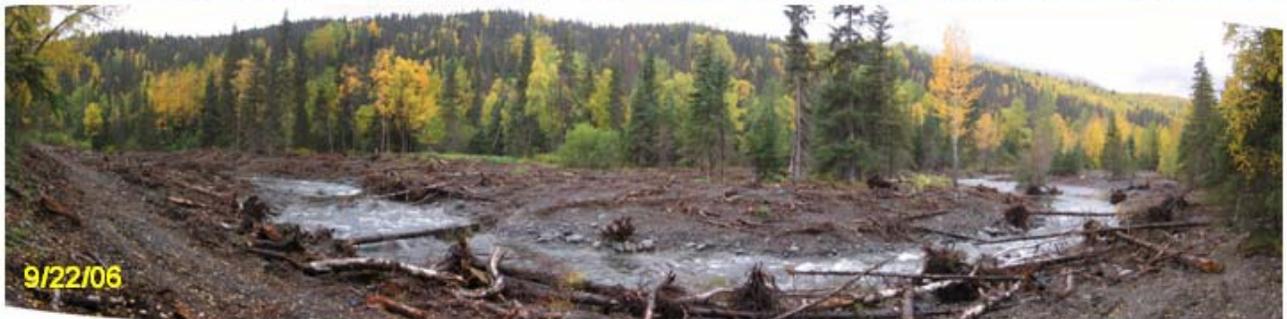
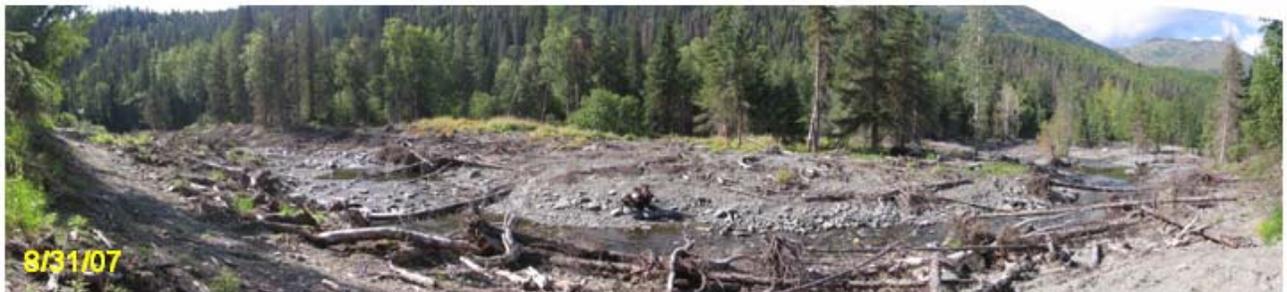
- The photo point 52 sequence shown in **figure 41** shows the construction of Channel 1 and one year of revegetation. Natural revegetation is occurring in this area. Soil cover on these slopes and floodplains is limited, but abundant organic material was scattered to promote natural regeneration.

**Figure 41:** Photo point 52 (panorama) progression from June 2006 to August 2007, showing construction of Channel 1.

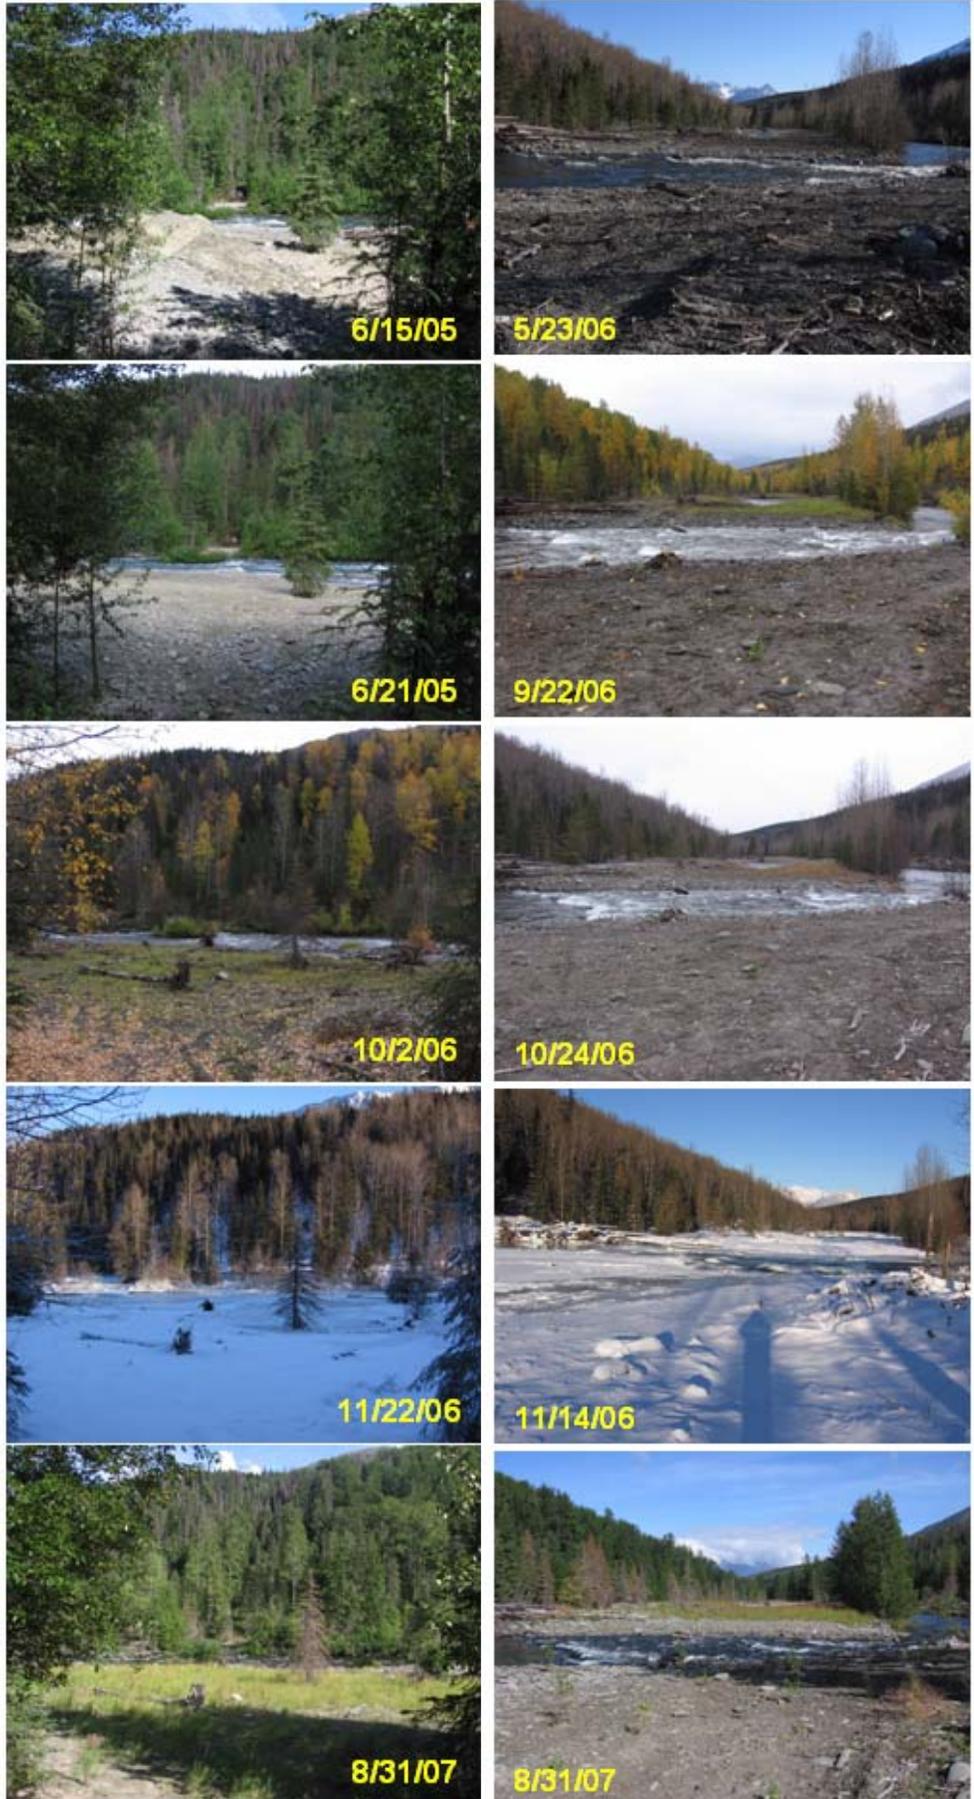
- The photo point 16 and photo point 42 sequences shown in **figure 42** show floodplain revegetation that has occurred in the 2 years since restoration occurred. Revegetation is much faster on the west side of the channel, where natural soils were transplanted.

**Figure 42:** Photo point 16 (left) showing floodplain revegetation at Meander 4, and photo point 42 (right), showing floodplain revegetation at Meander 3.
