**RESURRECTION CREEK RESTORATION
2005 Channel Morphology Monitoring Report**

**Bill MacFarlane, Hydrologist
Chugach National Forest
Anchorage, Alaska**

March 2006

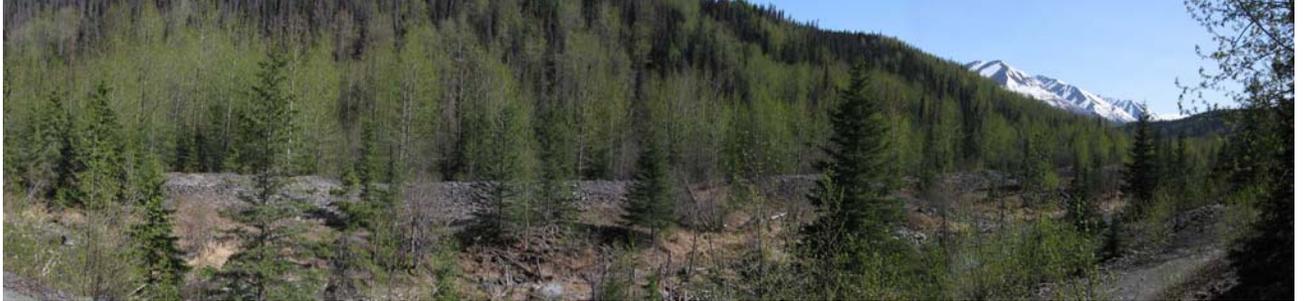
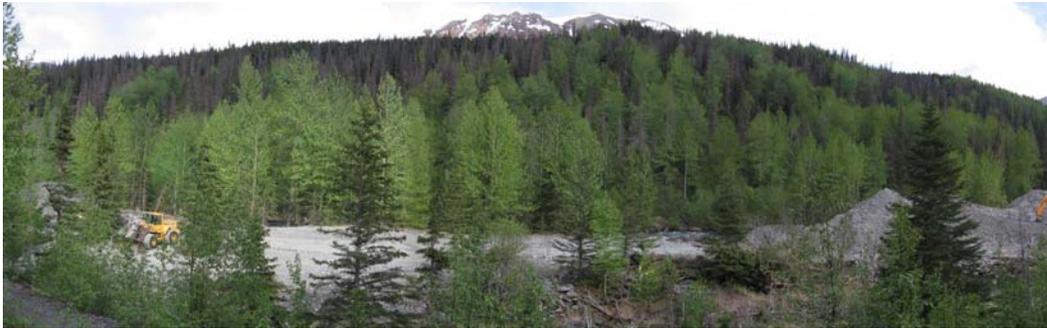
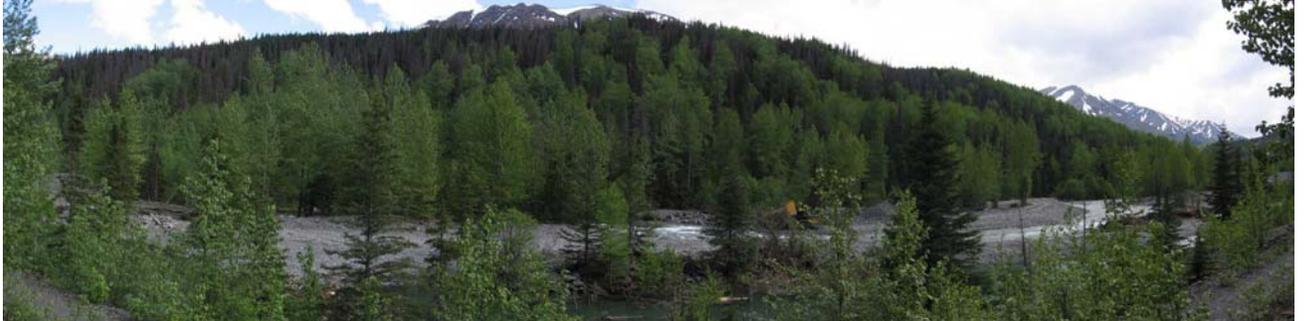
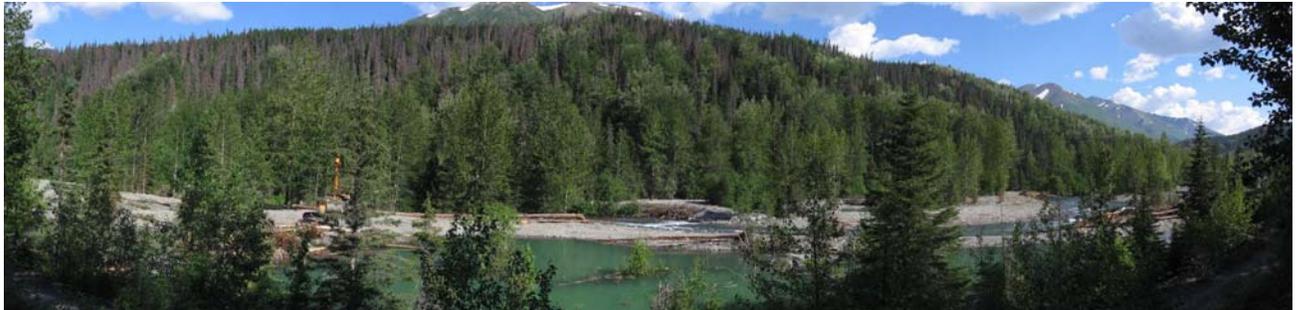
Figure 31: Sequence of photos from Photo Point #6.

Photo Point #6: This photo point shows the lower portion of Meander #2, as seen from the Resurrection Pass Trail (**figure 31**). Photos show old tailings piles, the channel diversion, and creation of the side channel pond.

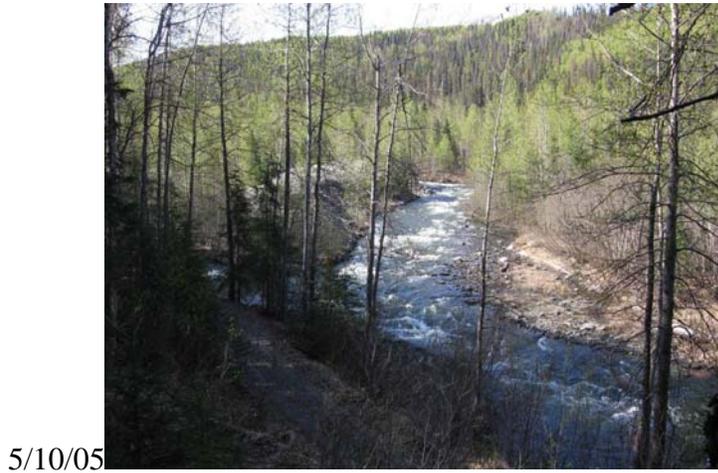
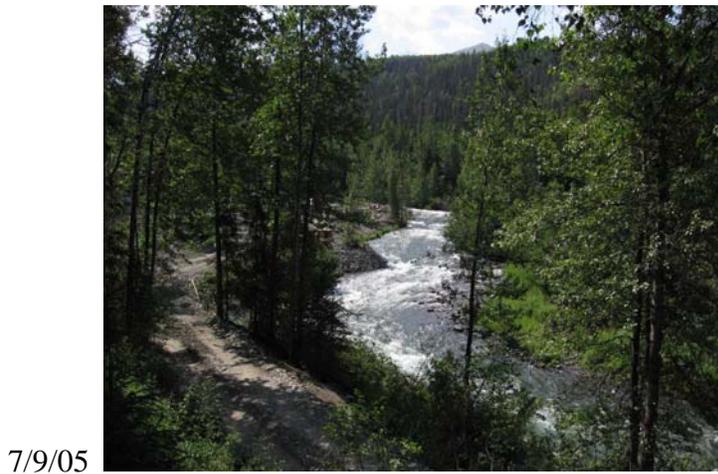
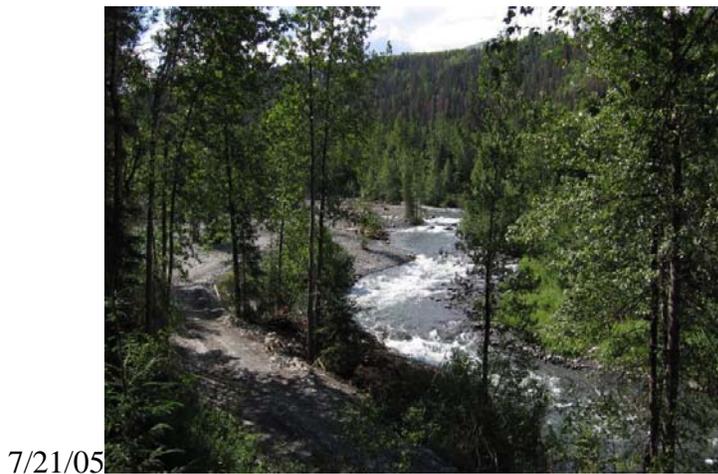
Figure 32: Sequence of photos from Photo Point #9.

Photo Point #9: This photo sequence shows an upstream view of the old Palmer Creek confluence, as seen from above the east-side road (**figure 32**). Photos show construction of the Palmer Creek fill and creation of two small rapids and pools in the channel.

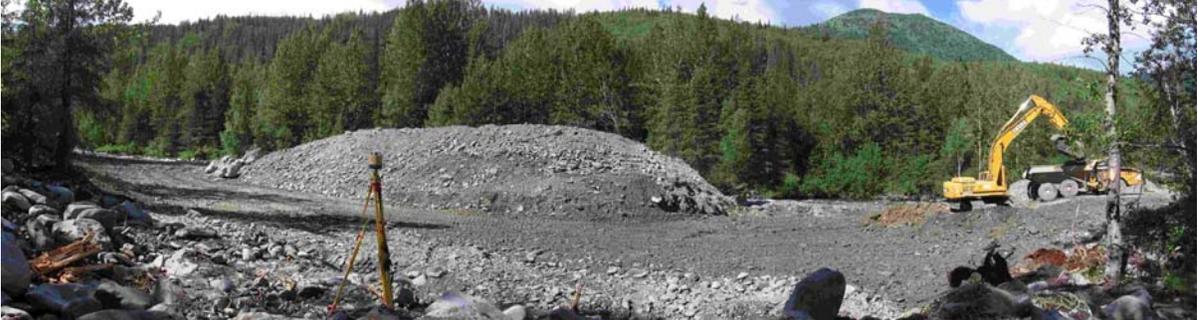
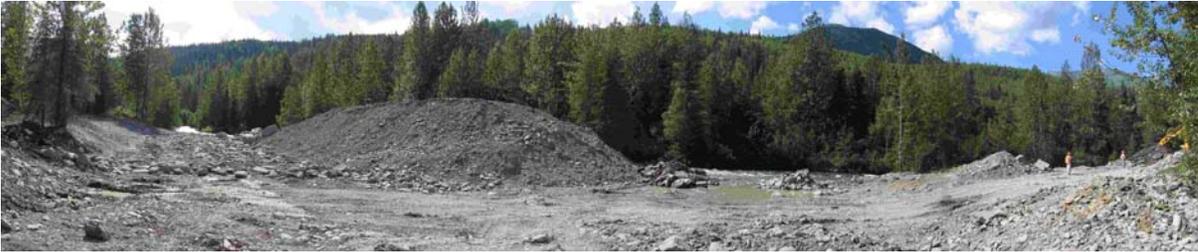
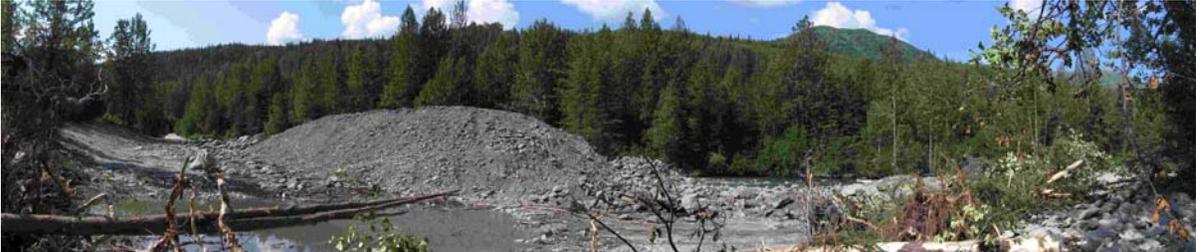
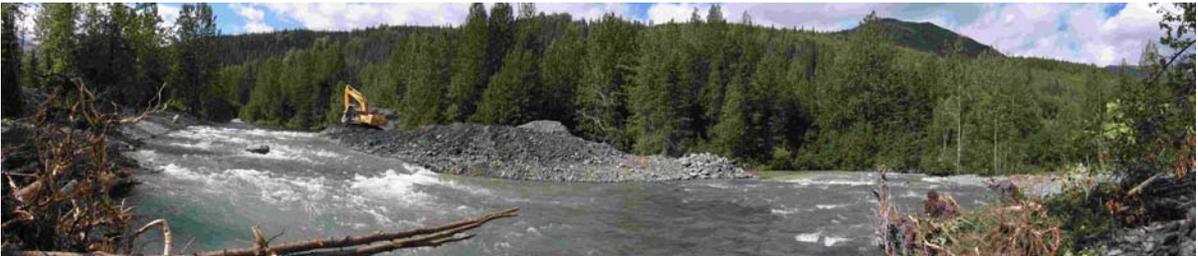
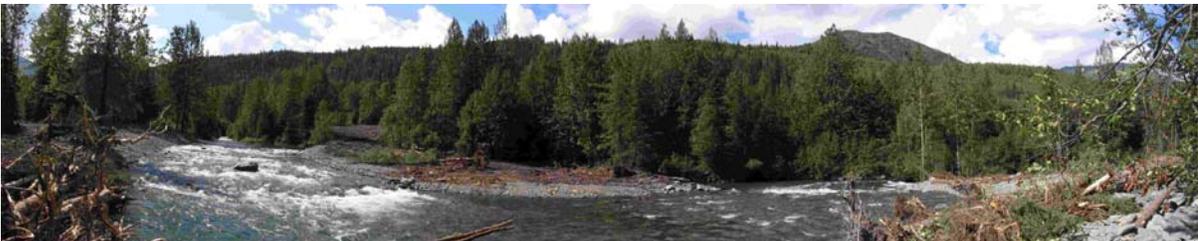
Figure 33: Sequence of photos from Photo Point #24.

Photo Point #24: This sequence of photos shows the construction of Meander #5, as seen from the right side of the channel (**figure 33**). Photos show the channel diversion, creation of the riffle, and smoothing of the floodplain.

- Meander 5 is a very tight bend, and the meander wavelength is short for the size of the channel. The left bank at the downstream portion of Meander 5 is fairly well protected by the steep hillside and terrace on the left, which includes a large pile of boulders. However, erosion may potentially occur on the floodplain area on the left bank point bar in the middle of the meander, or on the right bank point bar at the downstream end of the meander, possibly leading to a meander cutoff or realignment at some point in the future.

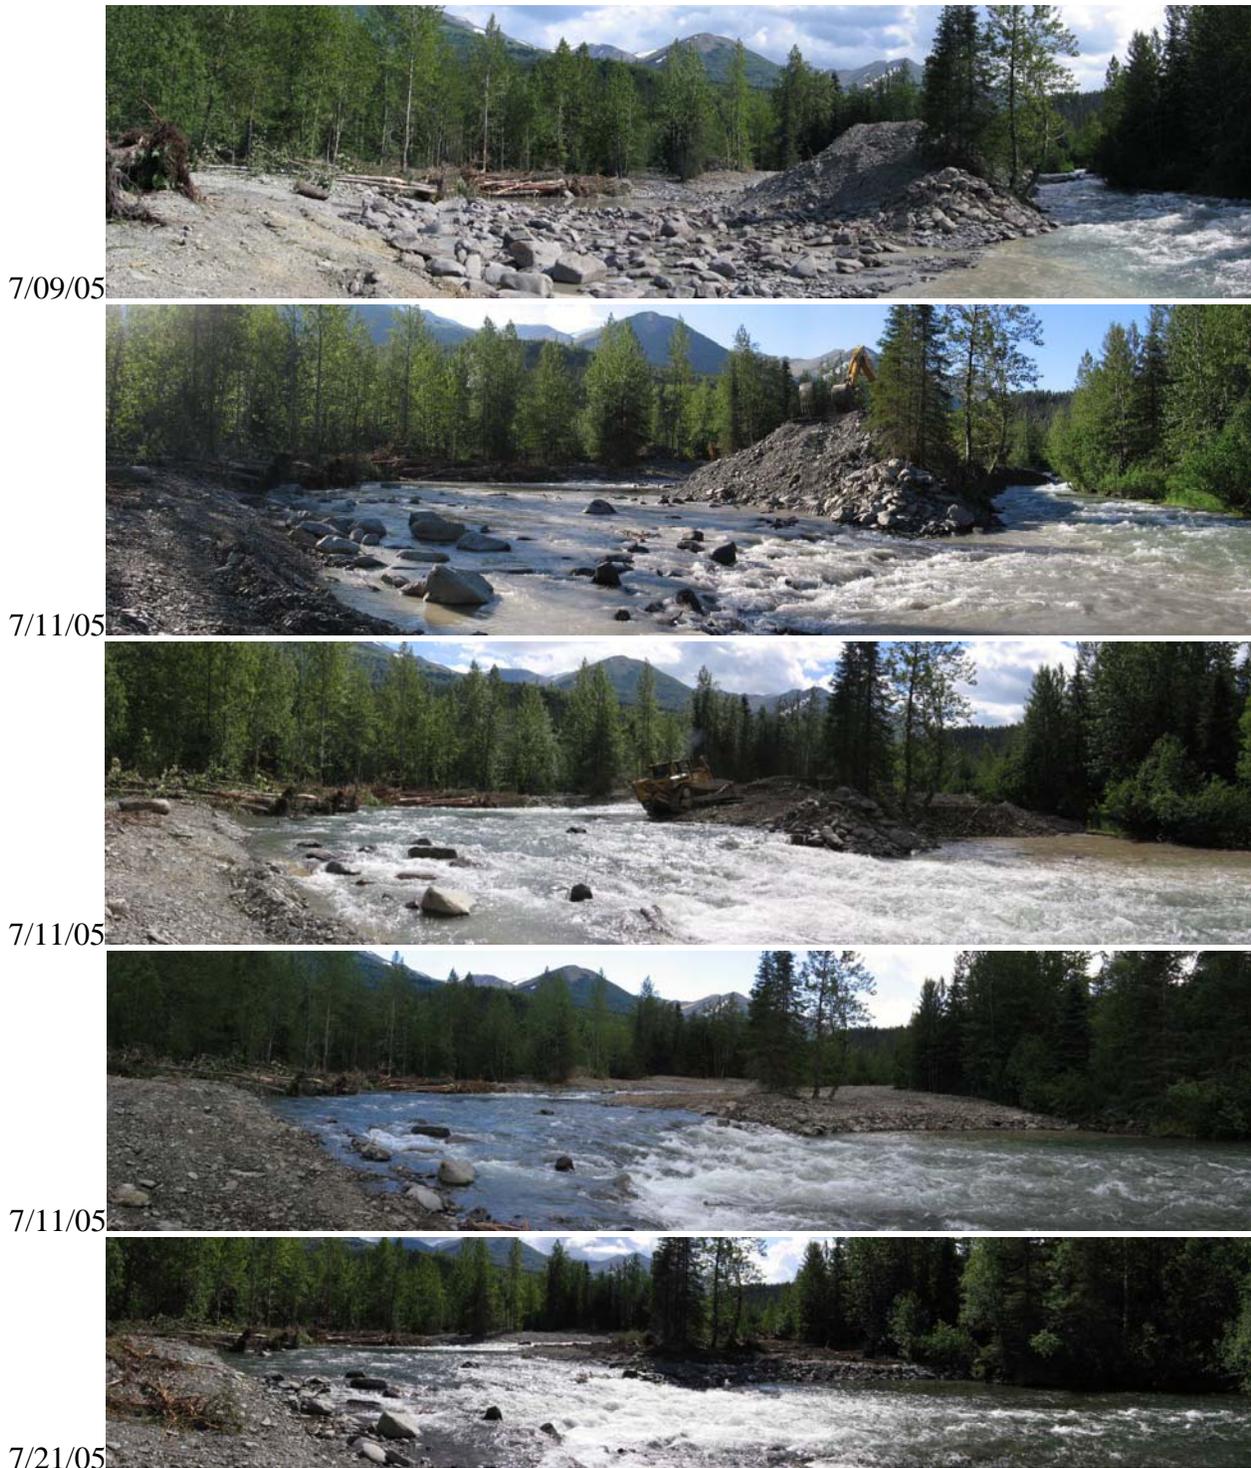
Figure 34: Sequence of photos from Photo Point #25.

Photo Point #25: This sequence of photos shows the construction of Meander #5, as seen from the downstream end of the meander (**figure 34**). Photos show the creation of the riffle, the channel diversion, and smoothing of the floodplain.

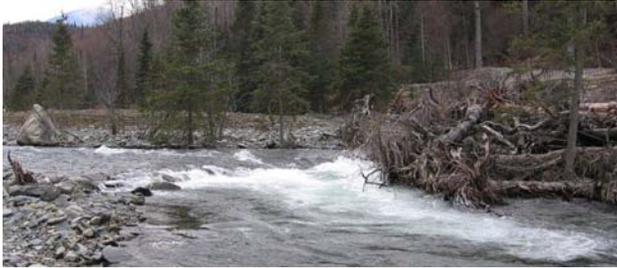
- The lower ends of the riffles at Meander 2 and Meander 5 are very steep (**figure 36**). High energy flows in these locations have the potential to move enough sediment so that headcutting may occur in these locations. Headcutting and downcutting of the channel at each of these riffles would potentially alter the inlets of the side channels just upstream. These areas should be closely monitored in 2006 and possibly reinforced.

Figure 36: Lower end of riffle at Meander 5 (top), and lower end of riffle at Meander 2 (left).

- Based on initial observations of potential headcutting at over-steepened ends of riffles, the transition areas from riffle to pool should be further reinforced with large boulders, and the slope of the riffle terminus should be decreased.
