**USDA Forest Service**  
**Southwestern Region**  
**Apache-Sitgreaves National Forests**

**Hannagan Meadow Motor Vehicle Accident  
Facilitated Learning Analysis**

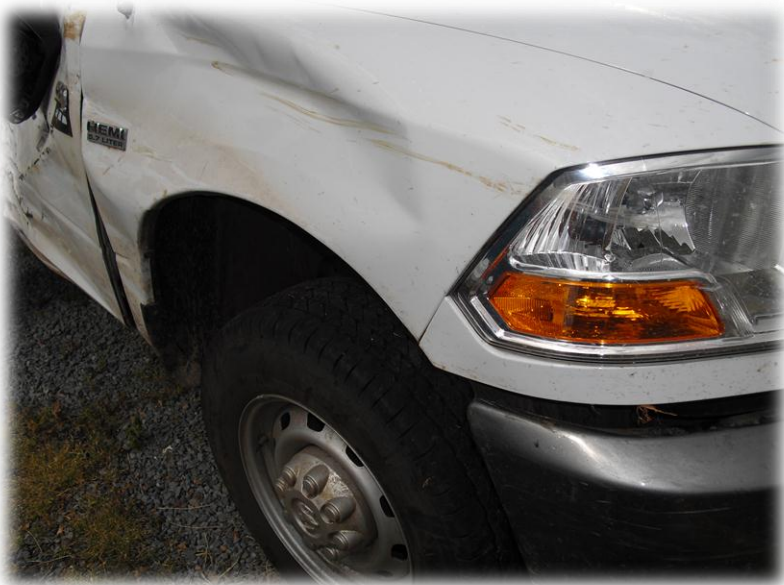
on FR26. Traveling approximately one mile on FR26, the work crew turned south at its intersection with HWY191. After following the lead vehicle for about eight miles, the driver of the second vehicle “started to sneeze”, tilting his head back slightly and closing his eyes. It was at this point that the road began to curve to the left. The passenger, noticing that the vehicle was “drifting to the right” and about to leave the roadway, yelled at the driver to “look out”. The right front tire of the vehicle dropped off of the asphalt surface, pulling the vehicle off of the highway. The driver attempted to correct by turning the steering wheel to the left. Departing the roadway at approximately fifty miles per hour the vehicle proceeded downward onto the soft shoulder as the driver attempted his corrective maneuver. As the vehicle began a slight turn back towards the roadway the right front fender impacted an eight inch DBH tree.

Due to the momentum of the vehicle and the angle and force of the impact, the tree began to collapse the passenger side of the vehicle. Upon impact with the right rear passenger door the vehicle came to a stop.

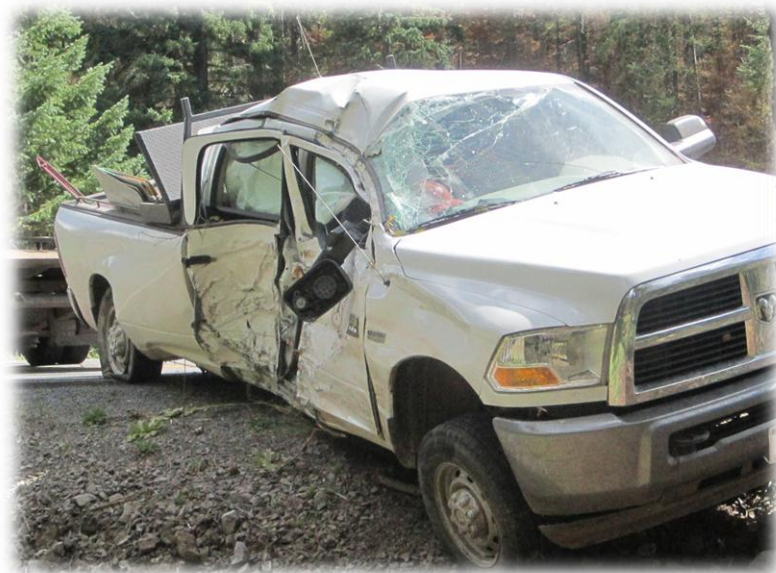
“A serious head injury to the passenger because of impact with the crushed interior door frame was avoided because he was still wearing his hard hat”
