## **BATTLE CREEK: LESSONS LEARNED FROM TINKERING AT A CONFLUENCE**

**Steven E. Yochum, Hydrologist**, US Forest Service, National Stream & Aquatic Ecology Center, Fort Collins, CO, [stevenyochum@fs.fed.us](mailto:stevenyochum@fs.fed.us)

prepared for the 10<sup>th</sup> Federal Interagency Sedimentation Conference  
April 19-23, 2015, Peppermill Hotel, Reno, Nevada, USA

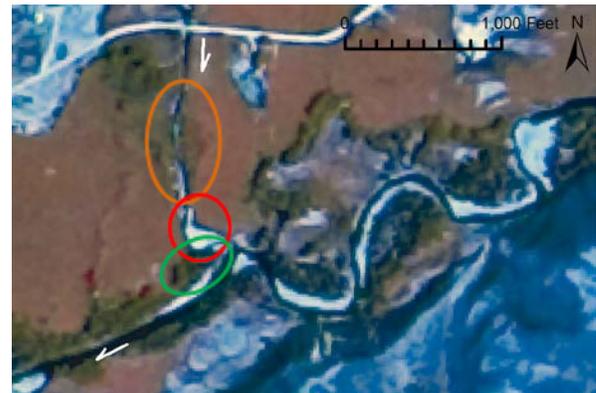
Over this period, the aerial images indicate cyclic sediment deposition and vegetative colonization along the last 1000 feet of Battle Creek upstream of the confluence. In 1953 (Figure 7), an upper depositional bar is apparent in Battle Creek (orange oval). This bar is in a similar location as the bar deposited in 2010 and 2011. A couple of small unvegetated bars are also visible in the lowest portion of Battle Creek (red circle). By 1968 (Figure 8) the upper depositional bar (orange oval) has become well vegetated though an avulsion across the bar is visible. Flow appears to be split at this point in time. The lower depositional bar has enlarged a bit, with a short series of exaggerated meanders at the confluence. Between 1968 and 1980 (Figure 9) the (streamwise) left channel has filled in the formerly unvegetated upper bar (orange oval) and Battle Creek flows in a single, relatively strait channel through this upper reach. This portion of the floodplain appears to be well vegetated. The increasing meandering form indicated in 1953 and 1957 straitened in 1968 and maintained this form in 1980. The lower depositional bar (red circle) has again increased in size and maintained little vegetative growth, with a growing point

Figure 7: Aerial image (8/23/1953).

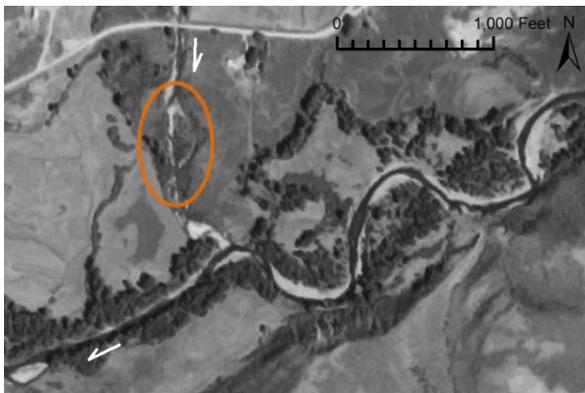
Figure 9: Aerial image (7/28/1980).
