BUCK CREEK

Site Information

Culvert Scour Assessment

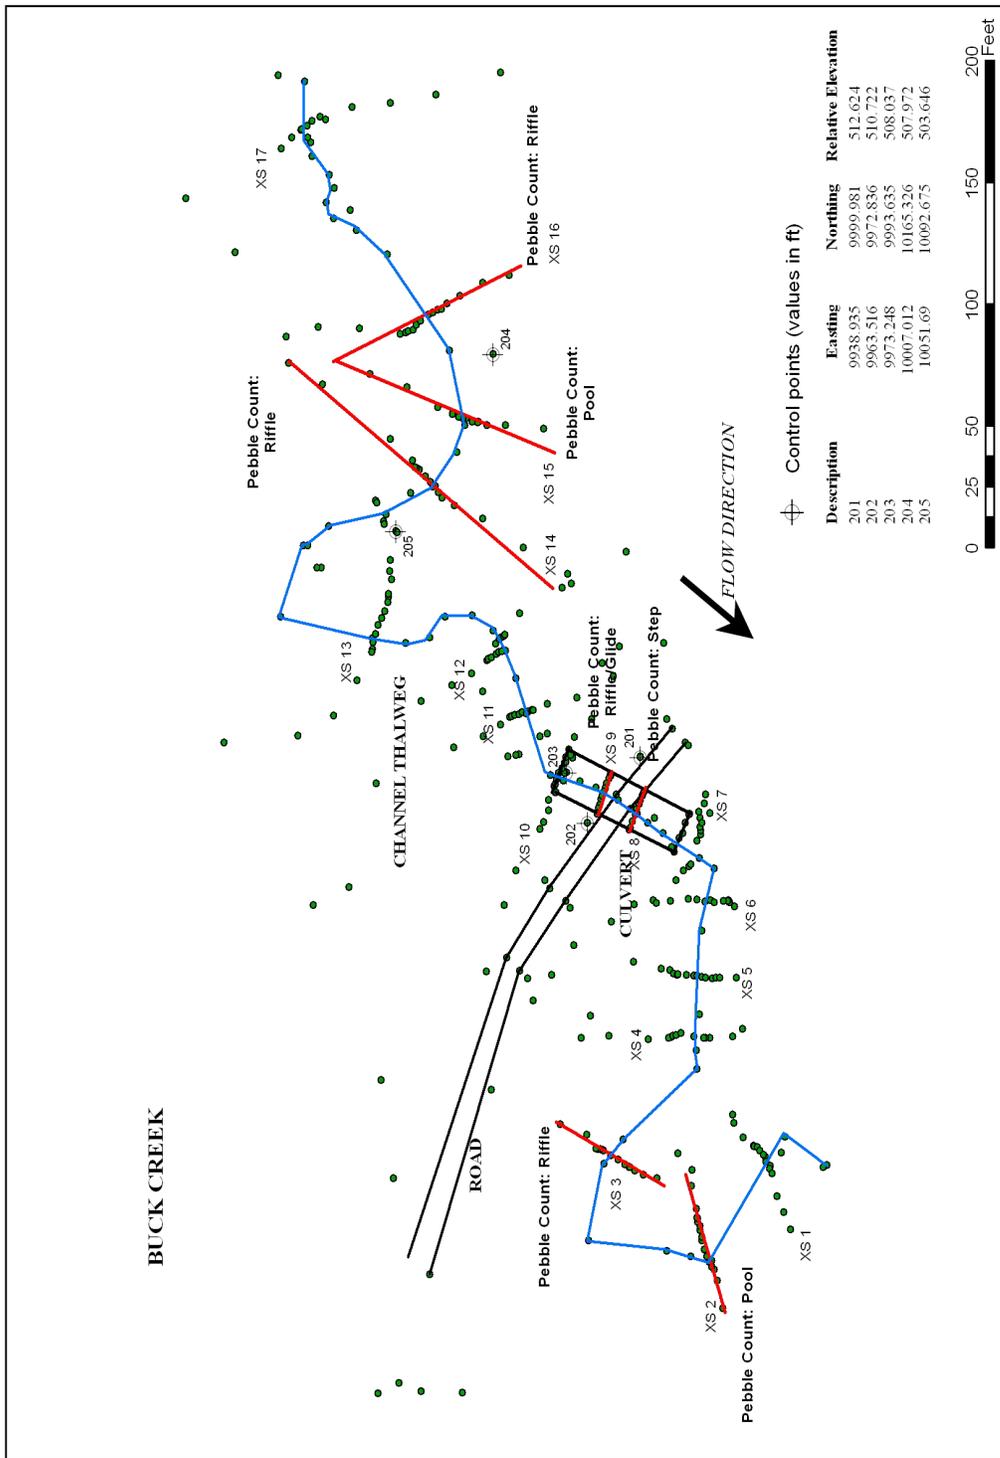
Figure 1—Plan view map.

Points represent survey points

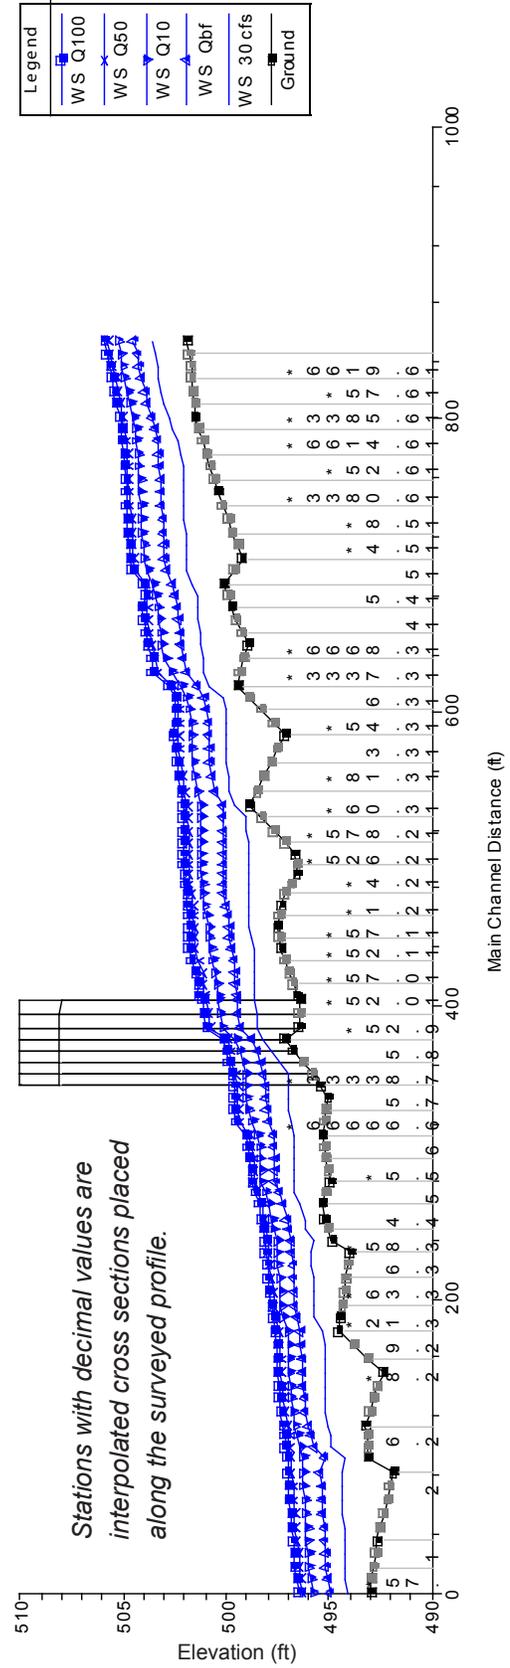
Figure 3—HEC-RAS profile

Profile characteristics—The most characteristic feature of the profile is a steep segment in the downstream portion of the culvert (figure 2). There is also an overall segment of steeper gradient extending from the first hydraulic control downstream of the outlet to the second hydraulic control upstream of the inlet. There was also channel incision noted both upstream of the inlet (extending 250 feet) and downstream of the outlet (extending approximately 80 feet). It is unknown whether this incision is related to this culvert or a previous installation. Downstream of the outlet, the channel abuts a high terrace along the left bank where it causes erosion of

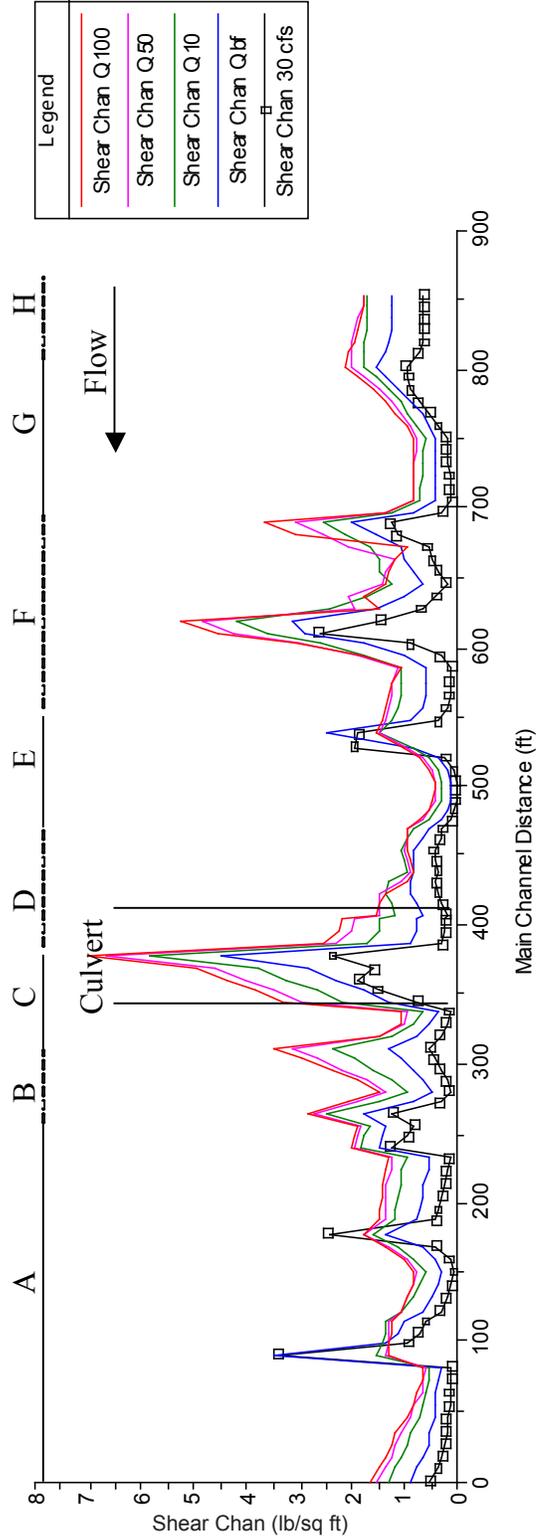
Figure 10—Shear stress (channel) profile.

Shear stress—Shear stress in the culvert is similar to the upstream and downstream channel for the range of flows (figure 19). However, the downstream segment of the culvert has higher median values than the upstream channel segment (G). The difference between the two culvert segments can be attributed to the change in slope. This transition between segments C and D experiences the highest shear stress values in the entire reach (figure 10). The upstream transition segment E's shear stress is similar to, if not slightly less than, the upstream channel segment G for all flows, a phenomenon related to backwater effects of the culvert.

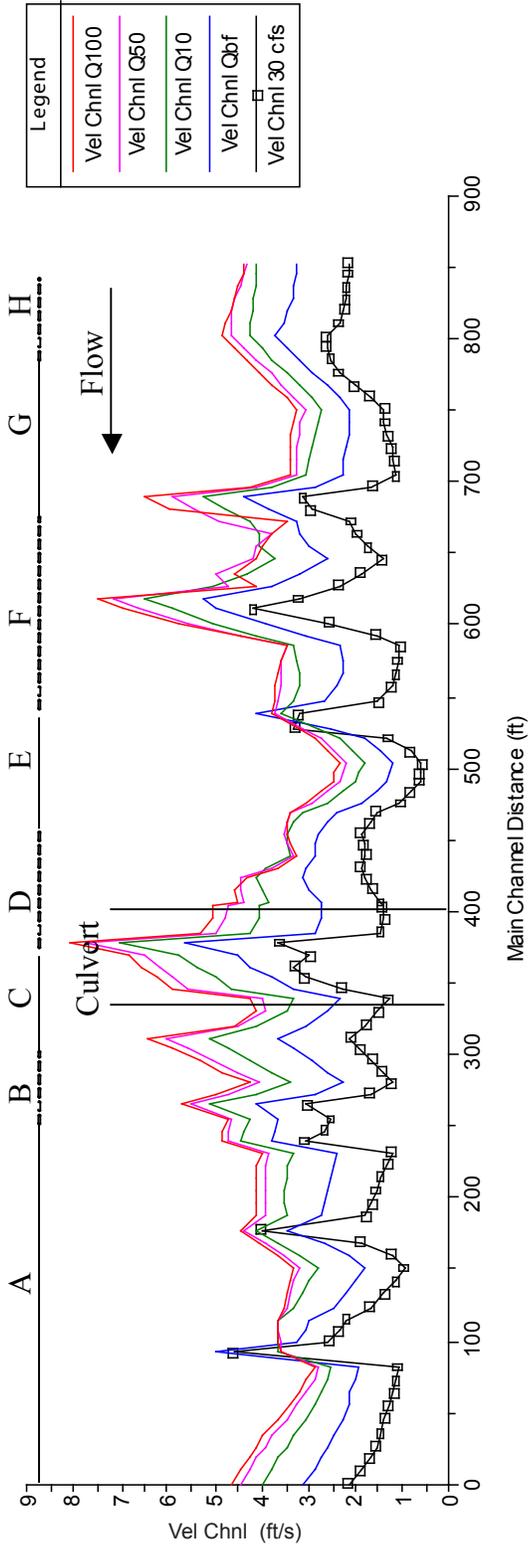
Figure 11—Velocity (channel) profile plot.

Velocity—Velocity in the upstream culvert segment (D) is similar to the upstream representative channel segment (F) but higher than the downstream representative segment (A) at the Q_{10} and above (figure 11, figure 18). Velocity in the downstream culvert segment (C) is higher than the upstream representative segment (G) at the Q_2 and above. These higher culvert velocities correspond to the flow contraction (reduction in flow area) caused by the culvert. The upstream transition segment (E) is similar, if not slightly less than, the upstream representative channel segment (G).

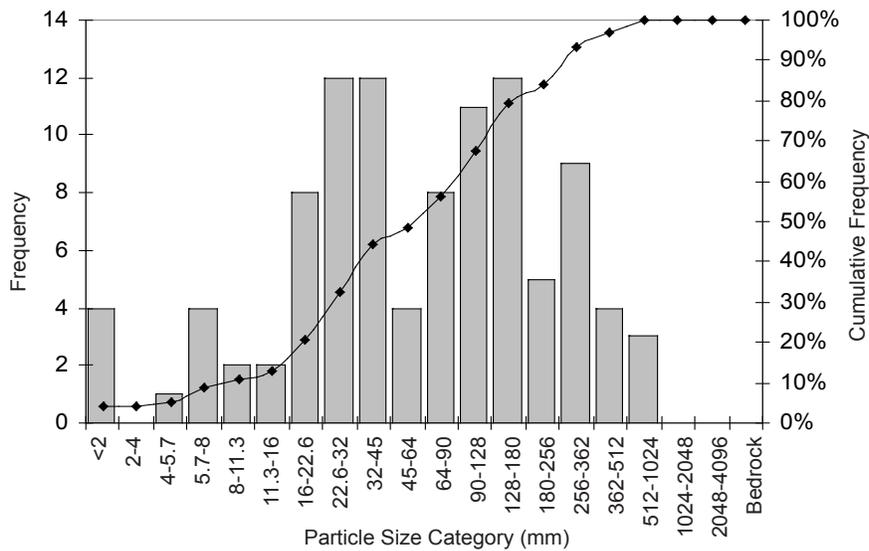
Cross section: Culvert—Upstream Pebble Count

Size Class	Size percent finer than (mm)
D5	6
D16	20
D50	70
D84	240
D95	406
D100	610

Material	Percent Composition
Sand	4%
Gravel	45%
Cobble	36%
Boulder	16%
Bedrock	0%

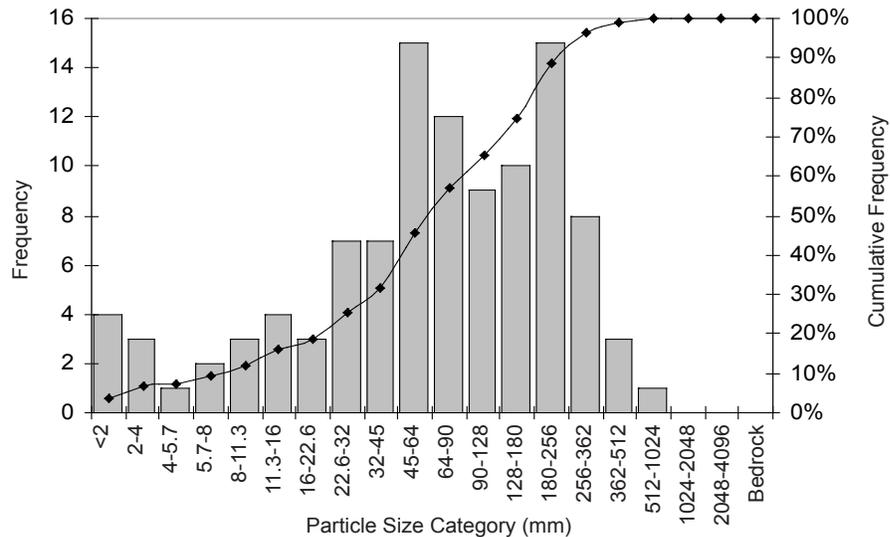
Cross section: Culvert—Downstream Pebble Count

Size Class	Size percent finer than (mm)
D5	3
D16	18
D50	80
D84	210
D95	337
D100	610

Material	Percent Composition
Sand	4%
Gravel	42%
Cobble	43%
Boulder	11%
Bedrock	0%
