Culvert Scour Assessment

Deadwood Creek Tributary North

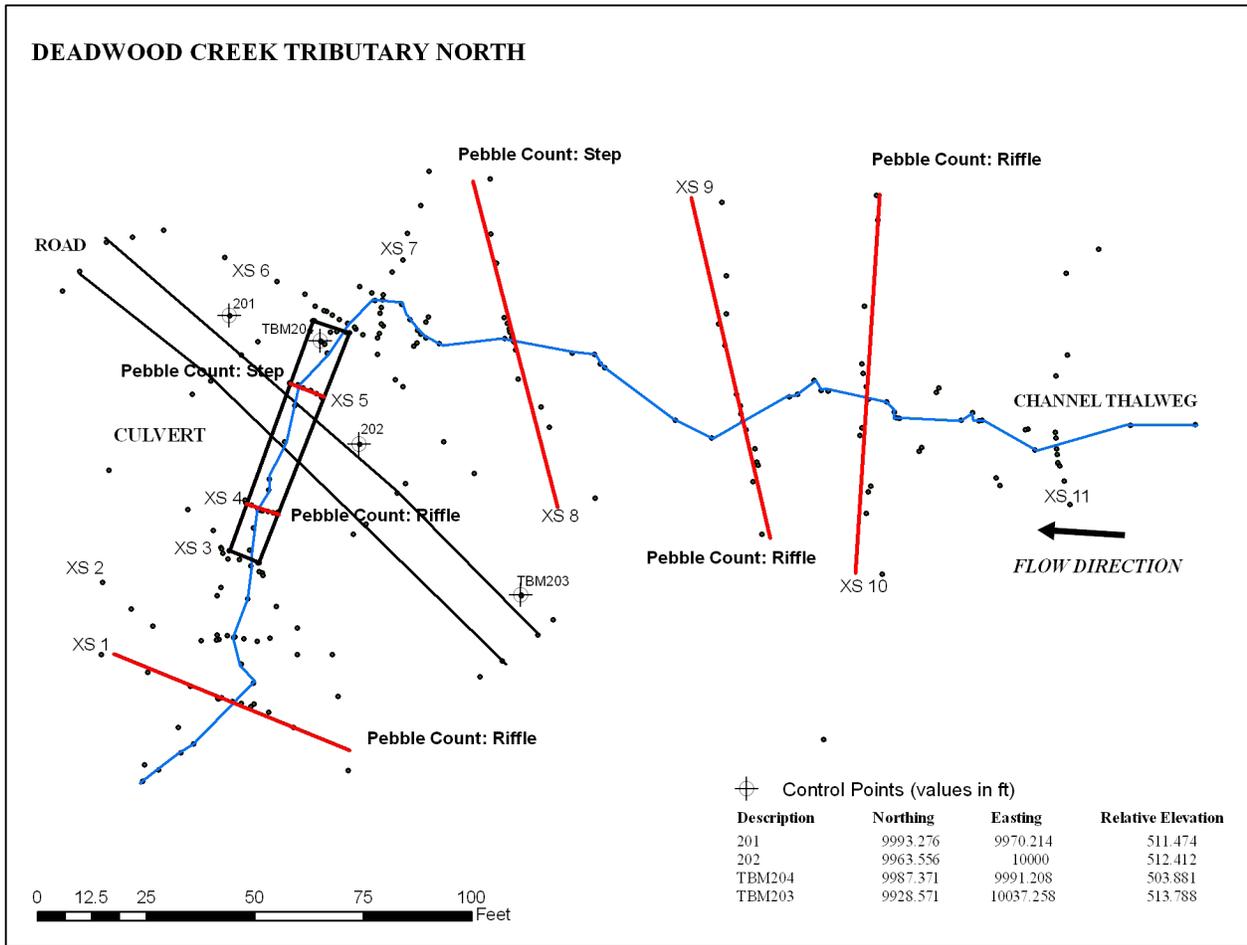
Figure 1—Plan view map.

Alignment Conditions: Culvert aligned to minimize length under road, thus creating greater slope and necessitating riprap deflector on right bank at inlet and also requiring a riprap step downstream of outlet to control grade.

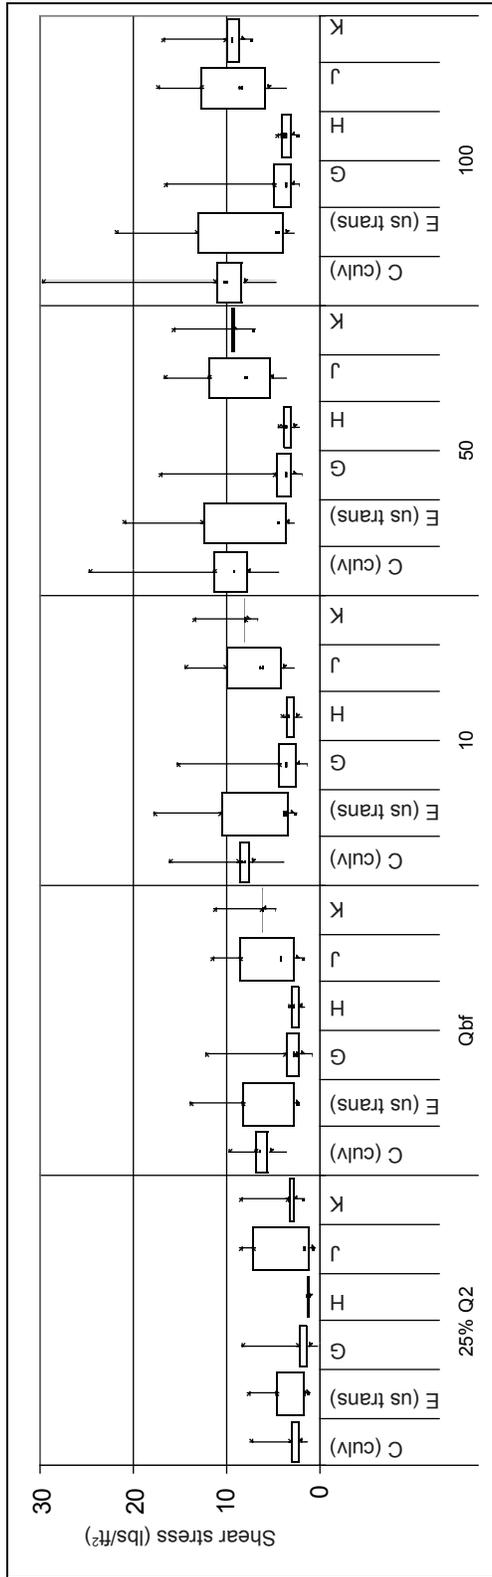
Figure 19—Shear stress (channel).

Shear stress – Shear stress appears to increase in the culvert compared to the upstream channel (figure 10) and then increases even more just downstream of the culvert. When compared to comparable slope segments, the culvert shear stress values are mostly within the range of natural channel conditions (figure 19); however, the maximum value for shear in the culvert is nearly twice the maximum value found in any of the comparable slope segments. The upstream transition segment shear is also within the range of its comparable slope segments.

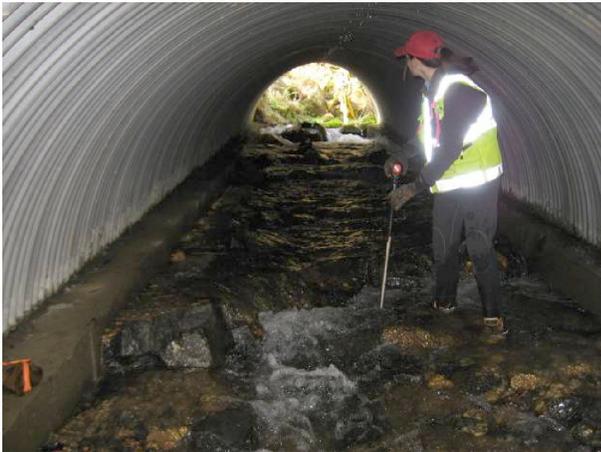
View upstream through culvert.

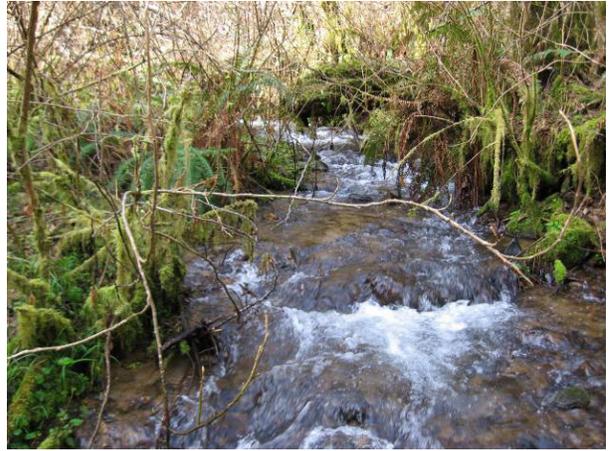
View upstream from confluence with Deadwood Creek.
