Culvert Scour Assessment

Eames Creek

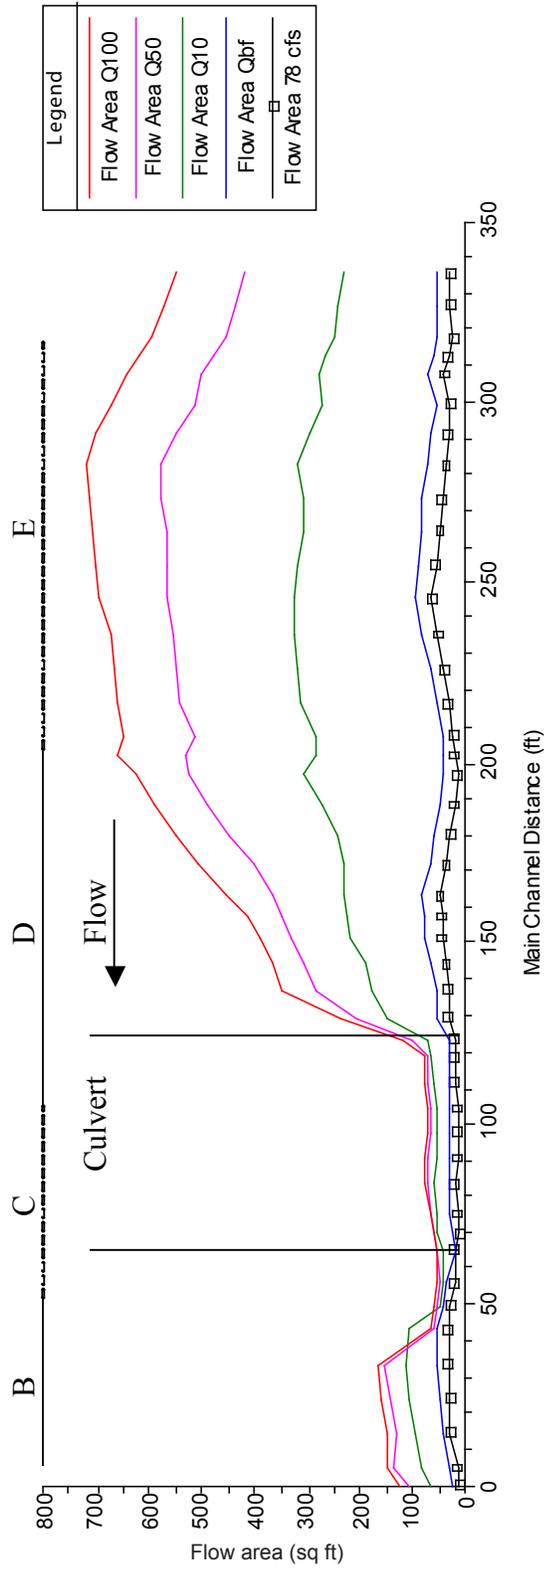
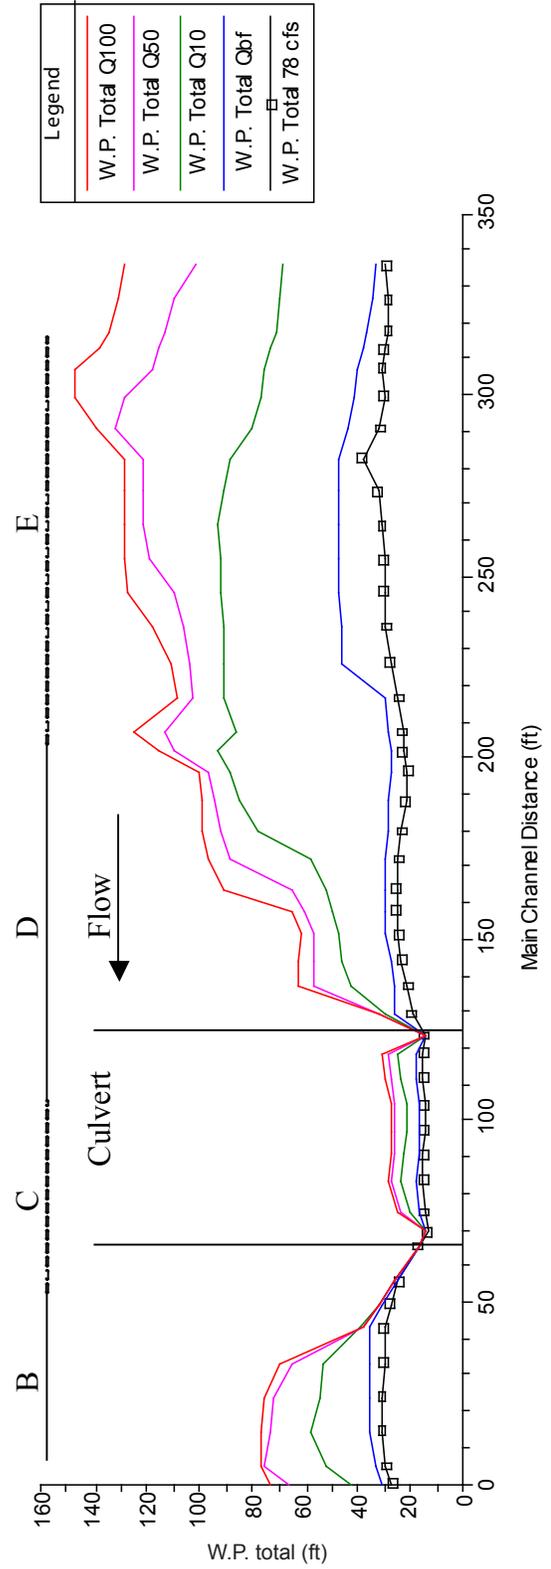
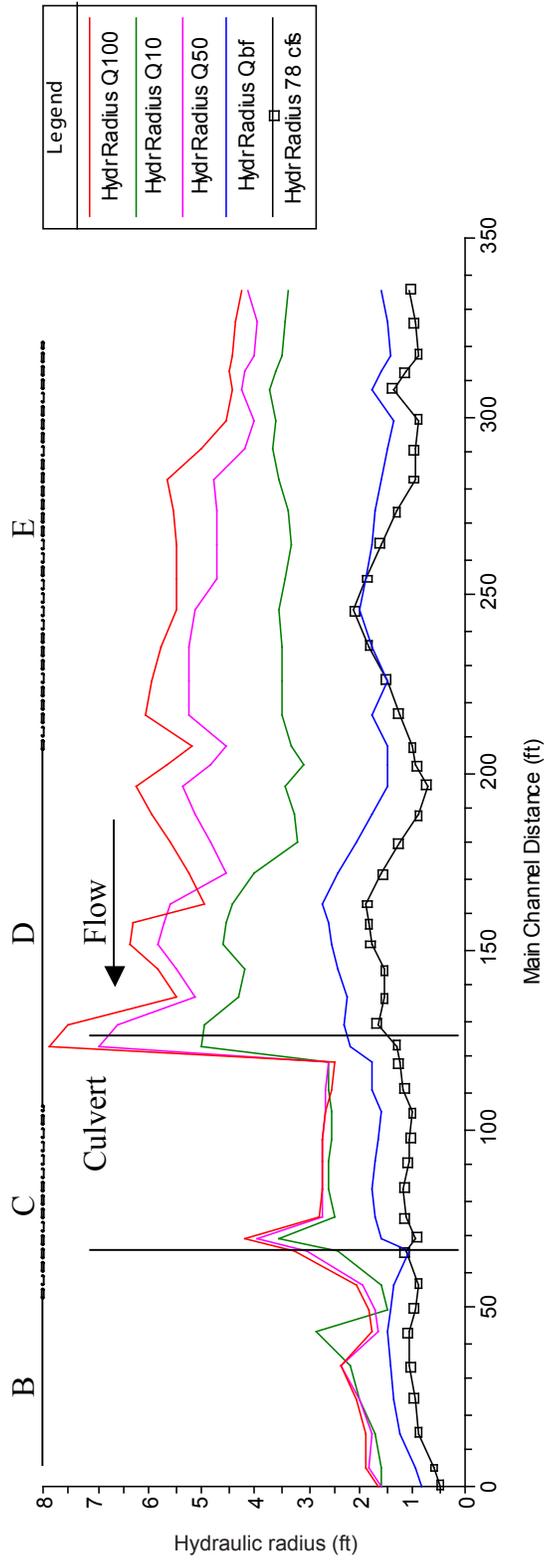
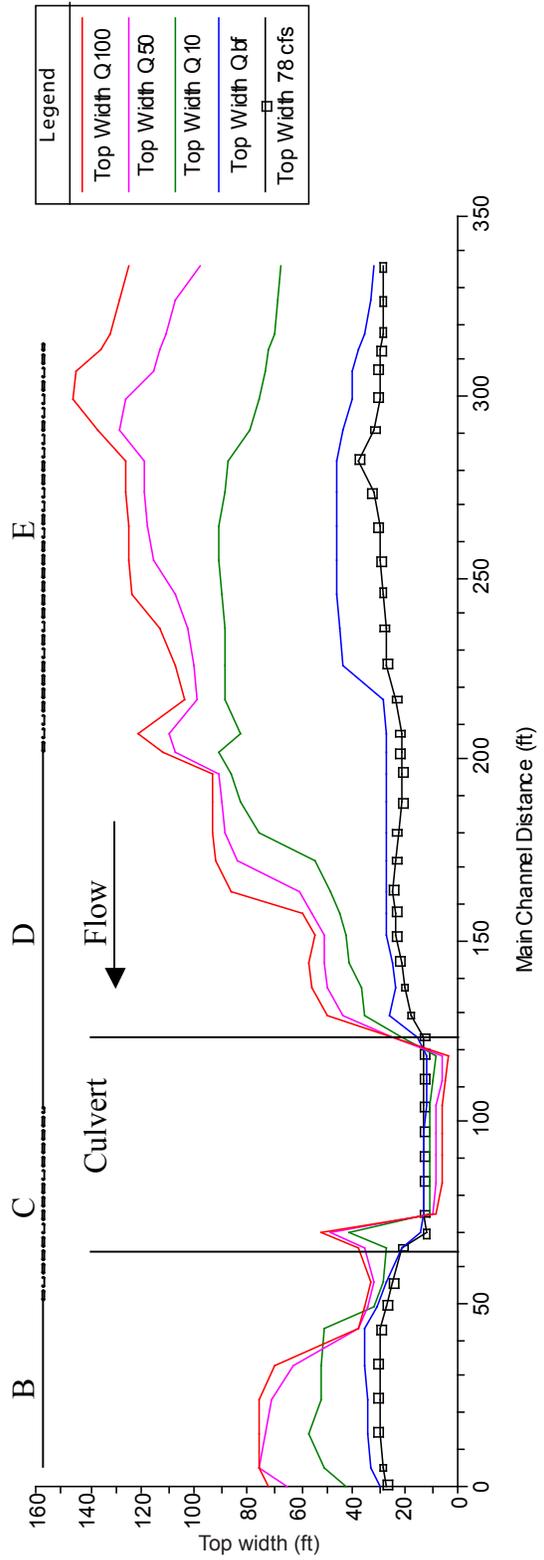
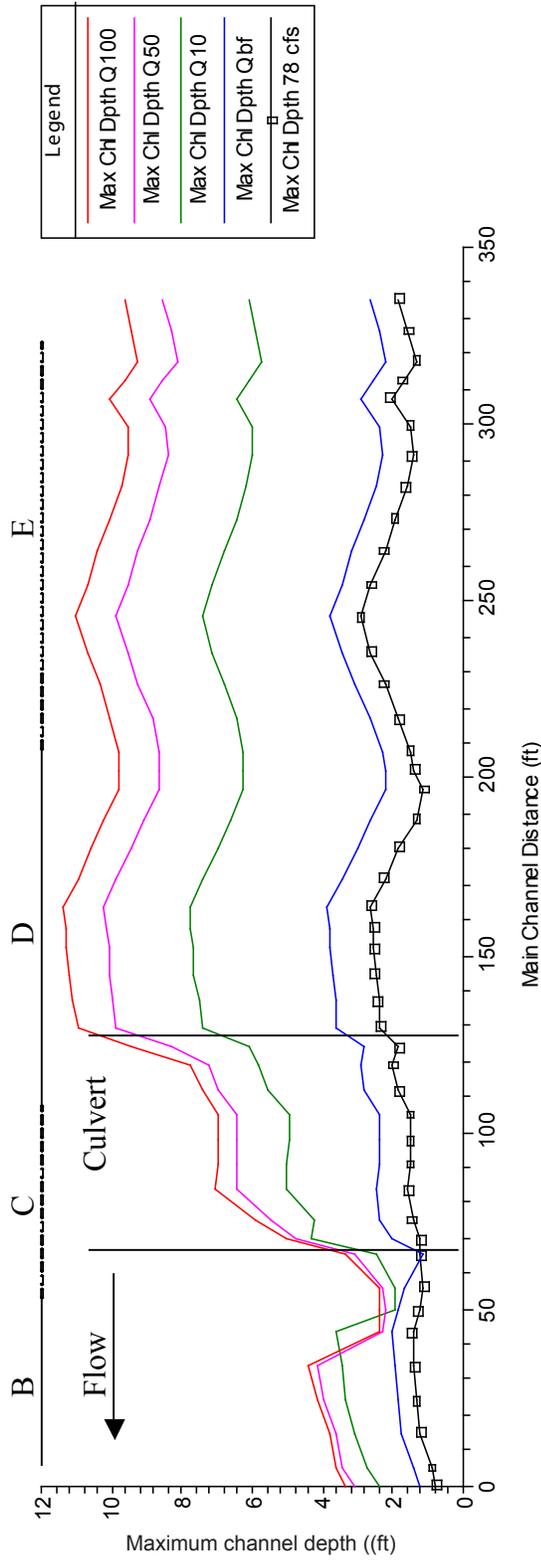
Cross-section characteristics – The culvert has a large effect on cross-section flow characteristics throughout the entire reach. The profile segments in the natural channel cannot be considered good reference conditions because they are impacted by backwater effects from the culvert. Because of the backwater impacts, flow geometry changes dramatically from the upstream reach, through the culvert, and into the downstream reach (figures 5 through 9 and 12 through 17).
