FALL CREEK

Site Location:	Willamette NF, S Willamette Valley, Fall Cr Rd west of Eugene		
Year Installed:	Circa 1999		
Lat/Long:	122°22'3.96"W	Watershed Area (mi²):	3.55
	43°59'56.83"N	Channel Type:	Step-pool
Stream Slope (ft/ft)¹:	0.0359	Survey Date:	April 4, 2007
Bankfull Width (ft):	21

Culvert Scour Assessment

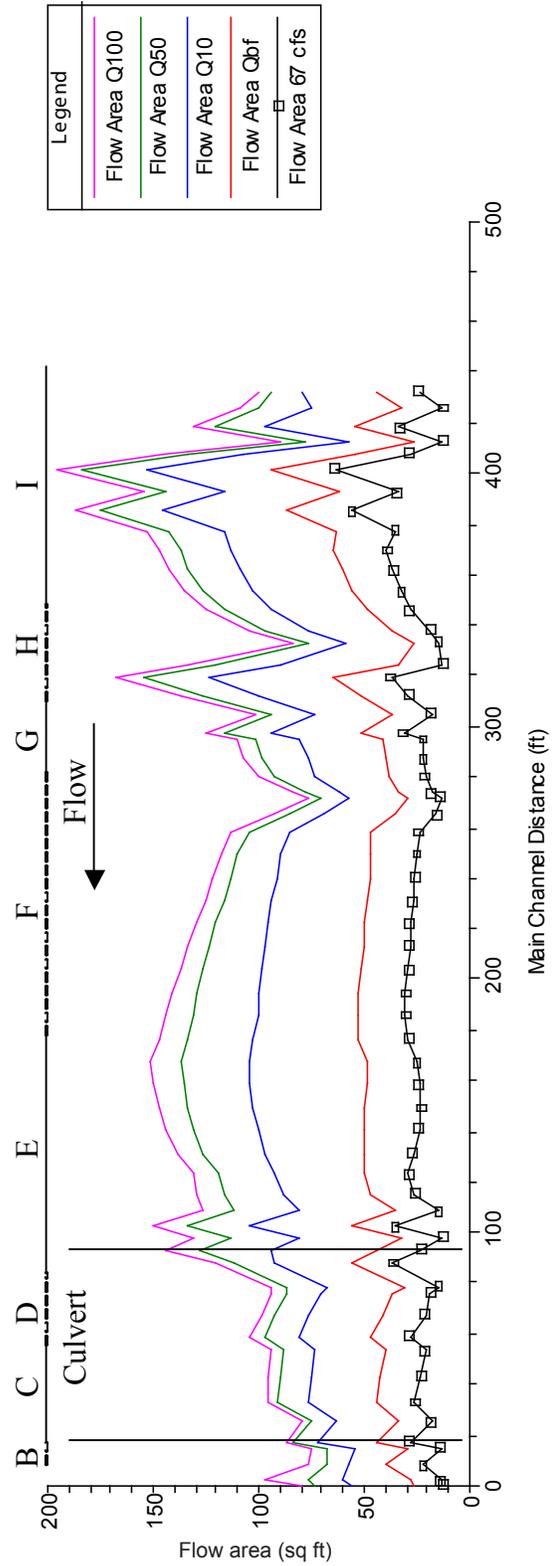
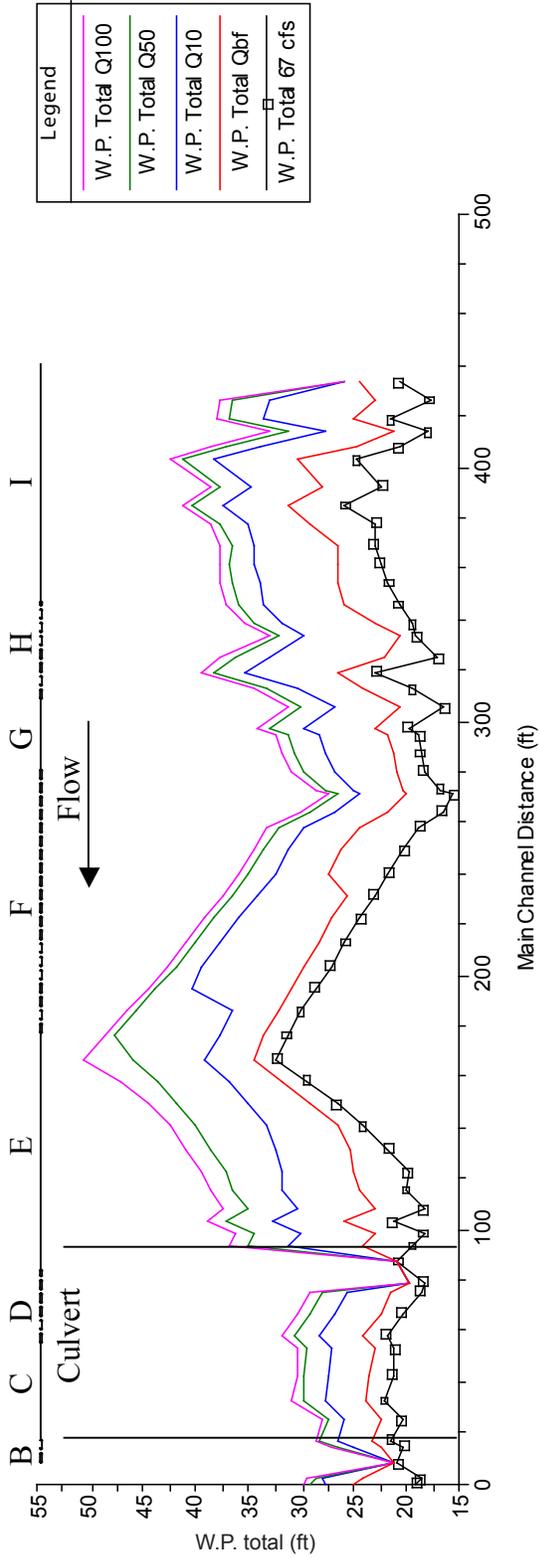
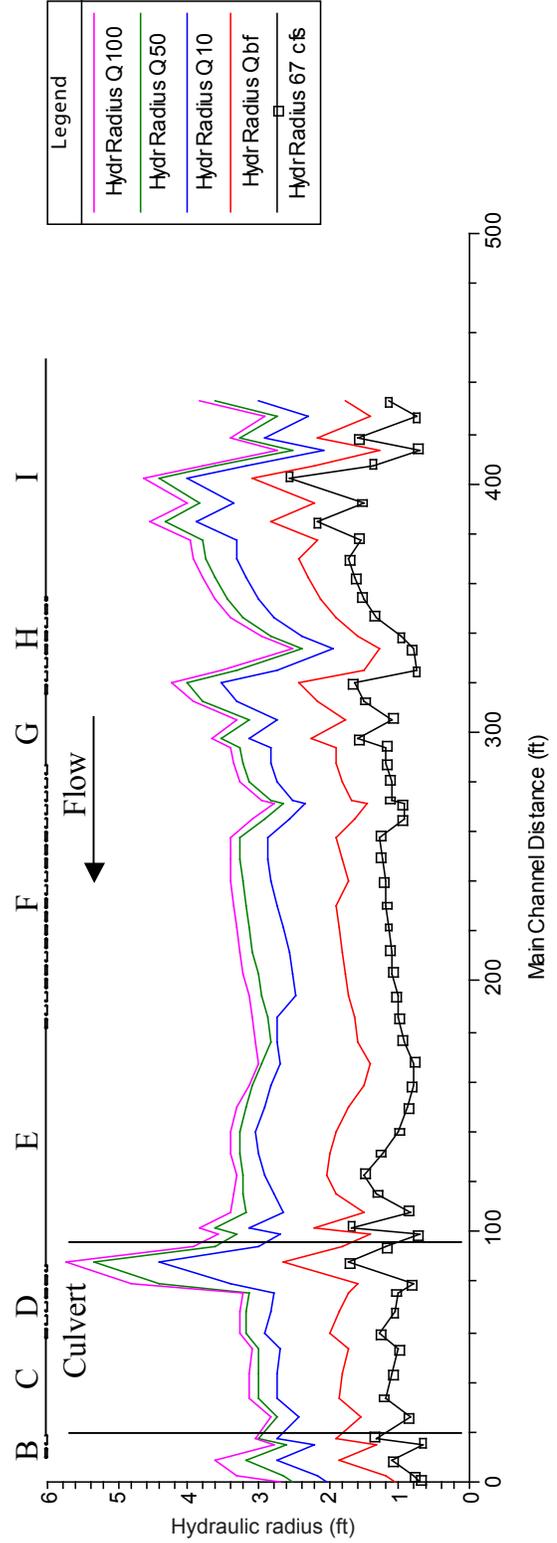
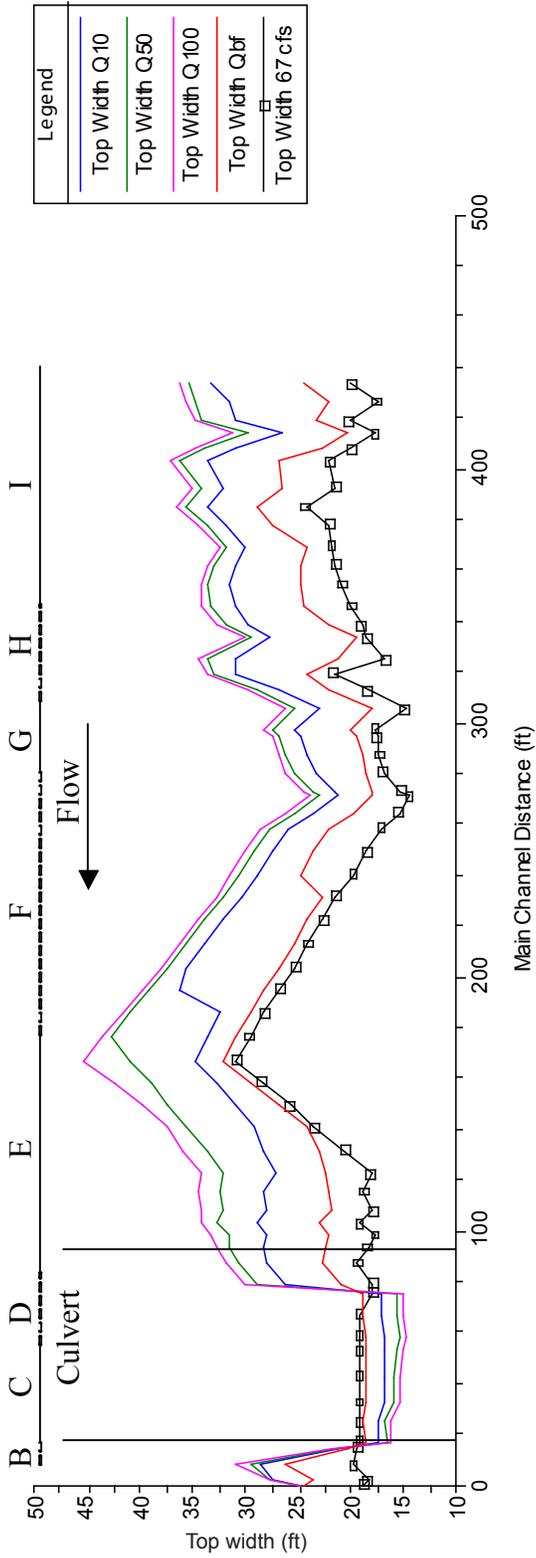
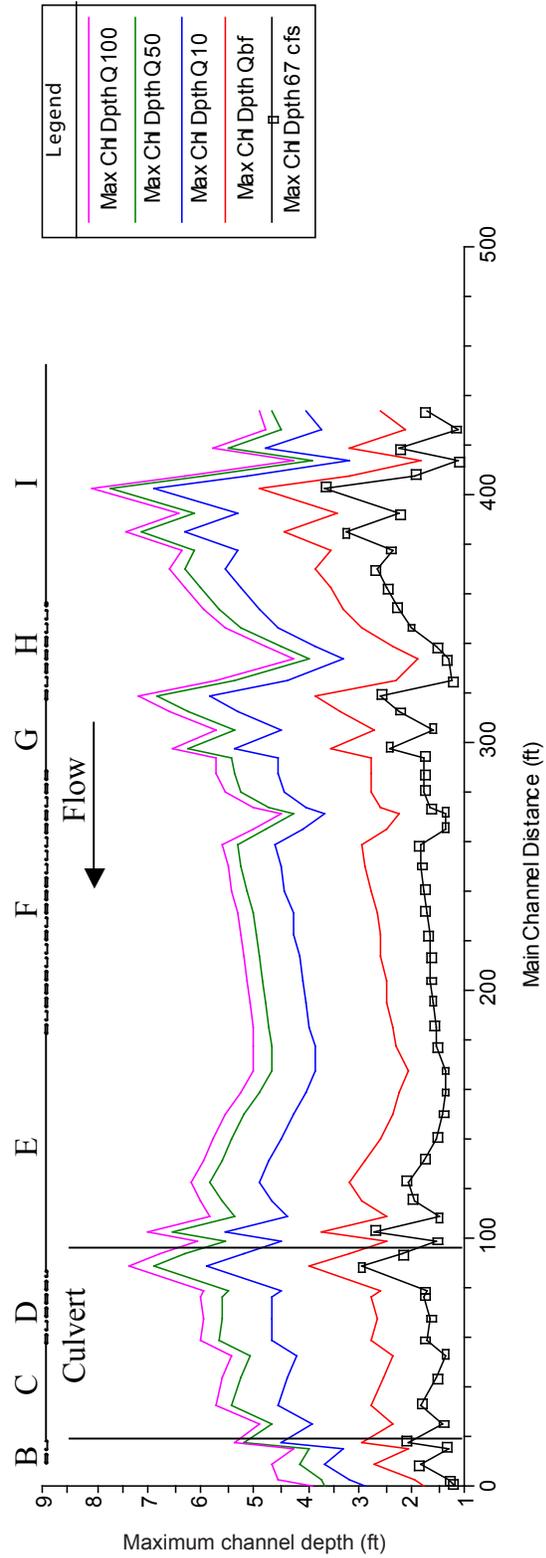
Cross-section characteristics – Cross-section flow characteristics are affected by the culvert, particularly with respect to the width-related measures top width and wetted perimeter (figures 5 through 9 and 12 through 17). This is true for culvert segments (B, C, and D) and the upstream transition segment (E).

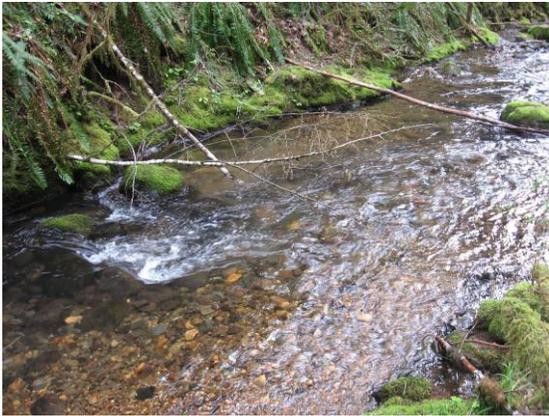
Substrate – The culvert bed material distribution is similar to the downstream sample site in the upstream channel. The upstream sample in the upstream channel exhibits a greater proportion of sand and bedrock. These differences can be attributed to the habitat unit (pool in the upstream channel) and the location adjacent to a bedrock wall along the left bank. Pebble count data is presented at the end of this site summary.

Upstream reference reach – upstream pebble count, pool.

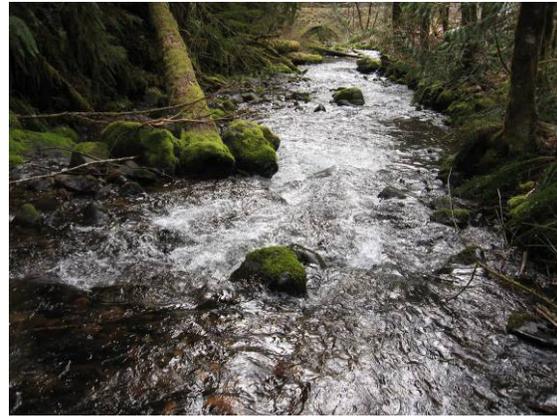
Upstream reference reach – downstream pebble count, steep riffle/step.
