Lower Eightmile Creek

Site Information

Culvert Scour Assessment

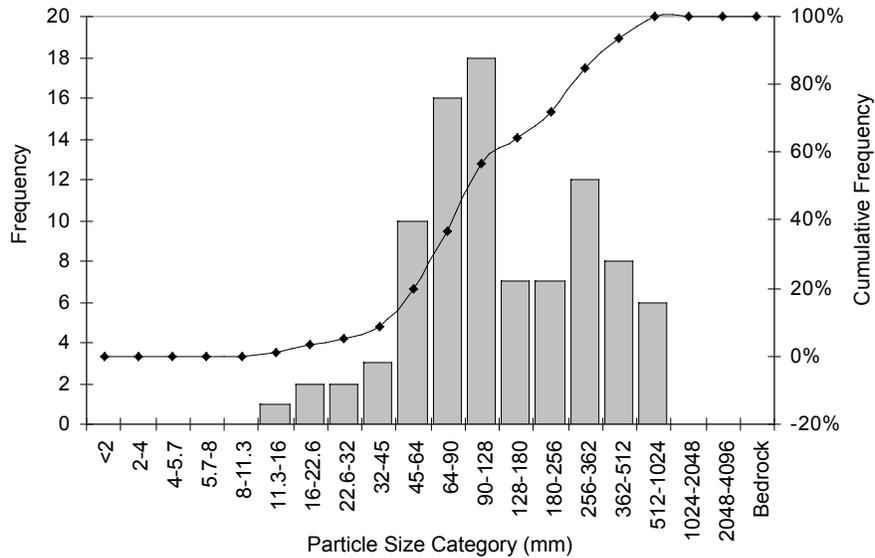
Cross section: Culvert – Downstream Pebble Count

Substrate – The bed material in the pool in the upstream portion of the culvert has more coarse material and fewer fines than pools in the upstream and downstream channels. This pool is more glide-like (higher velocity and less residual depth) than the pools in the natural channel. The step in the culvert also has more coarse material than the riffles/steps in the natural channel. The D_{84} and D_{95} s are both larger in the culvert than in the riffle and step units in the natural channel. There are also fewer fines in the culvert.
