Culvert Scour Assessment

UPPER EIGHTMILE CREEK

Site Location:	Mt Hood NF, Forest Road 4430 150 spur. Middle culvert in upper Eightmile Campground area		
Year Installed:	2000		
Lat/Long:	121°27'21.9"W	Watershed Area (mi²):	4.1
	45°24'24.7"N		
Stream Slope (ft/ft)¹:	0.0422	Channel Type:	Step-pool
Bankfull Width (ft):	20.5	Survey Date:	April 26, 2007

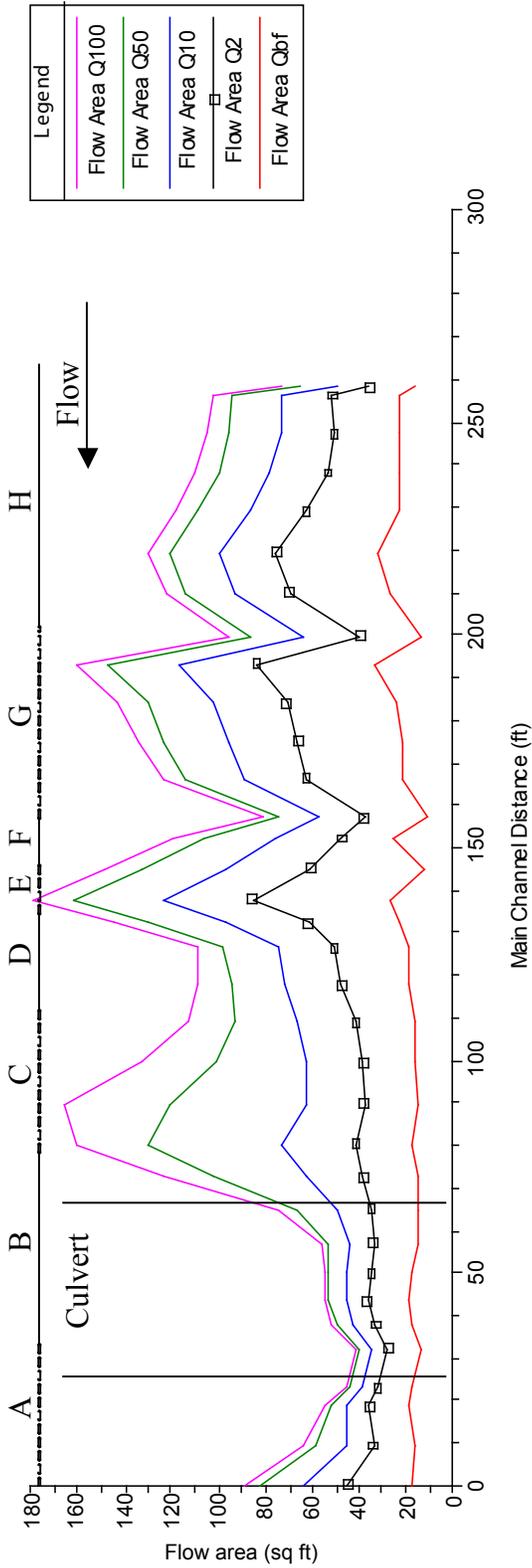
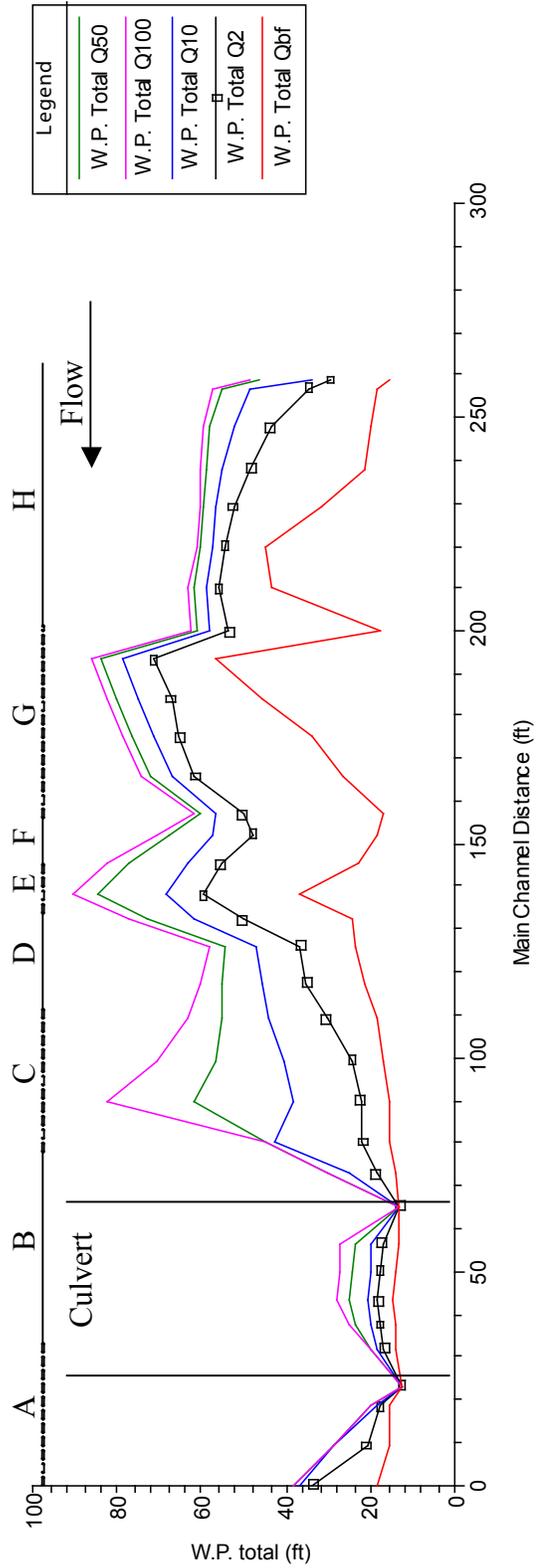
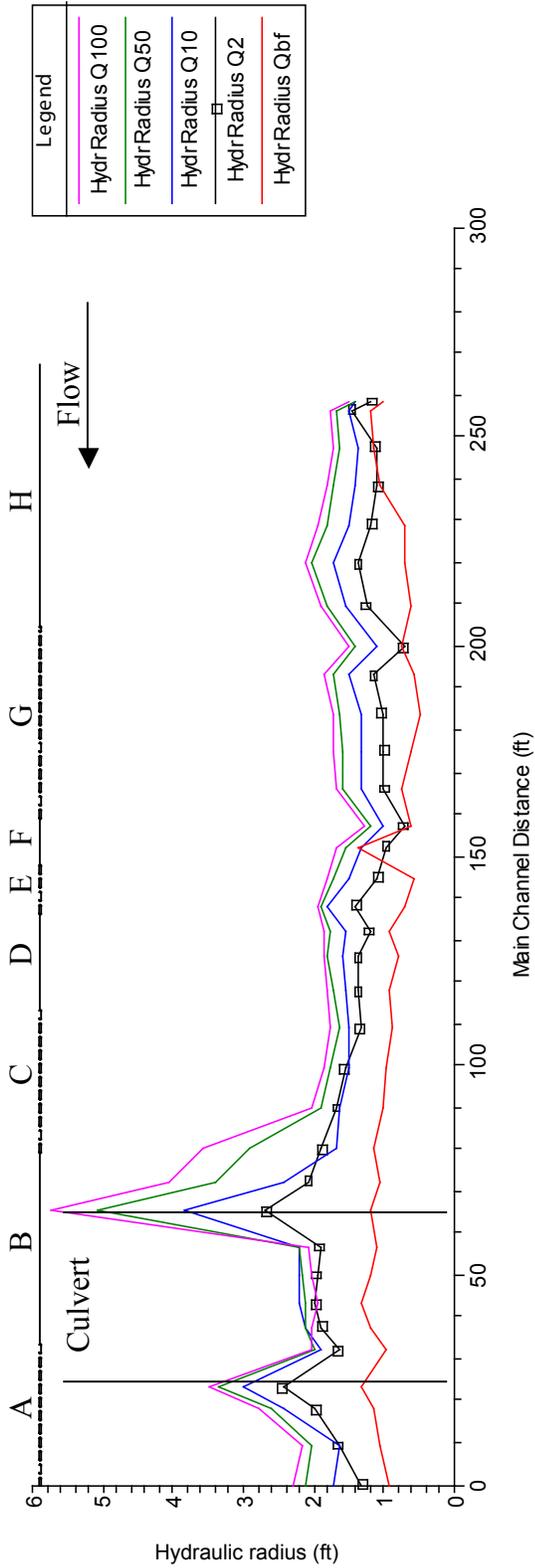
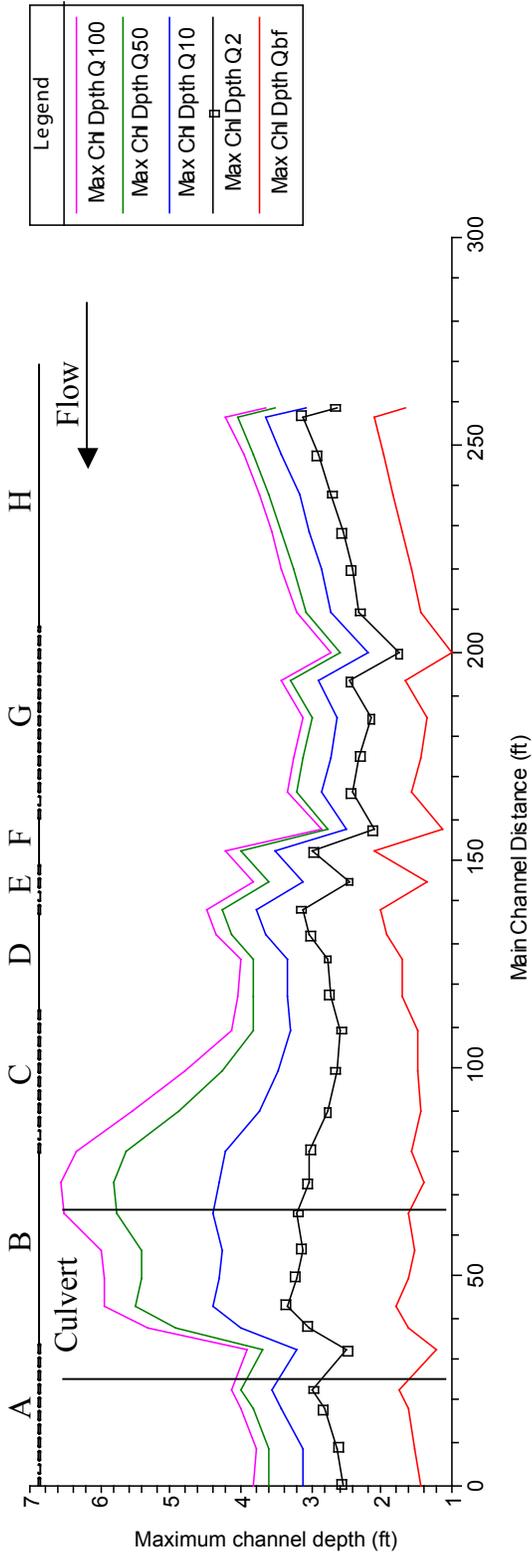
Cross-section characteristics – The culvert has a dramatic effect on cross-section characteristics at nearly all flows, but particularly at flows exceeding bankfull (figures 5 through 9 and 12 through 17). For top width (figure 15), the culvert segment shows some widths exceeding the width of the corresponding profile segment at high flows (Q_{50} and Q_{100}). This is because the culvert segment extends upstream of the culvert inlet and the model shows the culvert inlet backwatering flow at these high flows. Relationships are similar between the downstream transition segment and the natural channel, except for maximum depth, which is within the range of the natural channel.

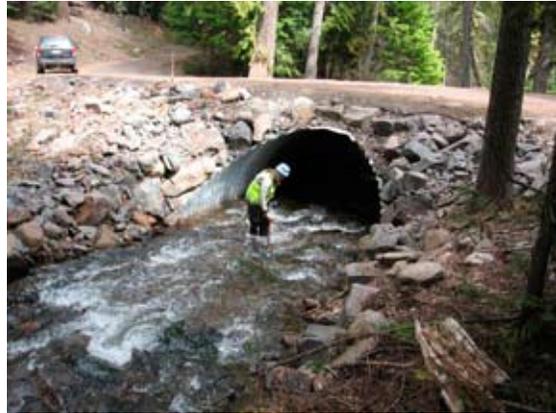
View downstream of culvert inlet.

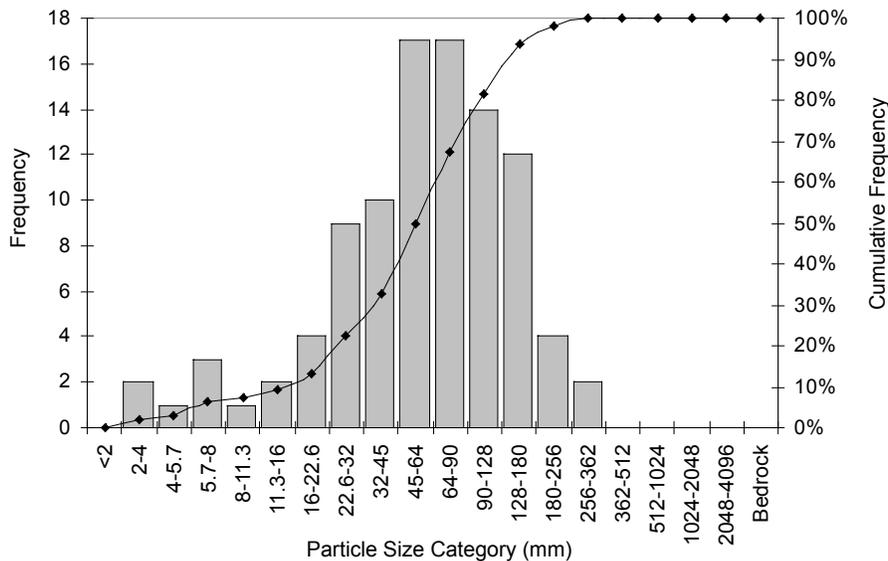
Cross section : Culvert – Only Pebble Count; Middle of Culvert

Substrate – Bed-material distributions in the natural channel have a greater proportion of fine material (sand and small gravels) than the culvert and are more poorly sorted than the culvert. Inside the culvert is a very plane-bed channel with coarse angular material.
