TIRE CREEK

Site Location: Willamette NF, Forest Rd 5826 MP 2.63
Year Installed: 1996
Lat/Long: 122°32'3.95"W **Watershed Area (mi²):** 3.9
 43°48'44.85"N
Stream Slope (ft/ft)¹: 0.0523 **Channel Type:** Step-pool
Bankfull Width (ft): 22 **Survey Date:** March 23 2007

Culvert Scour Assessment

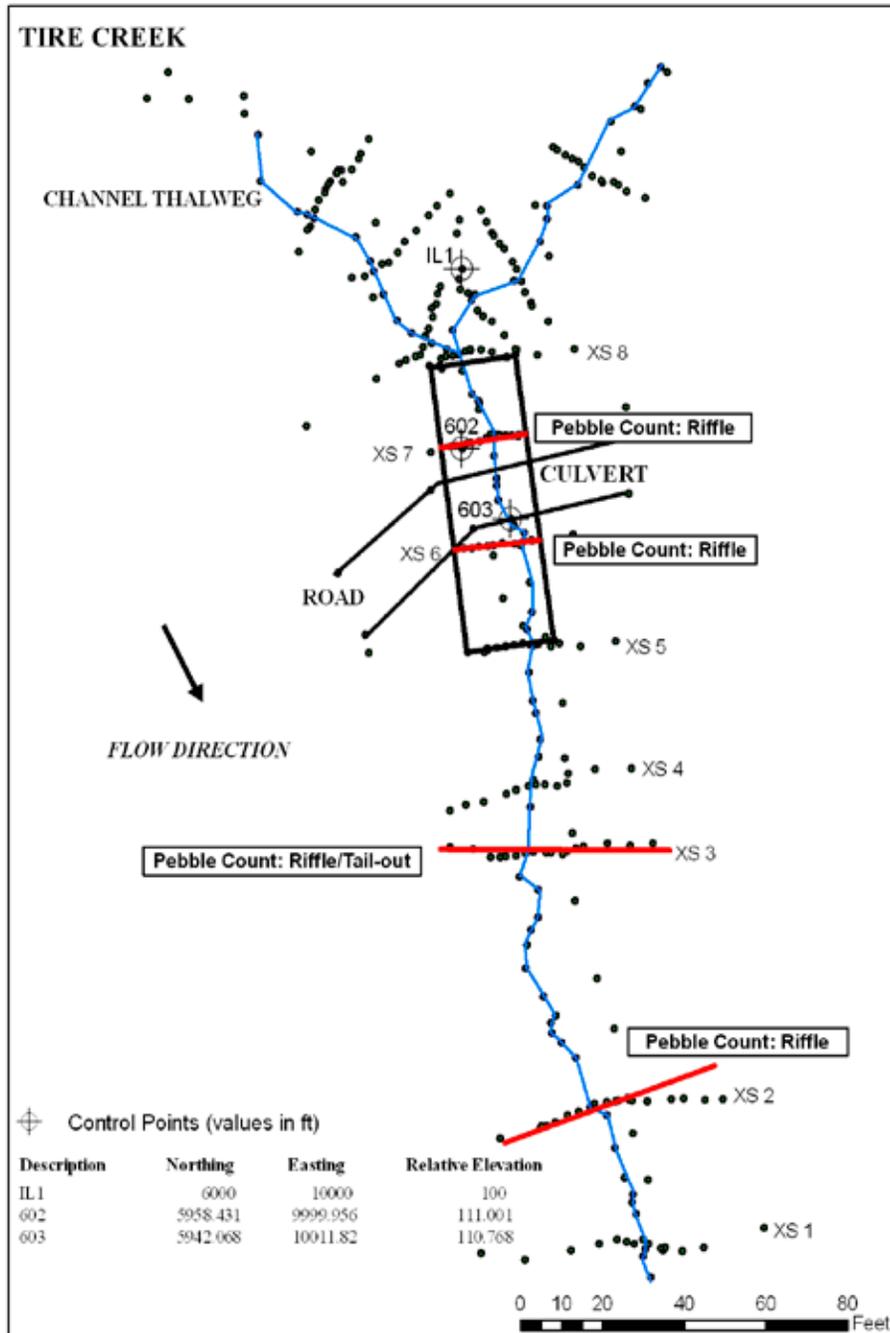
Figure 1. Plan view map

Alignment Conditions: Appears in good alignment with downstream channel but may be placed too close to confluence of upstream tributaries, which is creating scour at inlet.

Footing scour – There was evidence of inlet scour along the right bank where the footing is scoured to the depth of the base footing. Observed scour does not appear to be undermining footings or threatening structure integrity.

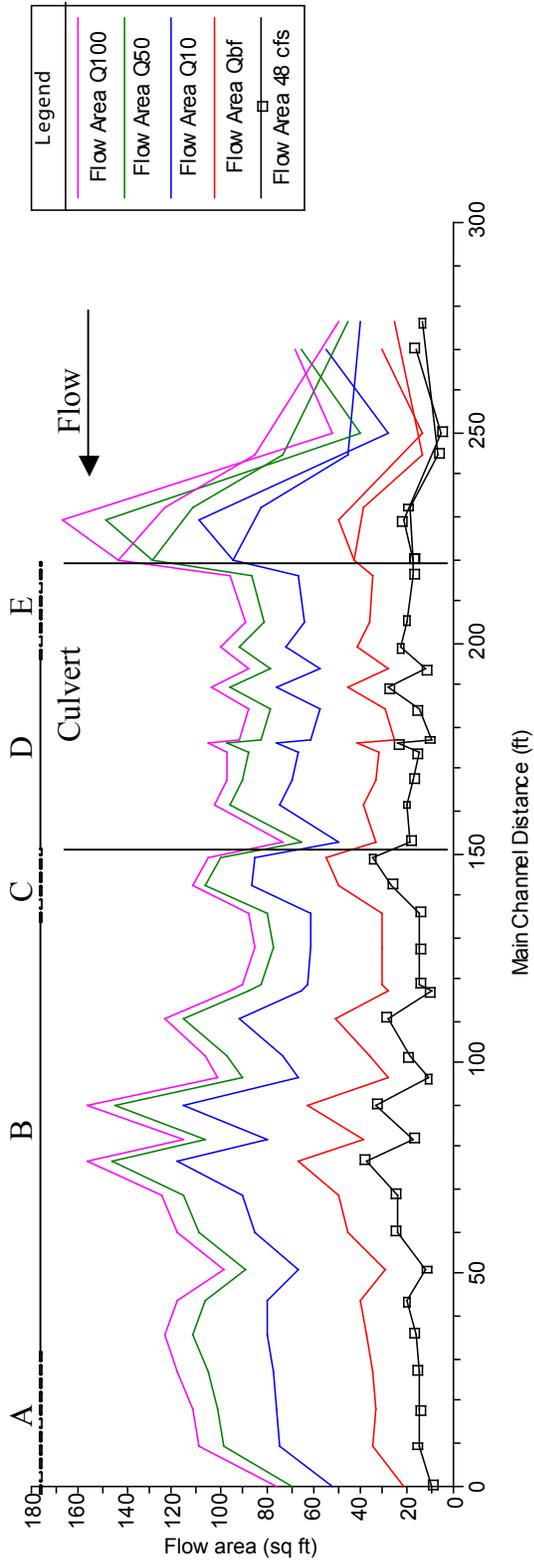
Figure 5—Flow area (total) profile plot.

Cross-section characteristics – Cross-sectional flow area in the culvert is similar to the downstream channel for lower flows but begins to diverge by the Q_{10} (figure 5 and figure 12). Flow area in the culvert is lower than that found in the downstream representative channel segment A above the Q_{bf} but similar to that found in the downstream representative channel segment B for all flows. Above the 25 percent Q_2 , the wetted perimeter in the culvert is less than in the downstream channel (figure 13). At the 25 percent Q_2 , the hydraulic radius in the culvert is similar to that of both downstream channel segments (figure 14). For flows at or above the Q_{bf} , the hydraulic radius in the channel is greater than in the downstream channel. In contrast, the top width in the culvert is less than the downstream channel at and above the Q_{bf} (figure 15). For all flows, the maximum depth is greater in the culvert than it is in both of the downstream

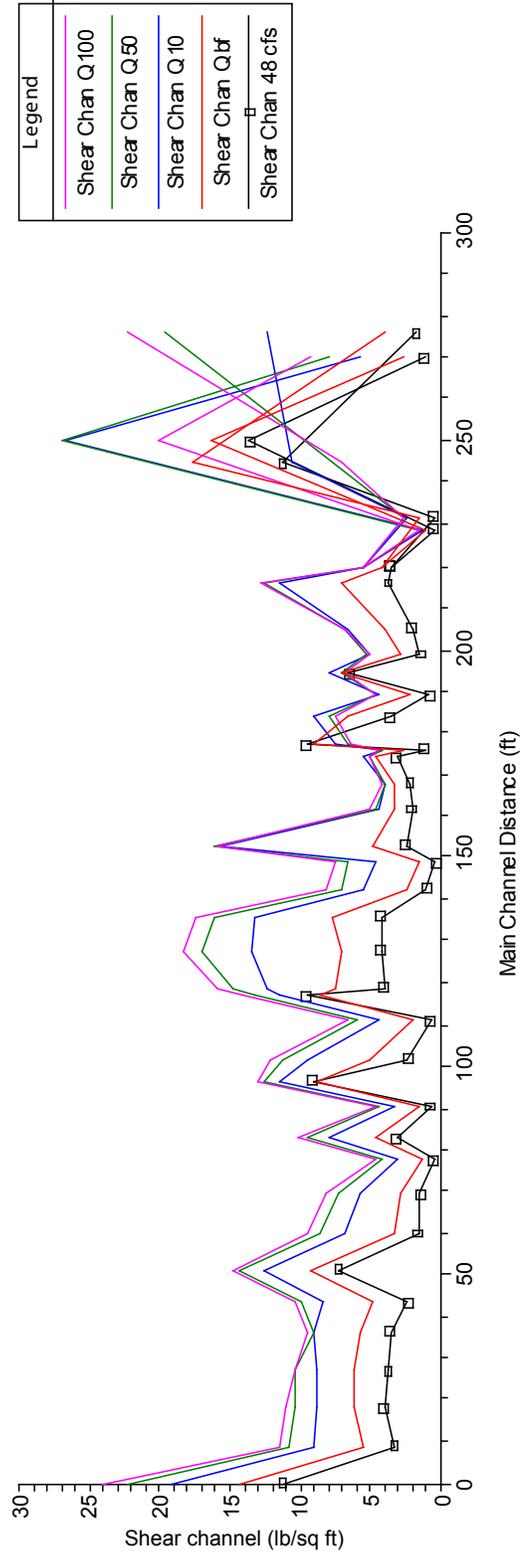
Figure 10—Shear stress (channel) profile.

Shear stress – Shear stress in the culvert is similar to the downstream channel for lower flows but begins to diverge by the Q_{10} (figure 10 and figure 19). Above the Q_{10} both representative channel segments A and B have greater shear-stress values than does the culvert. It is also above the Q_{10} that the shear stress in the culvert remains relatively similar with a slight decline in magnitude with increasing flows. This is most likely a result of the backwater created through the culvert. However, these results may not be real and may be a function of model limitations.

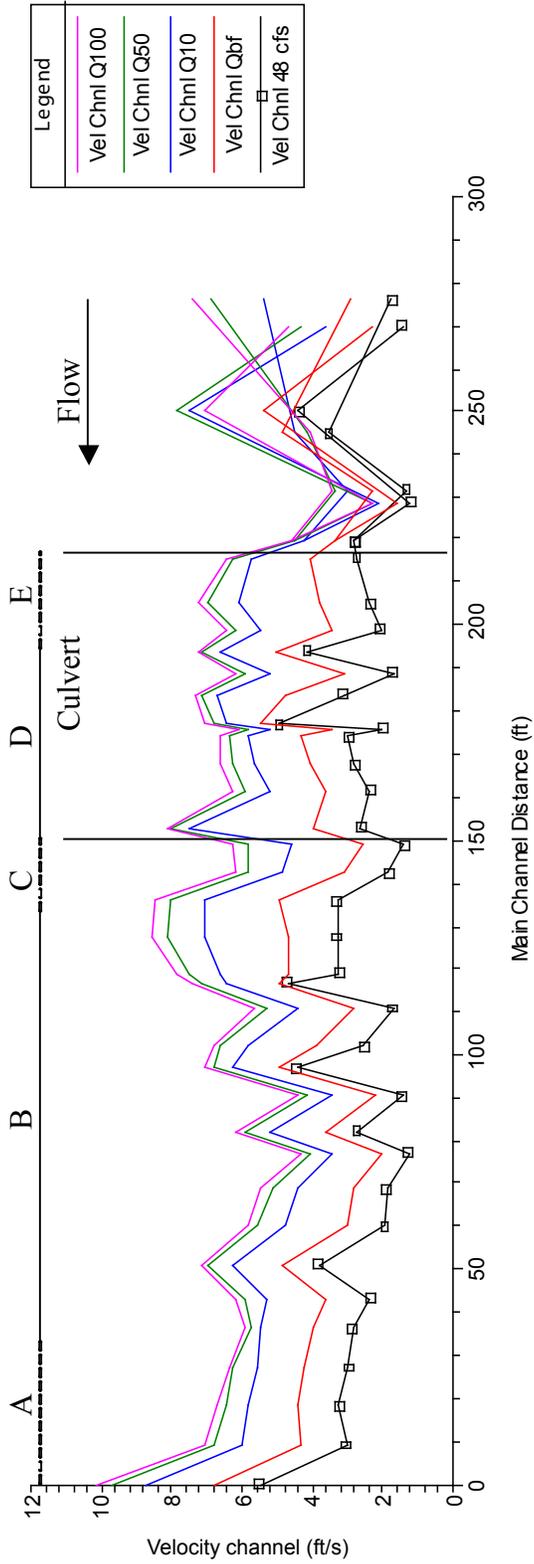
Figure 11—Velocity (channel) profile plot.

Velocity – Velocity in the culvert is similar to the downstream representative channel segments for all flows (figure 11 and figure 18). Additionally, the range in velocity values for a given flow through the culvert is relatively similar to the range of values in the downstream representative channel segments.

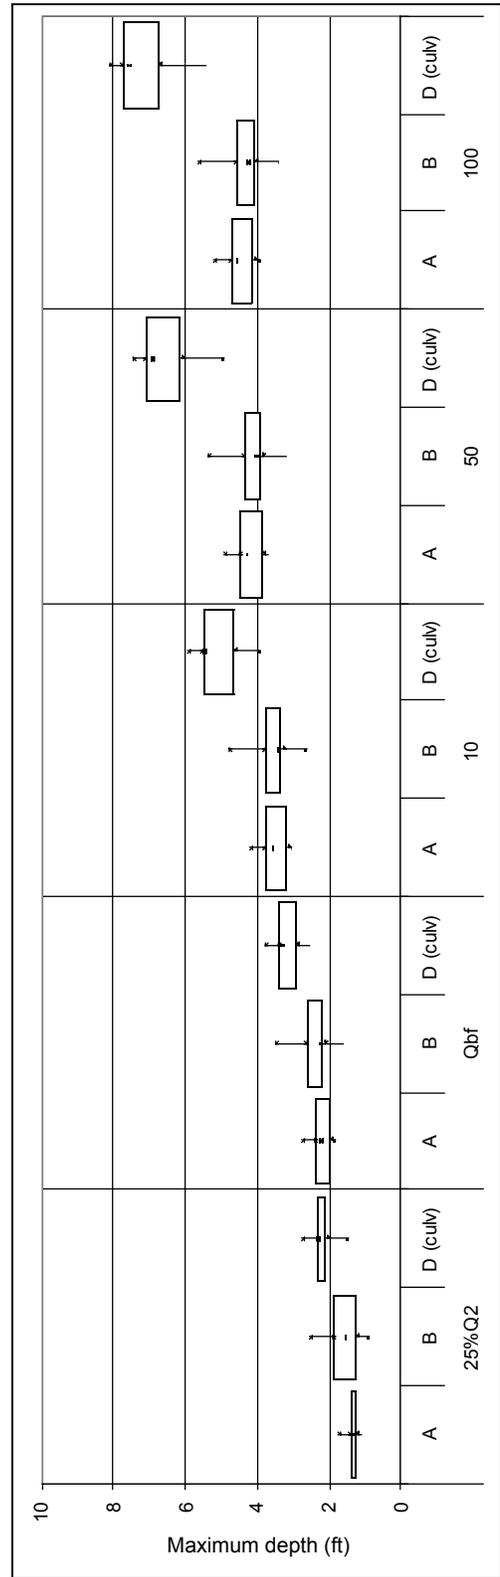
Figure 16—Maximum depth.

channel segments (figure 16). While width-to-depth ratio in the culvert is within the range of the downstream channel segment A at the 25 percent Q_2 , it becomes less than both channel segments at and above the Q_{bf} (figure 17).
