Culvert Scour Assessment

YOUNGS CREEK

Site Location:	Willamette NF, Forest Rd 21		
Year Installed:	Circa 2002		
Lat/Long:	122°26'10.61"W		
	43°30'40.77"N	Watershed Area (mi²):	2.92
Stream Slope (ft/ft)¹:	0.0635	Channel Type:	Step-pool
Bankfull Width (ft):	13.5	Survey Date:	March 21 2007

Culvert Type:	Pipe arch	Culvert Material:	Annular CMP
Culvert Width:	14 ft	Outlet Type:	Mitered
Culvert Length:	62 ft	Inlet Type:	Mitered

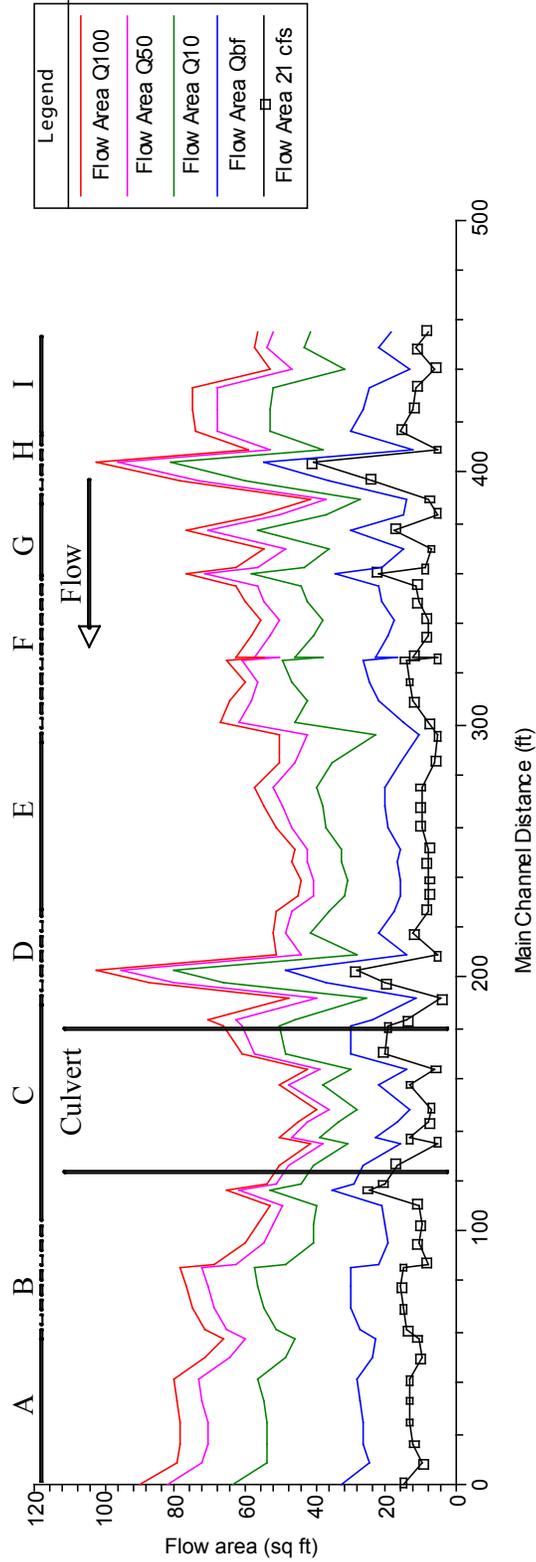
Figure 5—Flow area (total) profile plot.

Cross-section characteristics – Cross-section characteristics vary between the culvert and the corresponding profile segment (F) for most of the cross-section metrics beginning at or above the Q_{10} (figures 5 through 9 and 12 through 17). These results reflect the flow contraction created by the pipe. The upstream- and downstream-transition segments have values that are mostly within the range of their corresponding profile segments, except the upstream transitions have lower widths and greater depths than the natural channel at high flows.

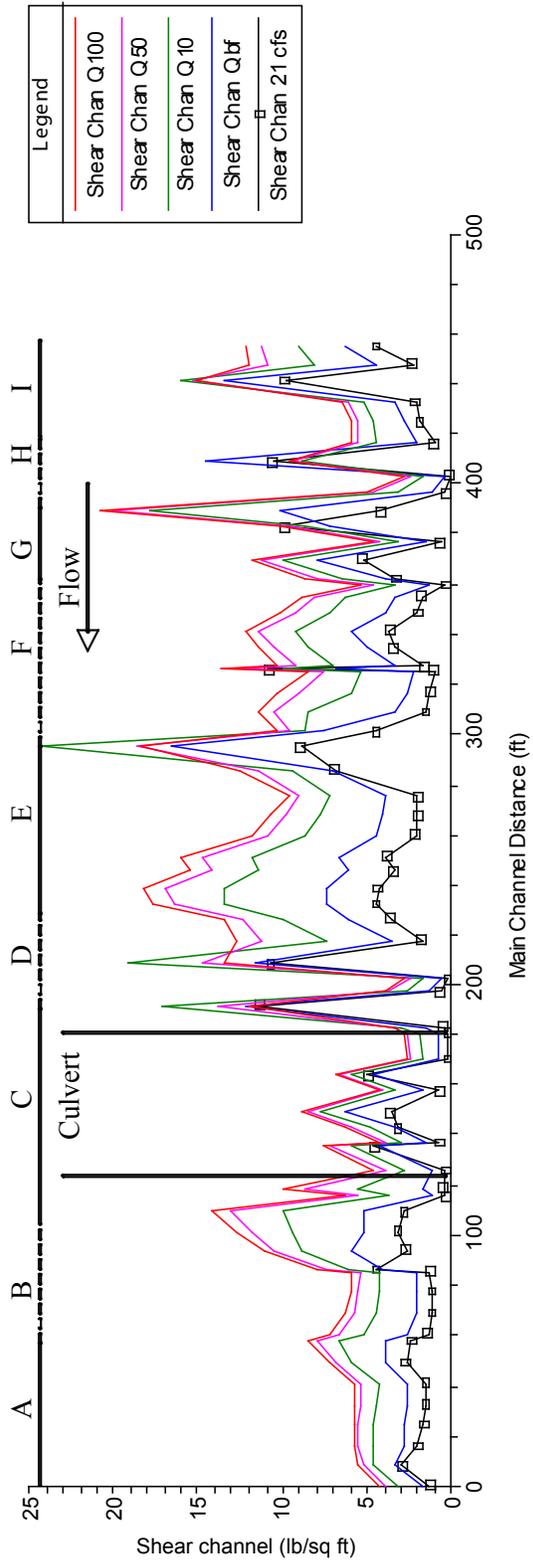
Figure 10—Shear stress (channel) profile.

Shear stress – The range of shear stress in the culvert becomes less than that of the natural channel segment (F) as flows increase above the 25-percent Q_2 , but maximum shear stress values remain similar (figures 10 and 19). Shear stress in the upstream transition segment E becomes greater than the corresponding profile segment (I) above the Q_{bf} , but the other transition segment (D downstream) is within the range of segment I. Shear stress in the downstream transition remains within the range of the corresponding profile segments for all modeled flows.
