## Case Study 12. Grubbs Concrete Slab Vented Ford

North central California. Plumas National Forest. Mount Hough Ranger District. Grizzly Creek. 3 miles west of Bucks Lake, CA. Forest Road 23N92Y, just off the Oroville-Quincy Highway (FH119).

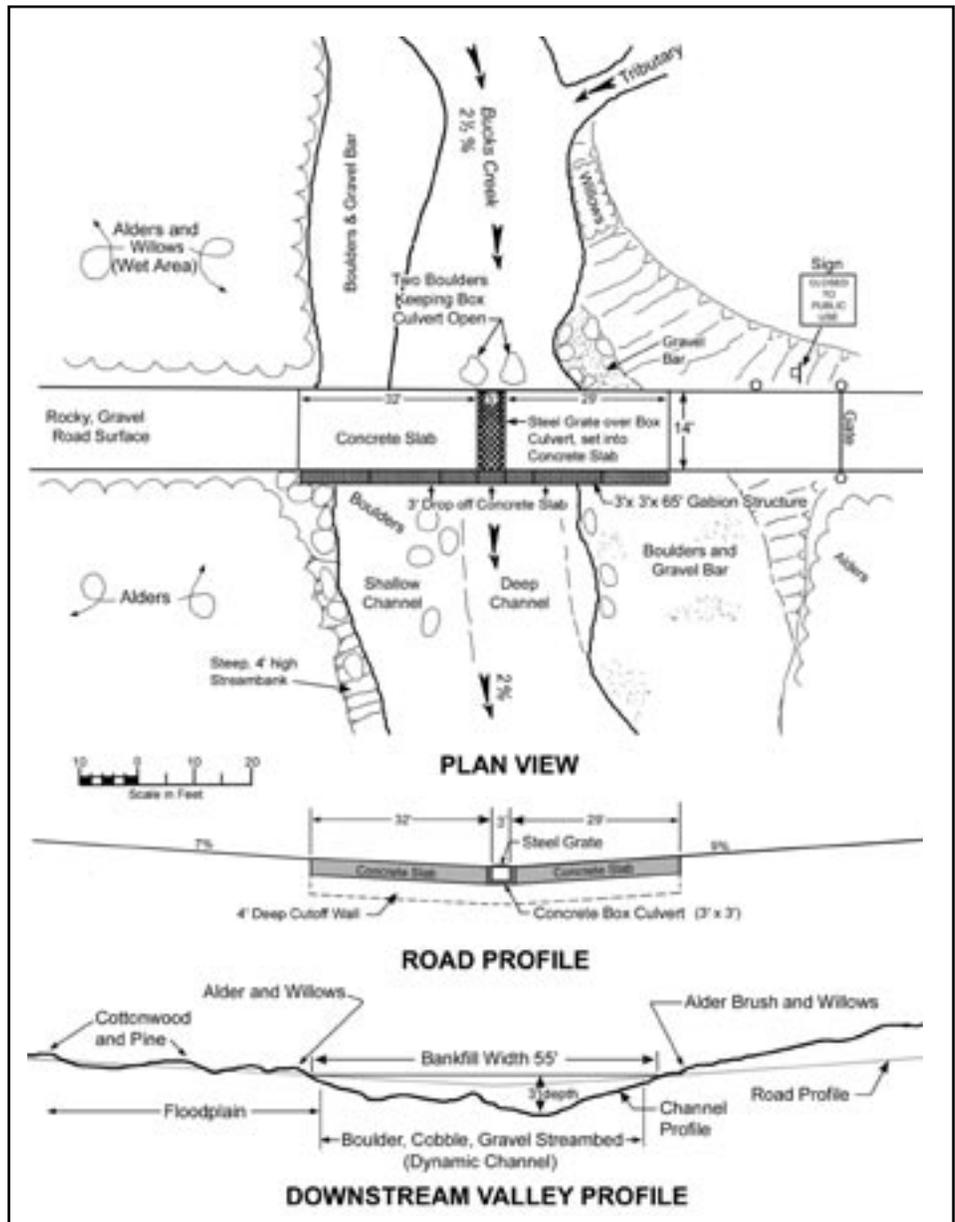
Figure A77. Site plan view and cross-section sketch.

**Bank and bed stabilization and approaches:** The ford slopes into the channel at 7 to 9 percent (figure A77). Four-foot-deep concrete cutoff walls were constructed along both edges of the roadway for scour prevention. The downstream edge was also armored with two rows of gabions. The upper row sits on a concrete sill attached to the wall of the structure. The lower row sits directly on the streambed.
