Case Study 15. Moonlight Crossing Concrete Box Vented Ford

Crossing Description

This large concrete box vented ford, reconstructed in 2000, is located on Lights Creek, a perennial fisheries stream. Previous crossing structures had caused upstream aggradation and downstream degradation, and there was an 8-foot elevation drop at the site. The vented ford is designed to prevent lowcutting from progressing upstream. The structure is a trapezoidal shape over four reinforced-concrete box culverts, one containing a fish ladder (figure A97). The roadway surface across the ford, including the steel cattleguard and the 6-inch-thick reinforced concrete approach slab, is 15 feet wide and 109 feet long. The driving surface over the boxes (across the active channel) is 32 feet long.

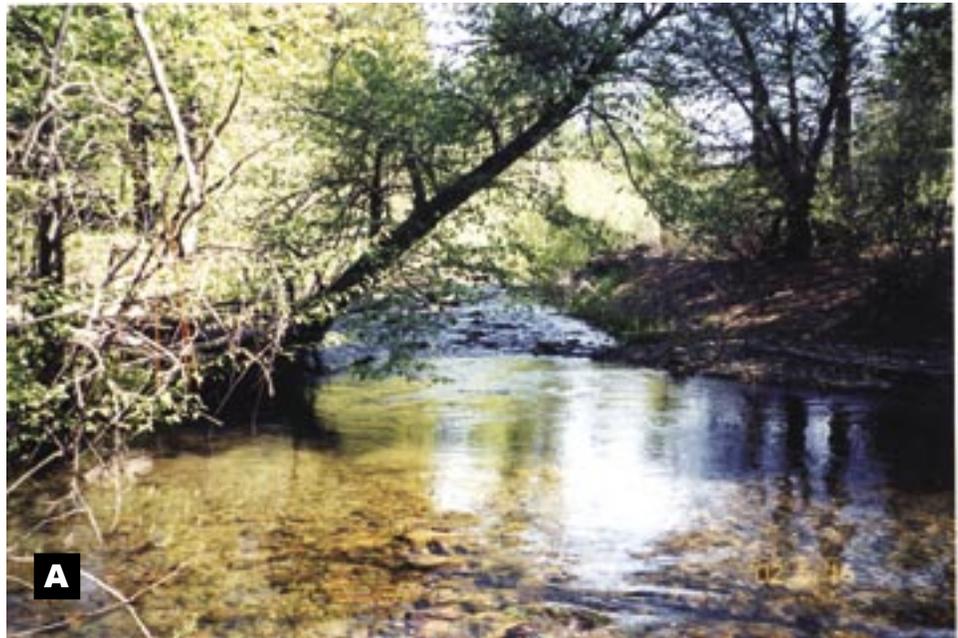
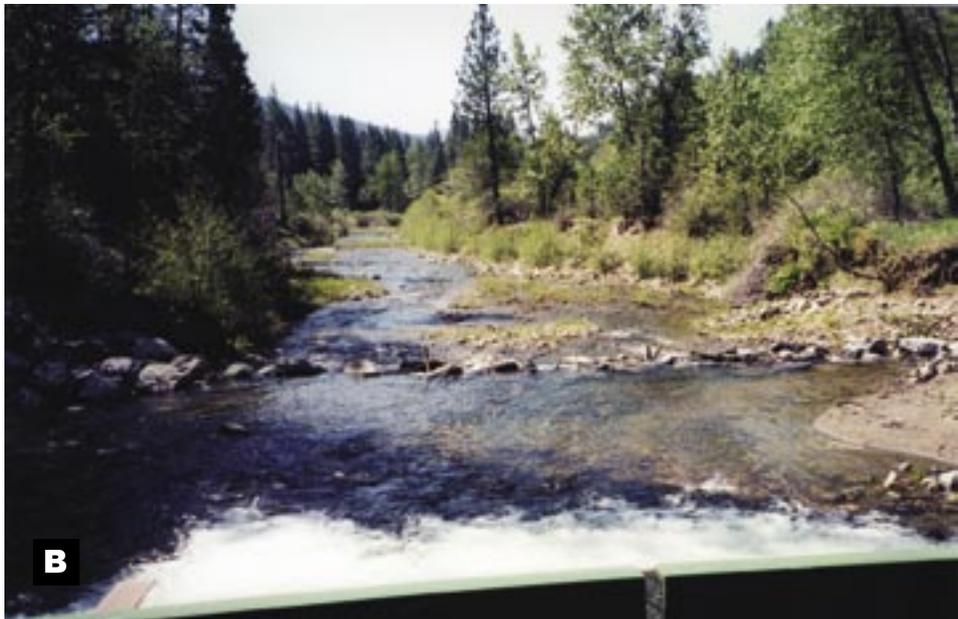
Channel Description: Lights Creek underwent severe downcutting prior to the installation of this grade control structure, and some aggradation has occurred upstream. The upstream banks are about 3 feet high and stable, with riparian vegetation including willow, cottonwood, alder, and pine trees as well as some shrubs (figure A101a). The channel is narrow with easy access to a wide flood plain on the right-hand bank. Downstream, the banks are over 8 feet high, nearly vertical, and subject to scour and raveling. The channel is over 60 feet wide and widening, forming mid-channel bars, without flood-plain access (figure A101b). Channel slope was measured to be about 1 percent. The streambed is made of a well-graded mixture of sands, gravels, and cobbles. Occasional boulders exist to a maximum size of 8 inches.

Figures A101a and A101b. Lights Creek a) upstream and b) downstream of the ford.
