**Case Study 18. French Creek Embedded Concrete Box Vented Ford****Location**

North central California, Plumas National Forest, on French Creek. Three miles northwest of Brush Creek and 15 miles northeast of Oroville, CA. Forest Road 22N34.

**Crossing Description**

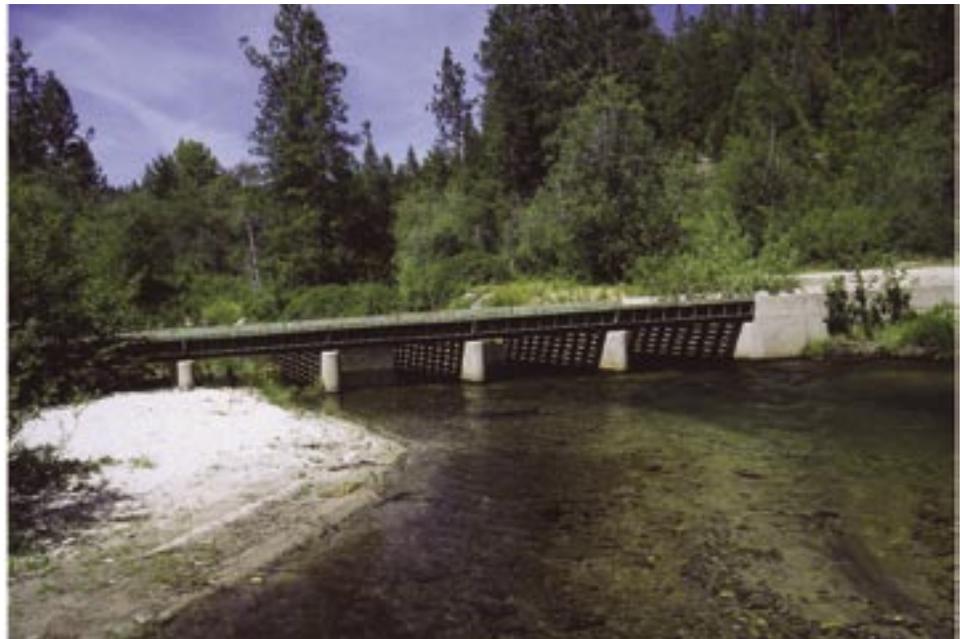
Figure A114. Looking upstream at the French Creek vented ford.

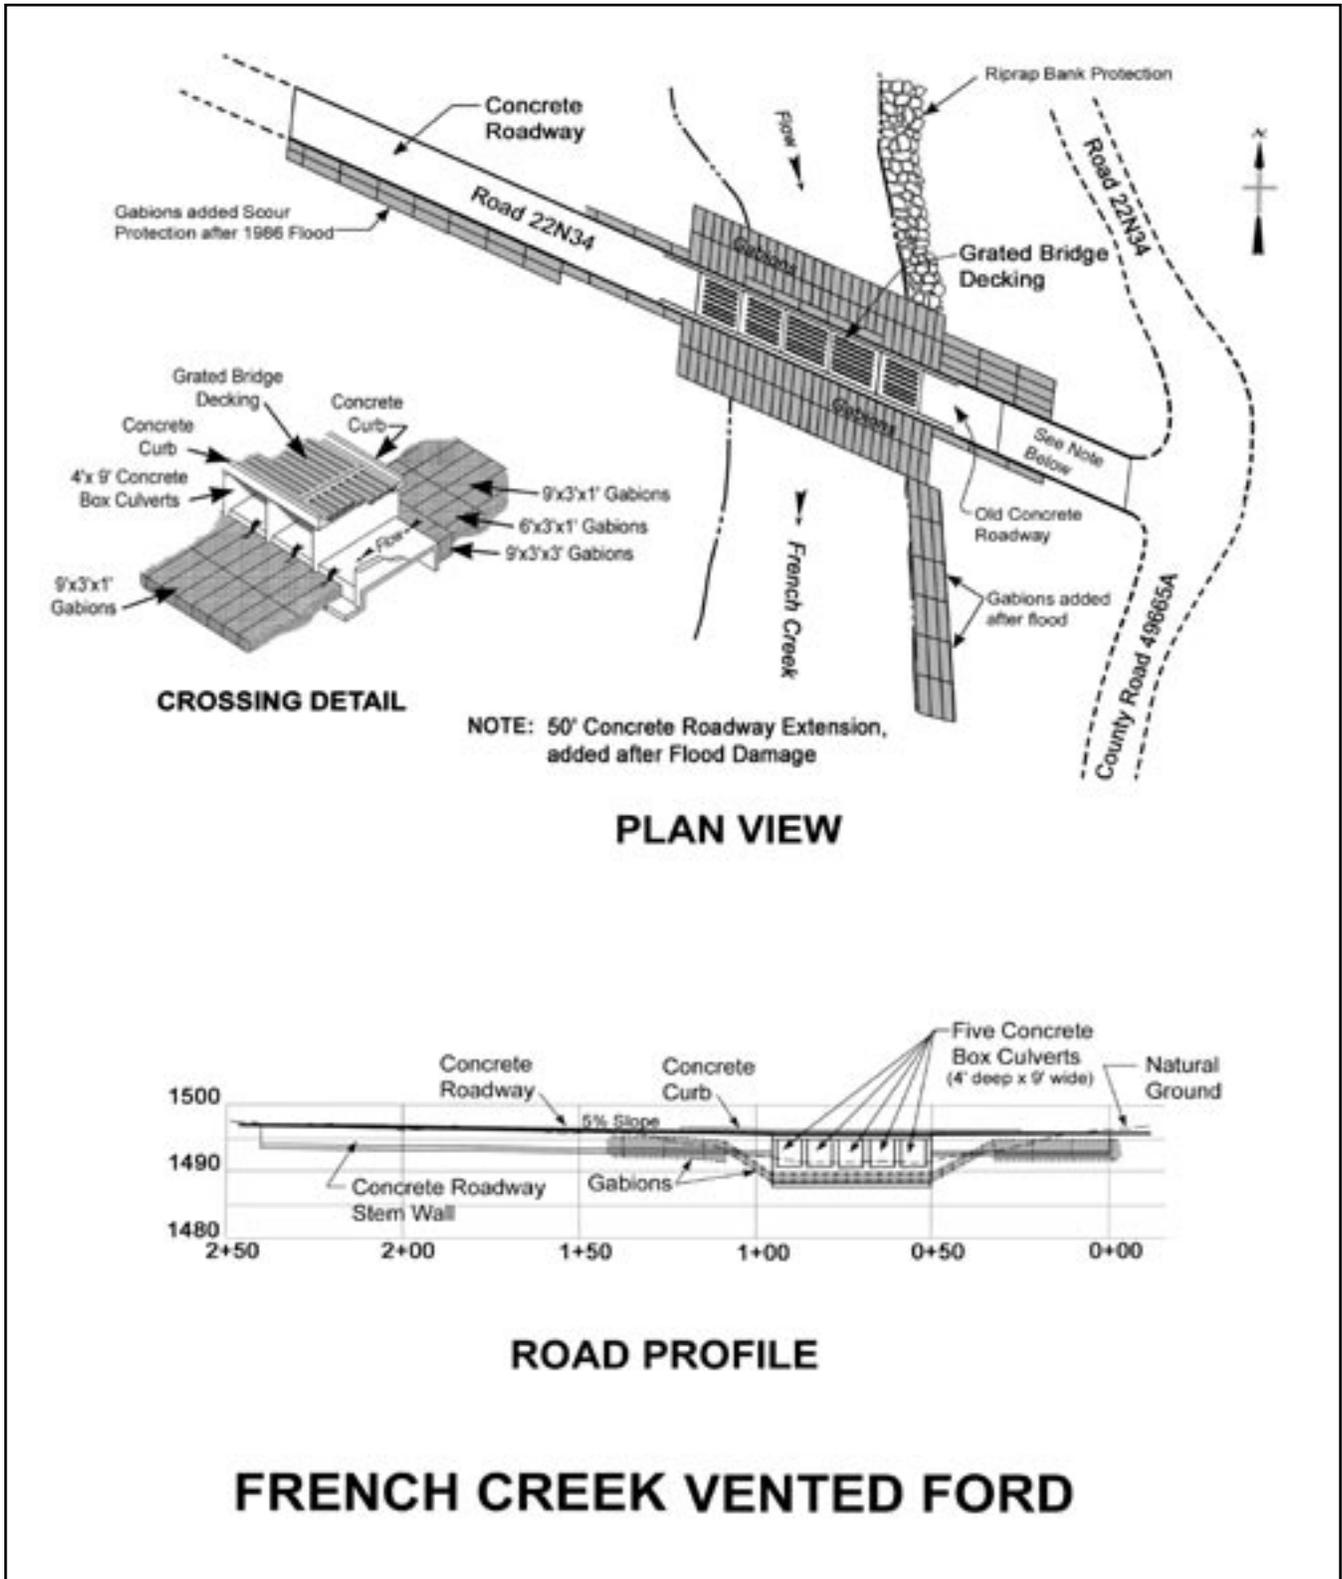
**Structure:** The structure was designed by the Plumas National Forest and constructed under a Public Works Contract. The project took 100 days to construct and required a total of 140 cubic yards of concrete, 190 cubic yards of gabions, and 77 cubic yards of Class VII riprap. The structure is made with five box culverts, with each concrete stem wall 1-foot thick. Each concrete box is 9 feet wide by 4 feet high, and they are embedded 6 to 12 inches below the natural stream channel bottom elevation to maintain streambed continuity through the structure (figure A116).

Four-foot deep concrete cutoff walls are located along the upstream and downstream edges of the structure (figure A116). Gabion mattresses protect both edges from scour. The raised concrete driving surface over the boxes and across the flood plain extends for a total of 240 feet.

The driving surface is 1 to 2 feet above bankfull elevation so as to pass bankfull flows and small debris. Across the active channel this capacity was good, but the raised concrete slab roadway across the flood plain has caused a “damming” effect which has led to upstream debris deposits and downstream scour.

Figure A116. Site plan view with valley and road profile sketches.
