**Case Study 5. Willow Creek Concrete Plank Ford**

**Crossing Description**

### Flood and Maintenance History

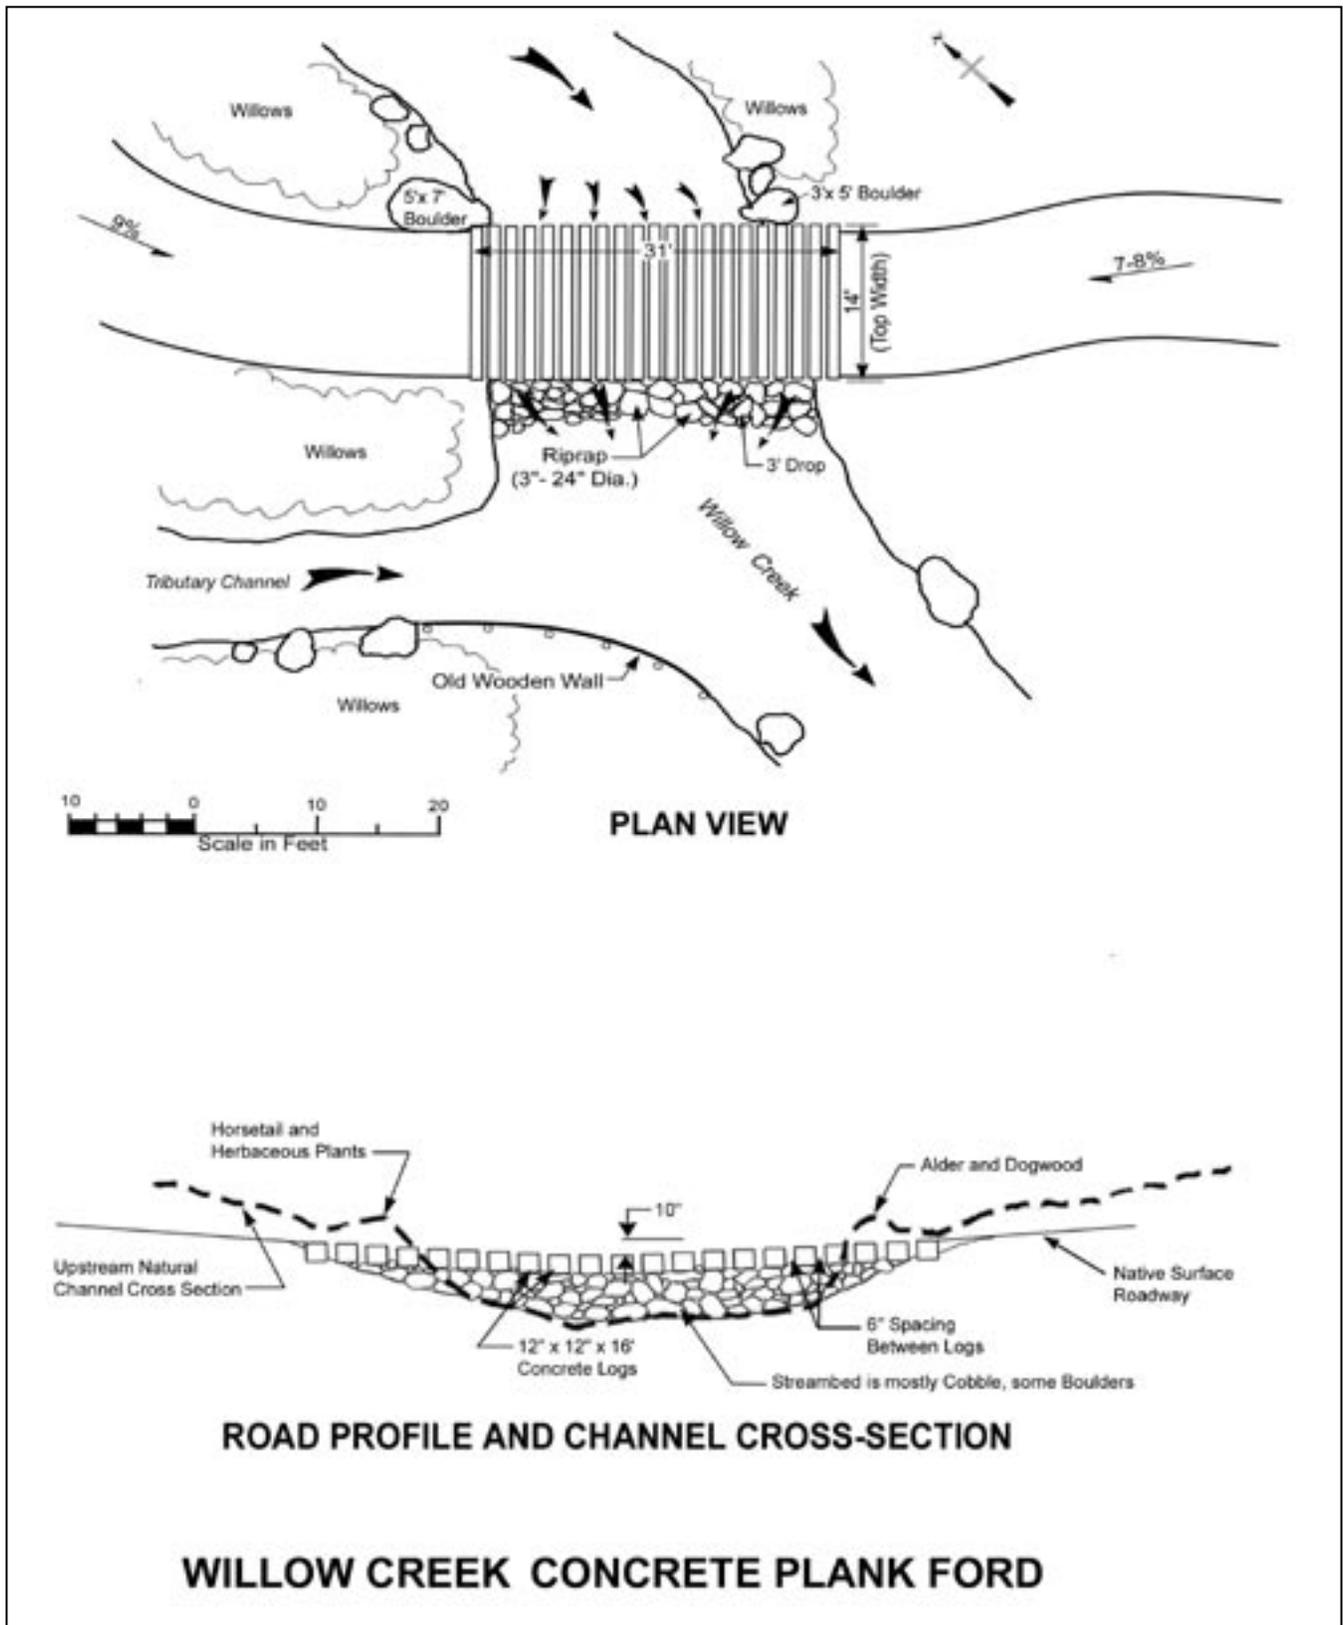
Figure A25. Site plan view and cross-section sketch.

**Channel Description:** Channel slope is about 3 to 5 percent at the crossing. There is a drop in the channel bottom elevation of 3.5 feet just downstream of the crossing. This is partially due to scour, but also to an old wooden diversion structure that failed and caused channel cutting. A tributary also enters the stream immediately downstream of the road-crossing (figure A23—upper right). Sloping streambanks are 1 to 2 feet high and quite stable with boulders and riparian vegetation including willow and fir trees. Bankfull width is approximately 15 feet, with a bankfull depth of 2.5 feet. The substrate is a mixture of cobbles, some gravels, and large boulders.
