**Case Study 8. Agua Fria River Concrete Slab Ford**

**Location**

**Crossing Description**

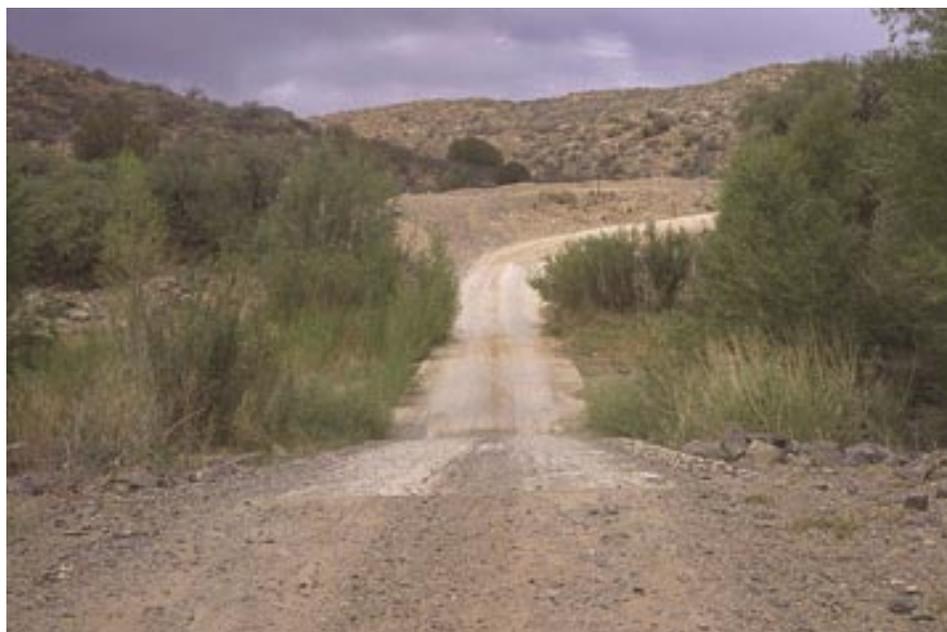
Figure A42. Agua Fria River ford.

This ford was constructed in 1994 on a perennial to intermittent fish-bearing stream. It is a reinforced-concrete slab with concrete approaches. The surface is slightly raised above the streambed surface, but it allows fish passage when the structure is submerged.

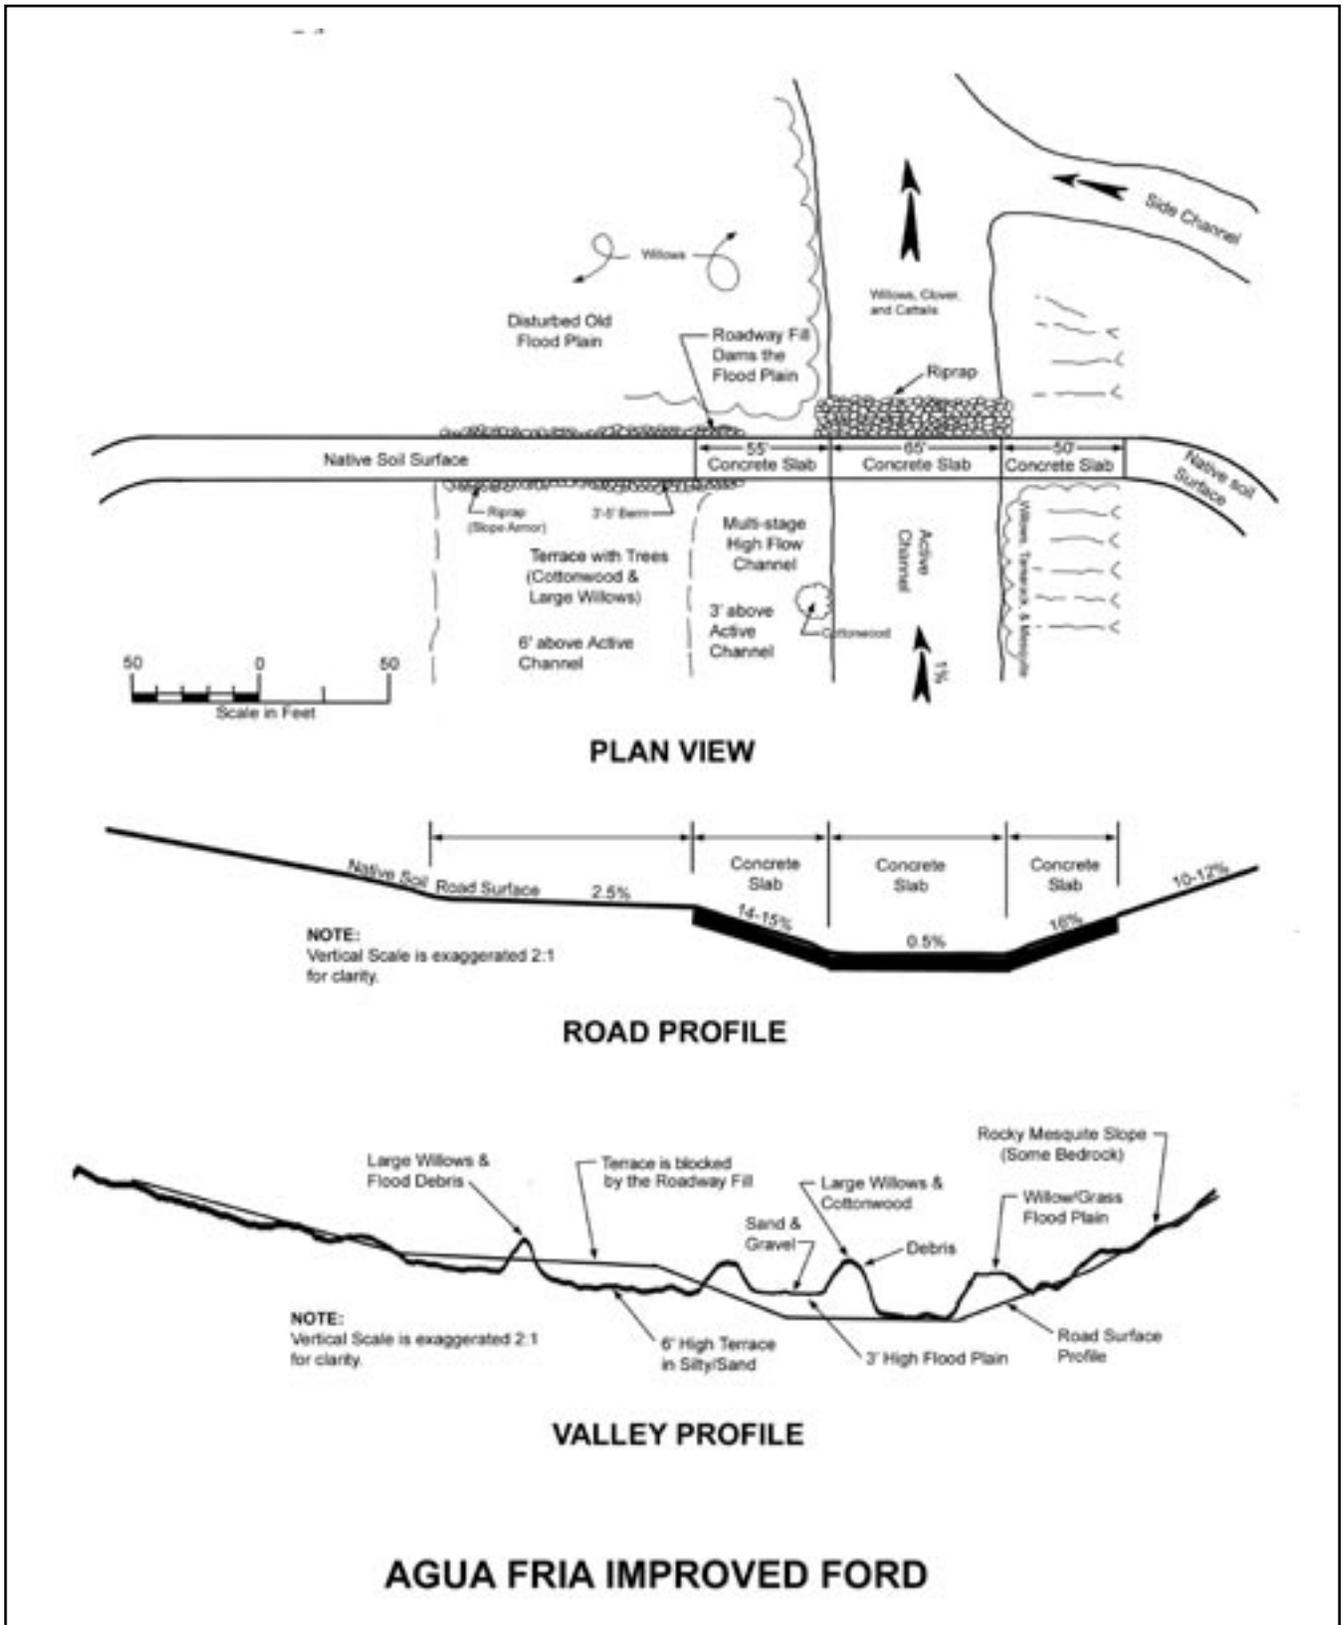
Figure A45. Site plan view and road and valley cross section sketches.

**Structure:** The ford is an 8-inch thick reinforced concrete slab raised slightly above the bed of the active channel. The driving surface is 15 feet wide and has no curbs. The slab is 65 feet long and flat across the active channel and the lowest flood terrace (figures A44 and A45). Including approaches, the structure extends a total of 170 feet across the channel and flood terraces.

**Bank stabilization and approaches:** Fifty- to 55-foot-long concrete approach slabs slope steeply into the drainage at 15 percent. The road fill obstructs flow on the upper terraces during very high flows, and riprap has been placed along the upstream fillslope to control gully erosion there.

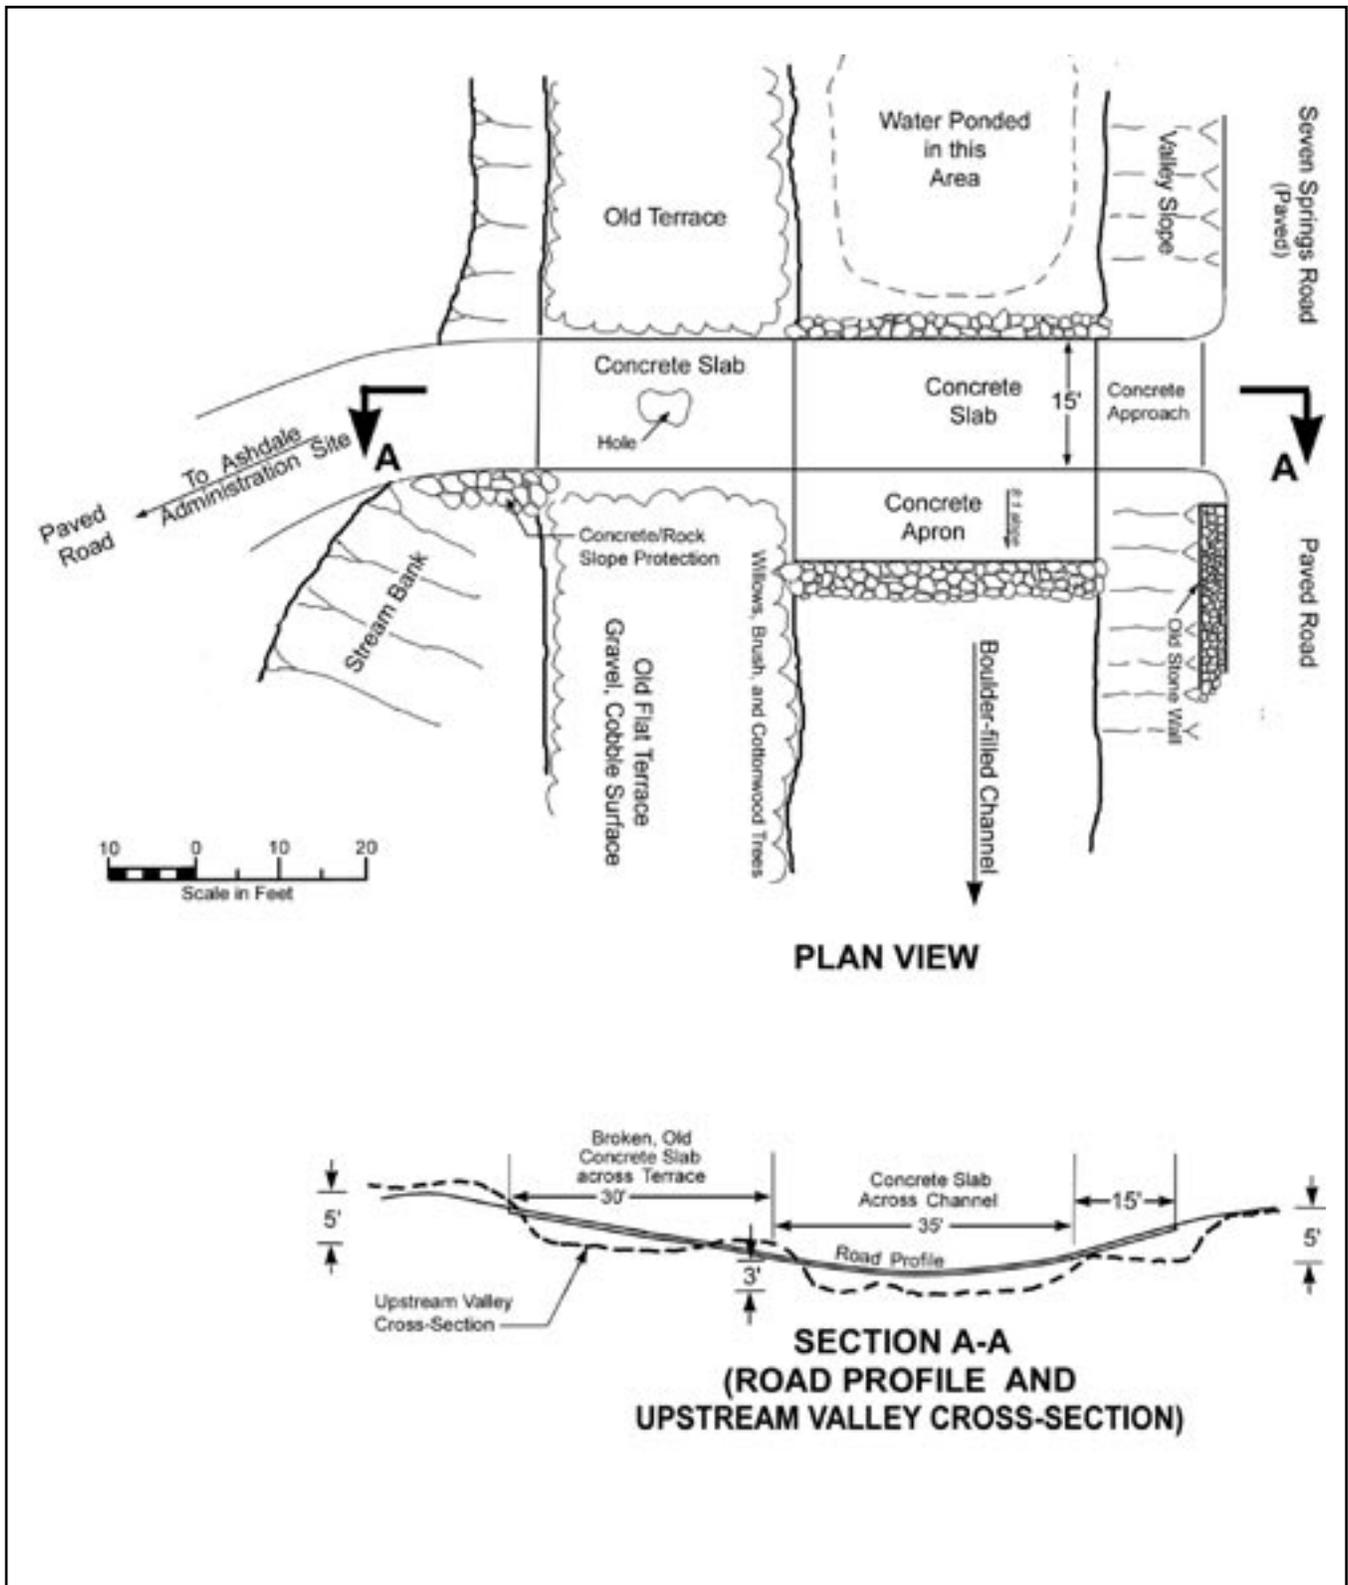
Figure A50. Ashdale ford plan view sketch and valley cross section with road profile.

The ford is 50-years old. It has been through many desert floods, including the major 100-year-flood event of 1993. Its concrete surface is battered and has been repaired or extended on both ends. Flows have partially outflanked it at some times in the past, so grouted riprap and pieces of concrete and rock have been placed along the approaches to control scour (figure A51). Downstream scour occurred at some point in its history, leading to the construction of the concrete apron, which currently provides adequate protection against scour. The ford has not received any maintenance since the late 1980s. The structure is appropriate to this high-energy site since it provides for free passage of debris and rock during high flows and there are no aquatic animal issues.
