Transportation Management Tech Tips

March 2009

GlasGrid Fights Pavement Reflective Cracking at Diamond Lake

Gordon L. Hanek, Geotechnical Engineer, Umpqua National Forest

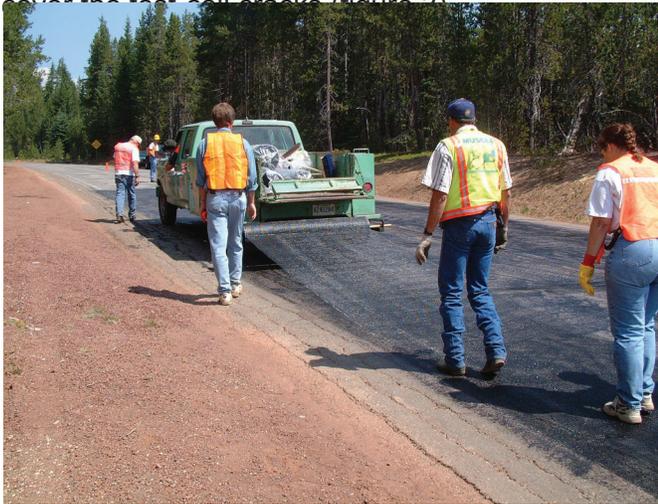
Figure 3—Placing GlasGrid from the spool, which is attached to a trailer hitch.

The GlasGrid arrived in 5-foot-wide rolls that were spooled off a trailer-hitch device as needed to cover the test cell cracks (figure 3).

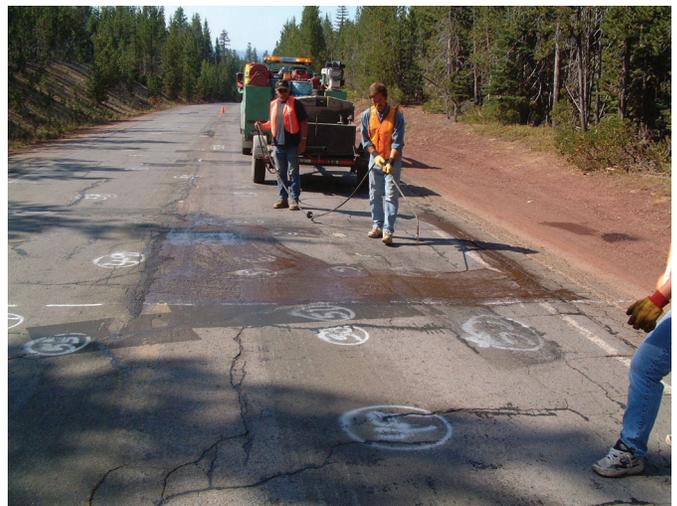
Figure 6—A quick-set tack was applied to GlasGrid test cells to ensure good bondage.

GlasGrid comes with a pressure-sensitive adhesive backing that, according to the manufacturer, is sufficient to hold the product in place on fresh asphalt surfaces, such as a leveling course or between overlay lifts. However, since this project was a single 2-inch asphalt lift on older asphalt surfaces without any preleveling, a special quick-set tack was applied prior to placement of the GlasGrid (figure 6).

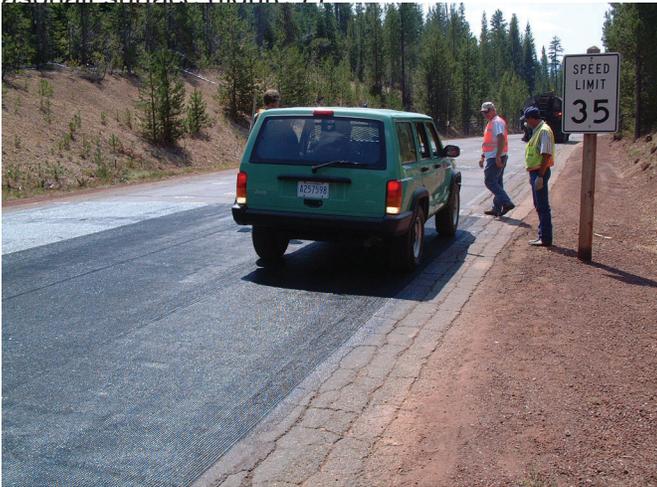
Figure 7—Seating the GlasGrid by rolling with a light-duty vehicle.

Following placement, a light-duty vehicle was used to roll the GlasGrid and seat it securely to the asphalt surface (figure 7)

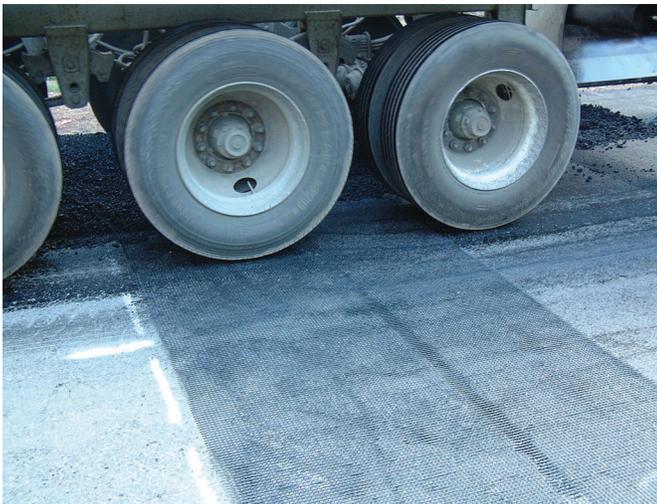
Paving occurred the same day as the GlasGrid placement, and no problems with grid movement under the paver machine or asphalt-concrete delivery trucks were observed (figure 8).

Figure 8—GlasGrid remained bonded to the underlying surface during paving operations.

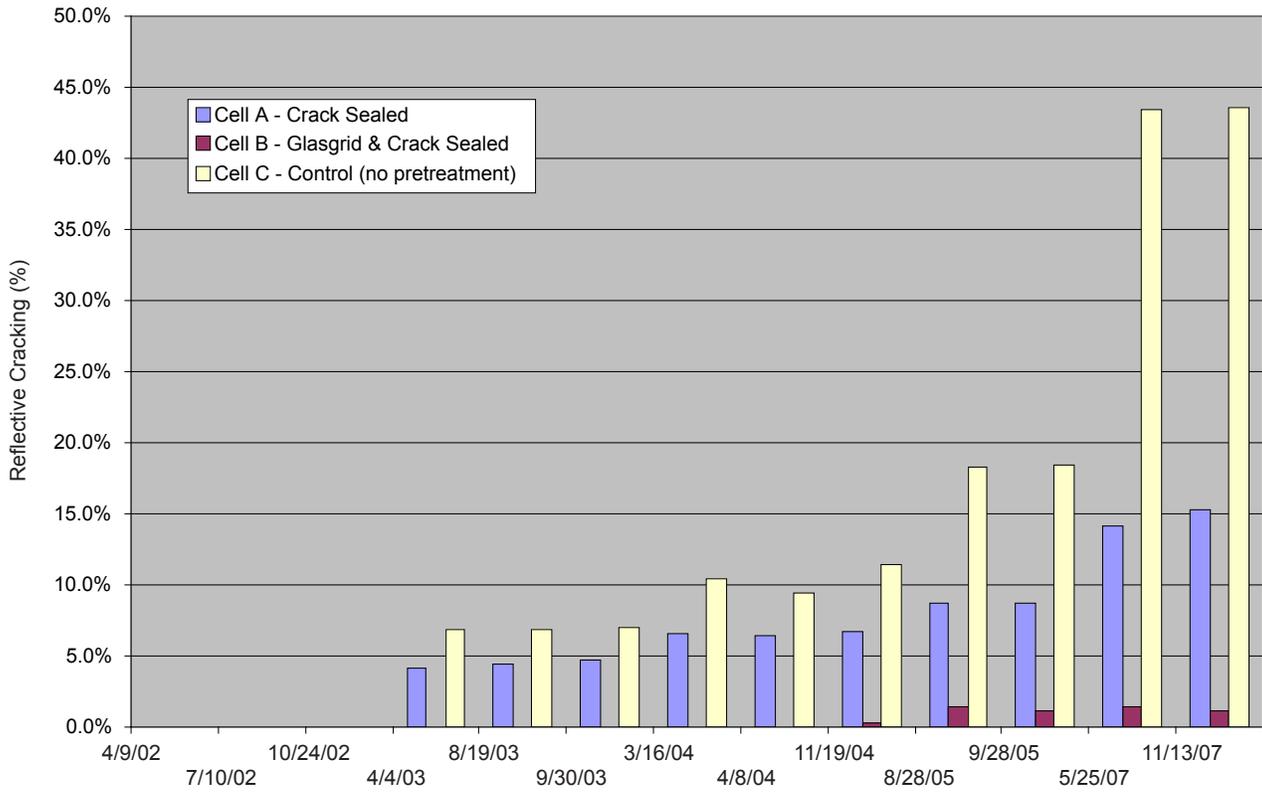
Figure 9—Test section no.1.

Periodic inspections of all test cells were made over a 6-year period. Average daily traffic counts during this time varied from about 150 to 900, depending on the time of year, and consisted primarily of recreational and administrative vehicles. The site inspections were generally held once in the spring and once in the fall of each year. During each inspection the locations, lengths, orientations, and type of cracks were noted. Photos were taken of any developing reflective cracks as well as the overall site conditions. Table 2 is a summary of the reflective cracking observed in the two test sections. Initial pretreatment-crack types (linear versus area) and lengths are shown for comparison. Linear cracks consisted principally of thermal and longitudinal cracks or other single-crack features. Area cracking consisted of block and alligator cracking along with areas covered by older geosynthetic patching (see figure 2). A composite-crack length was calculated that sums the linear-crack length and the linear length associated with area cracking to provide a more representative picture of the extent of reflective cracking. This was done since none of the reflective cracking progressed to the point of being “area” cracks during the 6-year observation period (although some linear-reflective cracks did appear over locations with underlying “area” cracking). Table 2 results are shown in figures 9 to 12.

The GlasGrid-treated cell in test section 1 (where large, regularly spaced, thermal cracks were the primary distress) has performed significantly better than either the control cell or the cell with only a crack-sealing pretreatment (figures 13 and 14). After 6 years, less than 2 percent of the crack length has reflected through in the GlasGrid section versus almost 45 percent in the control section. Originally, crack severity in test section 1 was generally medium (mean-crack width greater than 1/4 inch) to high (mean-crack width greater than 3/4 inch), whereas all cells after 6 years still have generally low-severity (mean-crack width less than 1/4 inch) cracks though a few medium-severity cracks have developed in the cells without GlasGrid. Reflective cracks are occurring over original cracks that were of medium and high severity.

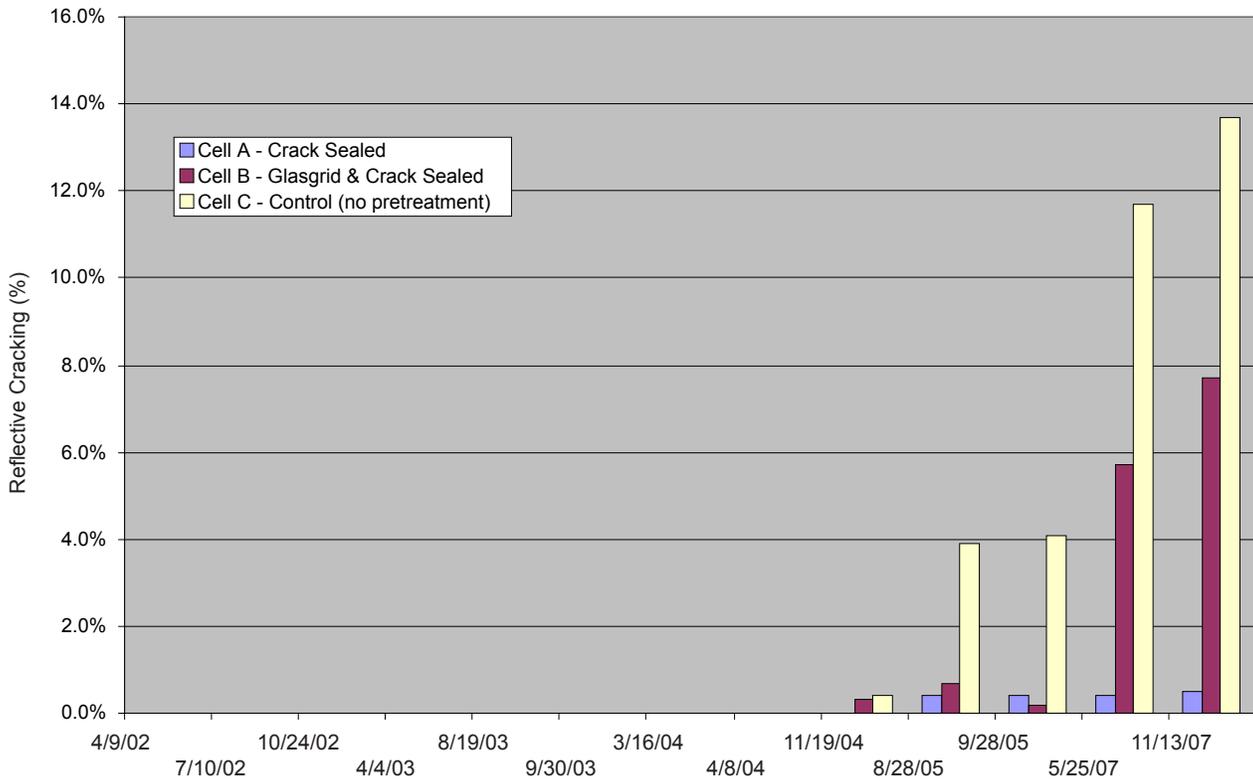
Figure 10—Test section no.2.

In test section 2, where a variety of crack-distress types including block, alligator, longitudinal, and thermal occurred, the GlasGrid-treated cell experienced less reflective cracking than the control cell but more than the cell with only crack sealing as a treatment. It appears that the GlasGrid was not as successful in retarding the more generally distributed and greater variety of cracking-distress types present in this test section. However, given the relatively small amount of overall reflective cracking that has occurred in test section 2, it may be premature to draw conclusions until additional future observations can be made. As was the case with test section 1, the pretreatment defect-severity in test section 2 was also generally medium. After 6 years, the defect severity in all cells of test section 2 is low (figure 15).

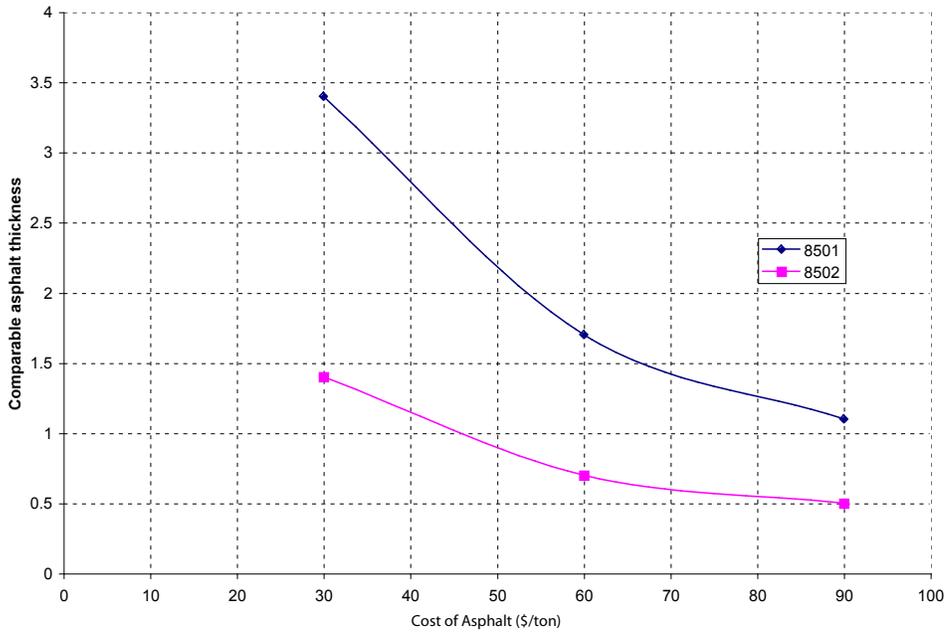
Current material costs (2008) for the GlasGrid 8501 and 8502 are \$0.50 per square foot and \$0.64 per square foot, respectively. Installation costs are about \$0.08 to \$0.11 per square foot. Figure 16 shows the thickness of asphalt that would be a comparable cost to that of GlasGrid, per square foot, where 100-percent coverage is assumed for GlasGrid 8501, and 33-percent coverage (i.e., thermal cracks at 15-foot spacing) for GlasGrid 8502. So, the cost of 100 square feet of GlasGrid 8501 would be similar to 100 square feet of asphalt 1.7-inch thick, at \$60 per ton.

Given the success of GlasGrid 8502 (in this project) at suppressing the reflective cracking of medium-to-high severity thermal and longitudinal cracks, the selective treatment of individual cracks appears to offer the greatest potential for life-cycle cost savings when using relatively thin overlays.

Figure 16—The thickness of asphalt that would be comparable to the square-foot cost of GlasGrid, where 100-percent coverage is assumed for GlasGrid 8501, and 33-percent coverage for GlasGrid 8502.
