Technology &
Development
Program

Response of Road- Stream Crossings to Large Flood Events in Washington, Oregon, and Northern California

**USDA Forest Service
Six Rivers National Forest
Pacific Southwest Region**

September 1998

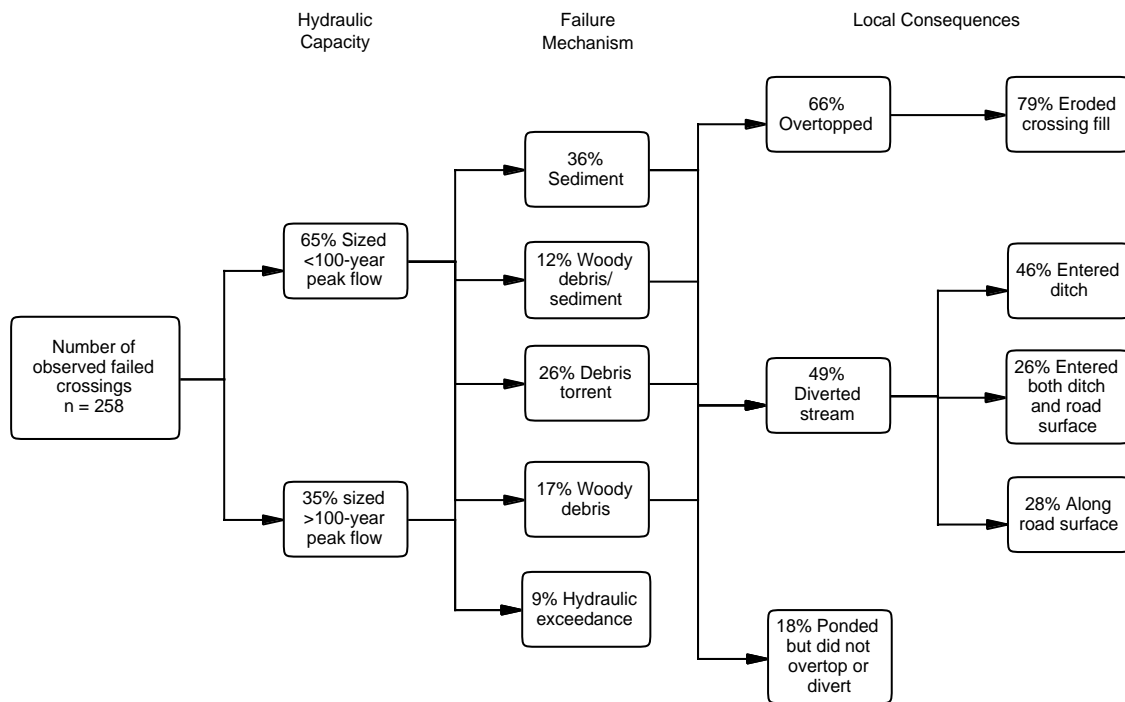
Sediment slugs (36 percent) and debris torrents (26 percent) were the most common failure mechanisms we observed (Figures 2 and 3). Sediment slugs were commonly the result of rapid deposition of colluvium from an upstream landslide or cutbank failure. Debris torrents were often initiated by a pulse of sediment and organic material entering the stream from a channel streambank or hillslope failure.

Woody-debris failures usually resulted from multiple pieces of wood lodging across the inlet of the culvert, trapping sediment upstream and plugging the inlet. Small pieces of wood appeared to be just as likely to initiate plugging as were large pieces (Flanagan, in preparation). Of the measured woody debris initiating culvert plugging, 23 percent ($n = 13$) were shorter than the diameter of the culvert they plugged. Failure from exceeding hydraulic capacity was infrequent (9 percent of the failures).

Figure 6—Results sorted by hydraulic capacity, failure mechanism, and local consequences

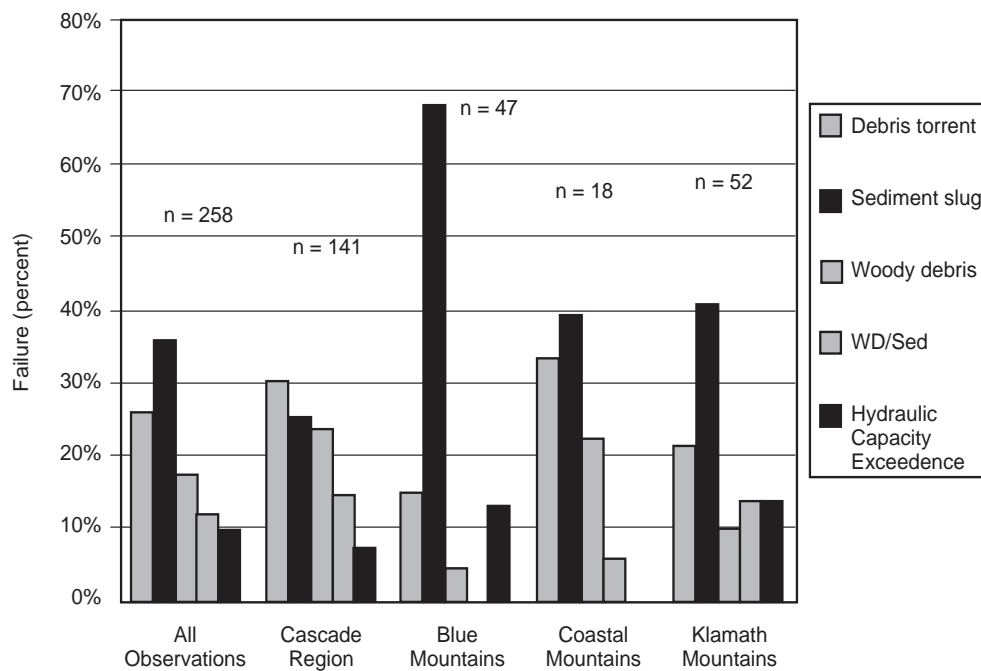
The leading mechanisms of failure observed in the Cascade Region were debris torrents (30 percent), followed by sediment slugs (25 percent), and woody debris (23 percent) (see Figure 3). Crossing failures were most commonly found in mid-slope road sections. These areas have high road-stream crossing densities and are characterized by steep, unstable slopes susceptible to mass wasting. Sediment slugs were the principal mechanism for failure in the Blue Mountains (68 percent), Coast Range (39 percent), and the Klamath Mountains (40 percent). For the Blue Mountains, the preponderance of sediment-slug failures can be attributed to fractured basalts found in the area, which tend to slump from steep roadside cutslopes and hillslopes, rapidly filling inlet basins and overwhelming the capacity of the culvert to pass sediment. Figure 7 shows the distribution of the failure mechanisms.

Figure 7—Distribution of failure mechanisms for physiographic regions in Oregon and Washington and the Klamath Mountains in California.

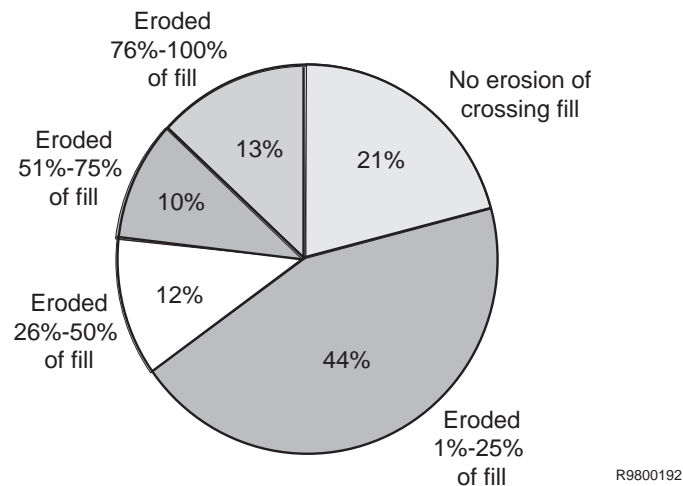
Road-stream crossing fill eroded, either progressively or catastrophically, at 79 percent of the sites where streamflow overtopped the road (n = 171) (Figure 8). Progressive erosion often led to head-cutting of the downstream fill slope, while catastrophic erosion, analogous to a “dambreak” flood, resulted in loss of a large proportion of the fill. At several sites, rapid stream aggradation associated with sediment slugs filled the inlet basin, depositing material on the road surface and resulting in net deposition and little or no fill erosion. Material was deposited onto the road surface, the crossing fill, or both at 15 percent of the sites (n = 92) commonly associated with sediment slug and debris-torrent failures.

Figure 8—Proportion of road-stream crossing fill eroded where streamflow overtopped the road (n=171).

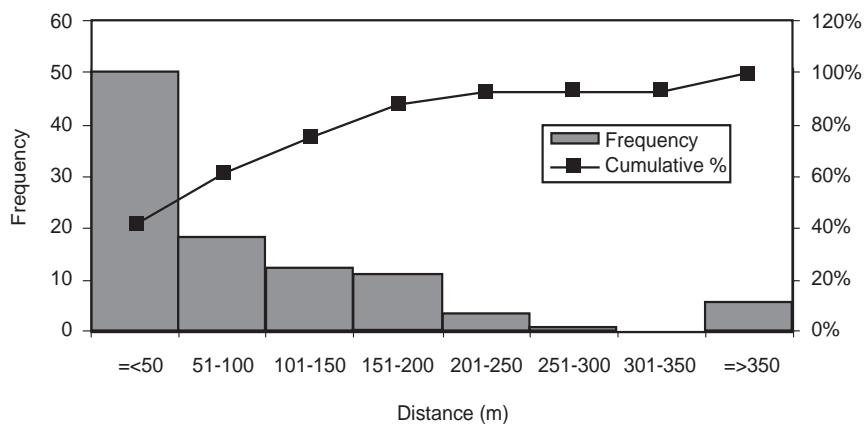
Figure 9—Observed diversion distances at failed stream crossings (n=104).

stream crossings. Diverted streamflow was routed along the inboard ditch, road surface, or often both. Diversion out of the ditch and onto the road surface was often the result of runoff forced out of the inboard ditch, through ditch deposition, failed cross-drains, sharp bends on steep roads, cutslope failure into the ditch, road outcropping, and exceedence of the ditch’s hydraulic capacity. Fifty-three percent of diverted streamflows entered adjacent cross-drains or road-stream crossings; the remaining 47 percent either flowed across the road and onto the hillslope or infiltrated the road fill (n = 103). Figure 9 shows the distribution of observed diversion distances.

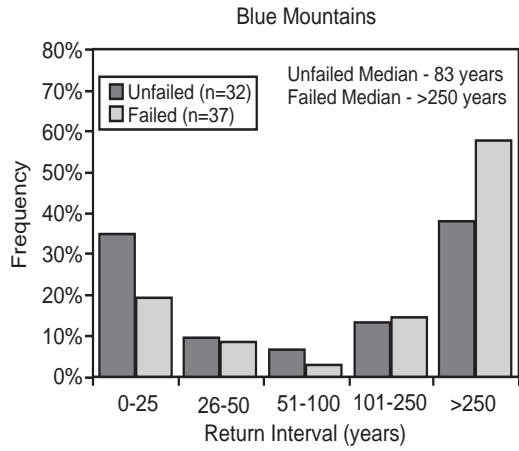
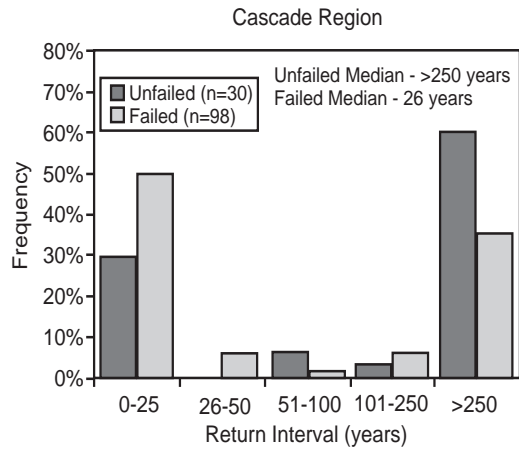
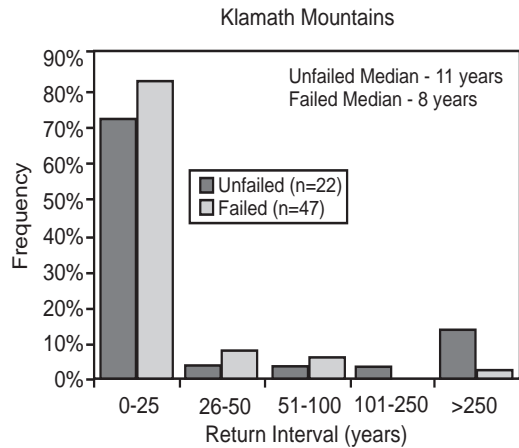
Similar to the observations of Piehl et al. (1988), we found that T_d was distributed bimodally for both failed and unfailed culverts (see Figure 10). The median of T_d in the Cascade Region was greater than 250 years for unfailed crossings but only 26 years for failed crossings. Failures caused by debris torrents were suspected of being unrelated to culvert size. If we neglect debris-torrent failures, the median T_d for failed crossings is only 18 years. The relative frequency distribution in Figure 10 suggests that culverts in the Cascades sized for less than the 25-year peak flow have a higher probability of failure than those sized for greater than the 250-year peak flow. Stream crossings in the Blue Mountains exhibited the opposite trend, with the median of T_d for unfailed crossings less than that of failed crossings. The hydraulic assessment template was not useful as a screening tool in the Klamath National Forest study area because a majority of the sites, both failed and unfailed, had T_d values less than the 25-year peak flow. The survey size in the Coast Range was insufficient for the analysis of the T_d distribution.

Figure 10—The relative frequency of the probability of exceeding culvert hydraulic capacity, expressed as peak flow recurrence interval, T_d , for failed and unfailed stream crossings in the Blue Mountains, Cascade Region, and Klamath Mountains. Within the Cascade Region, failed culverts were more frequently sized for less than the 25-year peak flow (at $HW/D = 1$), while the majority of unfailed culverts were sized for greater than the 250-year peak flow (at $HW/D = 1$). The opposite relationship was found for the Blue Mountains.
