**United States
Department of
Agriculture**

Project Report
8671 1201

Evaluation of Nonmetallic Culverts

James R. Bassel—*Civil Engineer*
Forest Service
Equipment Development Center
San Dimas, California

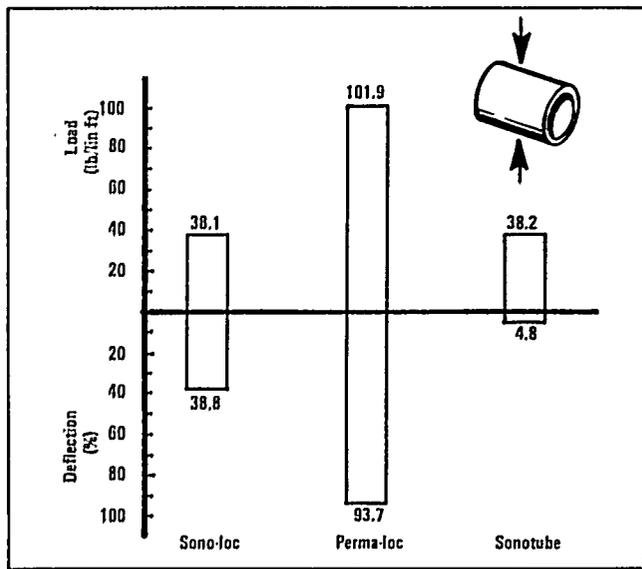
Figure 2. Load deflection.

Pipe stiffness (PS), pipe deflection (D), and stiffness factor (SF) were calculated from the measured loads and deflections. They are listed in table 2. Figure 2 illustrates load deflection results.

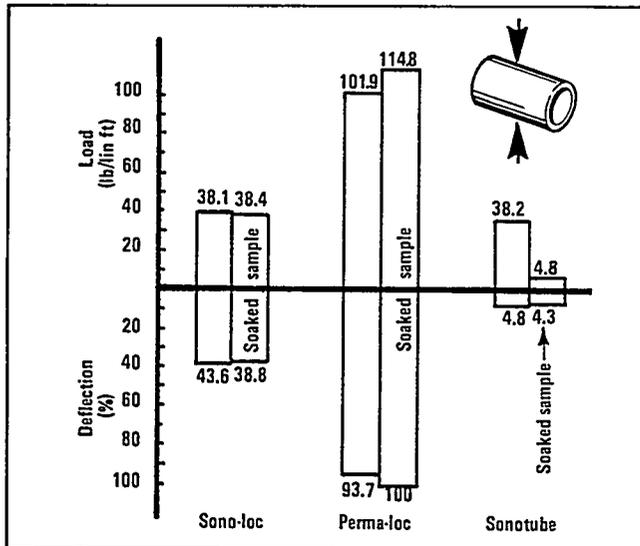
Figure 3. Comparison of soaked (96 hours) and unsoaked load deflection.

material were to be tested. They were immersed in water for 24, 48, and 96 hours, respectively. Each specimen was weighed before and after soaking. Because the Sono-Loc and Perma-Loc pipes did not weigh any more after soaking 96 hours, this test was modified. All three test samples of the Sonotube and only one each of Sono-Loc and Perma-Loc were tested. The results are shown in table 3. Figure 3 compares soaked and unsoaked load deflection.

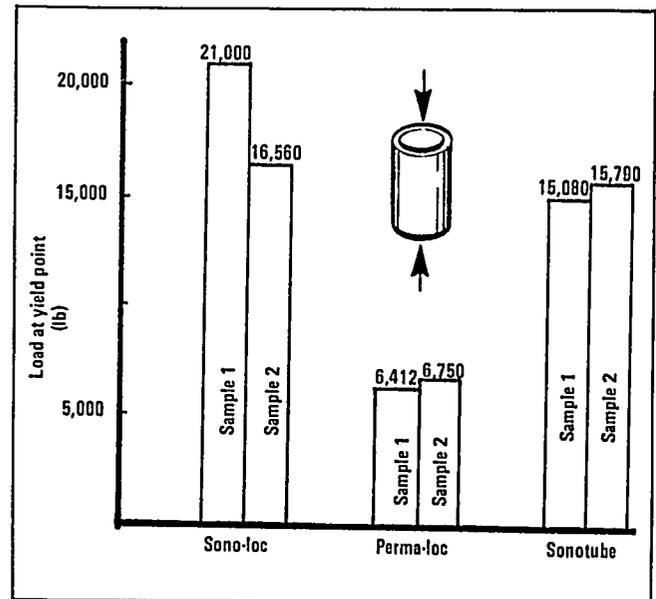
Figure 4. Compressive strength.

test samples were loaded at right angles to centerline. Two samples of the three test materials were cut into 1-foot lengths and measured according to ASTM standards for length, wall thickness, and inside and outside diameters. Each test specimen then was placed between the surfaces of the Tinius Olson pressure plates and compressed to the yield point. The results of this procedure are shown in table 4. Figure 4 illustrates compressive strength results.

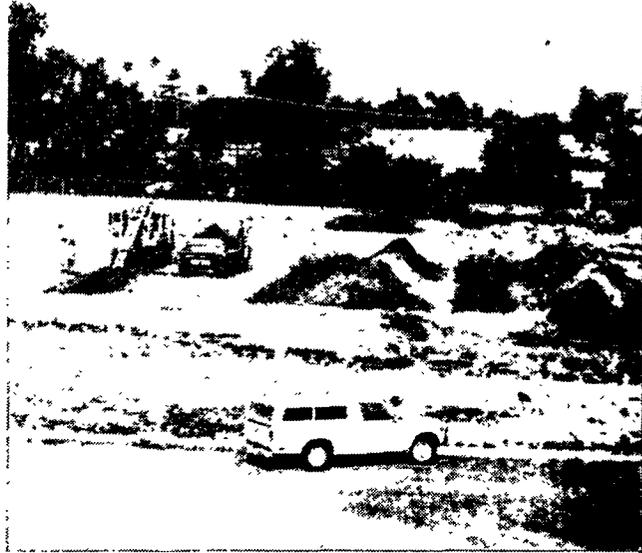
Figure 6. Preparation of the test course.

This field test determined the ring deflection when an H-20 (16 kips/dual wheel) was applied under varying soil covers and compactions. A test course (fig. 6) was constructed at SDEDC. The course had sixteen 20-foot pipe installations—six Sono-Loc pipes, six Sonotubes, and four polyethylene pipes. The pipes were installed (fig. 7) in sloping trenches and backfilled to their original soil level to provide a continuously decreasing height from one end of a pipe run to the other. The test was designed for three soil densities: 85 percent, 95 percent, and uncompacted. Natural soil was used for backfill in 10 sites, and crushed aggregate was used in the other 6 sites.

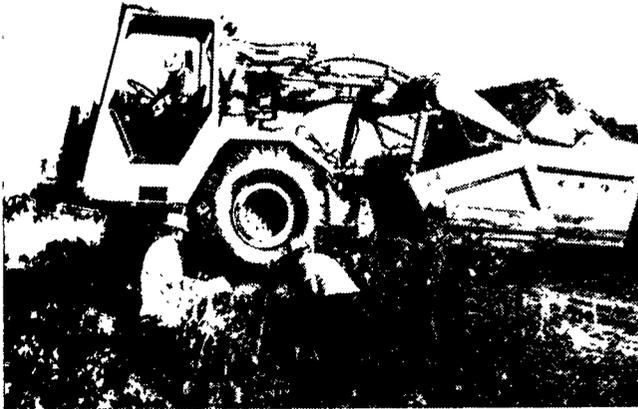
Figure 8. H-20 loading.

A scraper was used to produce an H-20 load (fig. 8). The exact weight, ring deflection, and soil cover height were obtained for each loading. At some sites, the load was increased above the H-20 load by lifting the wheels of the scraper off the ground and using only the blade to

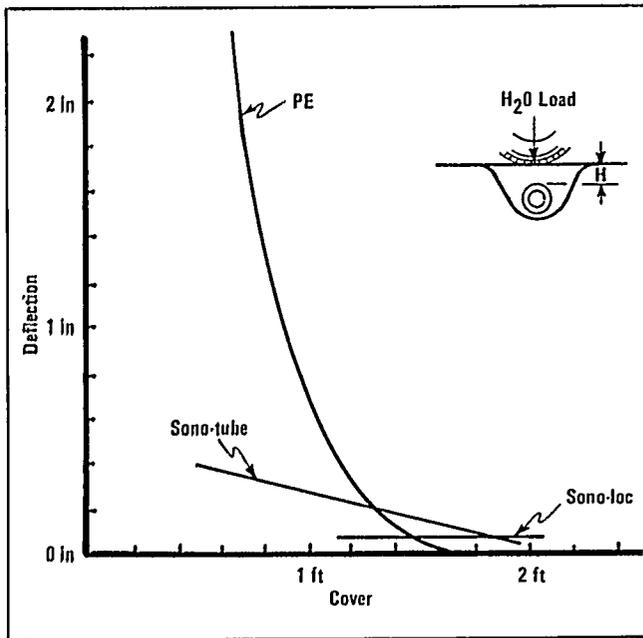
Figure 9. Deflection at H-20 loading.

support the scraper. The results of this test are shown in table 5. Figure 9 illustrates deflection at H-20 loading.

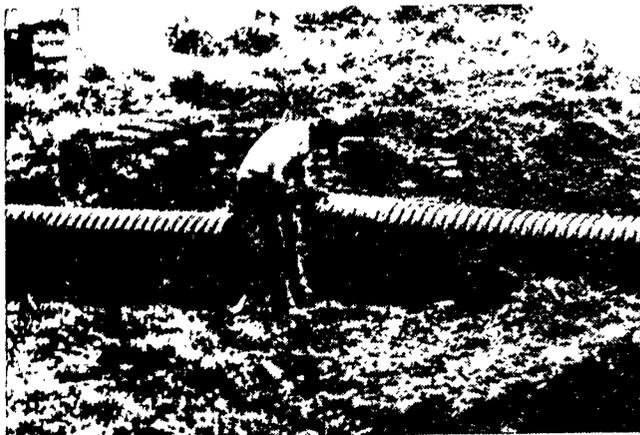
Figure 15. Installing the PE coupler.

The two PE's were easily installed. The coupler that was developed for PE (fig. 15) acts as a thread nut joining the two pipe ends. The crew determined that it was easier to use this coupler than the standard five-bolt metal band.

The PE was flexible and conformed to the streambeds. As of October 1984, the installations were still functional.
