# PARKING LOT SHADE STUDY

A Critical Examination of Davis Parking Lot Tree Shade

Tin-Wah Wong

by  
Tin-Wah Wong  
June, 1996

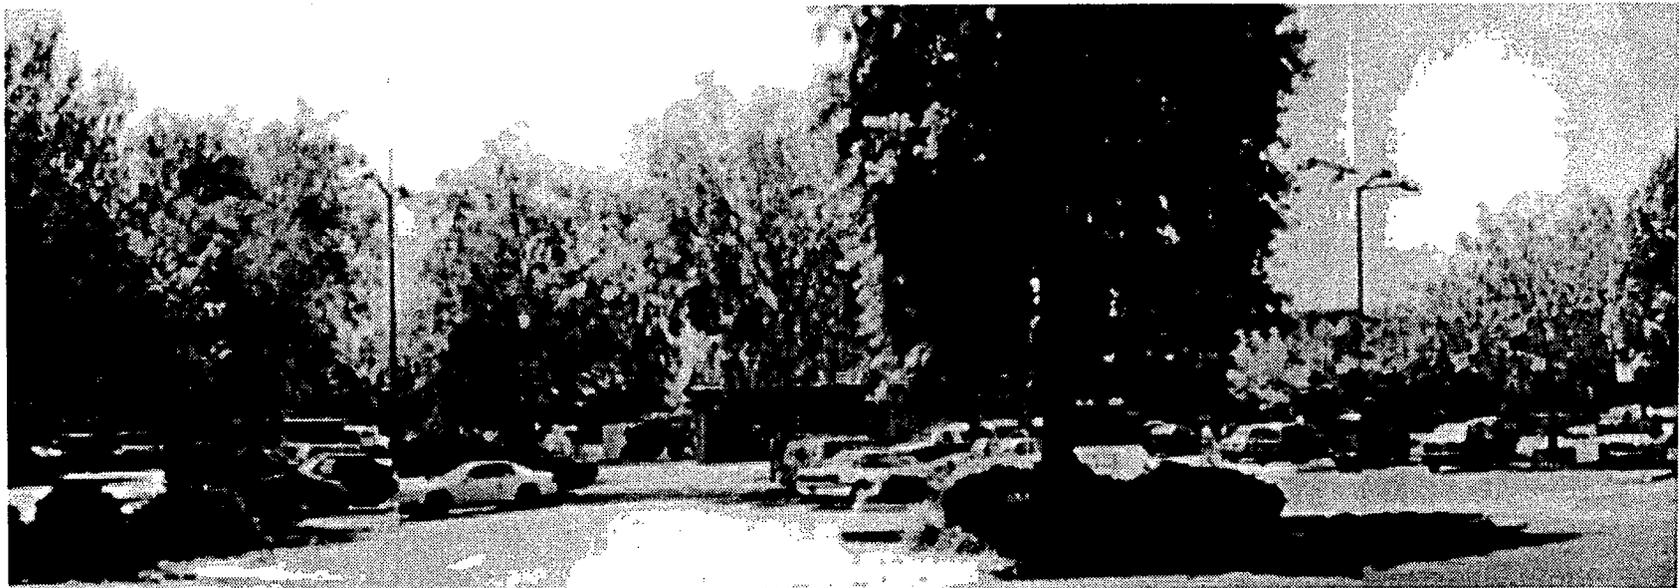
Figure 17: Albertson's parking lot.

Stakes are left on new replacement trees. The stakes appear to be unnecessary since the trunks of the replacement trees are of good, stable, independent size and the stakes are also conflicting with branches and tree trunks. Black plastic linings were left in the large interior planting beds. Some interior tree canopies are conflicting with the interior lighting. Spray irrigation heads found in raised circular planters may not be appropriate for these smaller planters since most of the water dispersed from the sprayers is not retained in the raised planters but forced outside the planter onto the asphalt. Bubblers would provide more water for trees grown in raised planters.

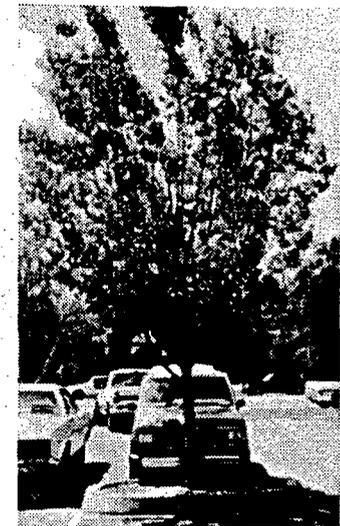
Figure 23: Davis High School parking lot tree planter.

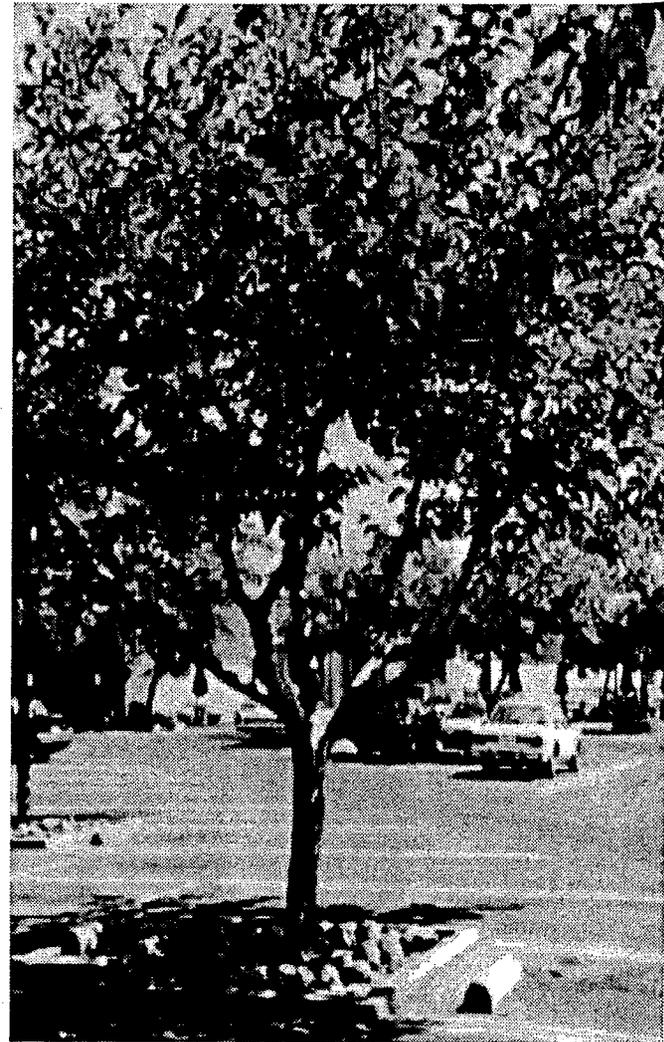
Figure 30: 2.2m x 2.2m square planter with 9" cobble stones.

rial certainly deter people from walking on the cobbles since the irregular stones make it pretty unstable for people to walk on. Other advantages of using cobble stones as surface material include an increased amount of water and moisture to the root structures. The second type of interior planters is circular raised planters with 2.2 meters in radius. Again 9 inch river cobbles are used as surface material medium. No irrigation source could be found in this type of circular planters. Trunk protection is not truly needed since the raised planters protect tree trunk damage, yet wheel stops are still found along this type of planter. Initial construction might have caused soil compaction, but little foot traffic contributes to increasing compaction. The last type of interior planter type found in this parking lot has dimensions of 2.15 meters by 5 meters. Bare soil and Oleander were used as surface planter materials. Spray irrigation is present in these interior planters. Wheel stops are available along planter's edge. Soil compaction could have been caused by initial construction. No foot traffic exist now since the Oleander shrubs prevent people from tramping through these planters (Table 3).

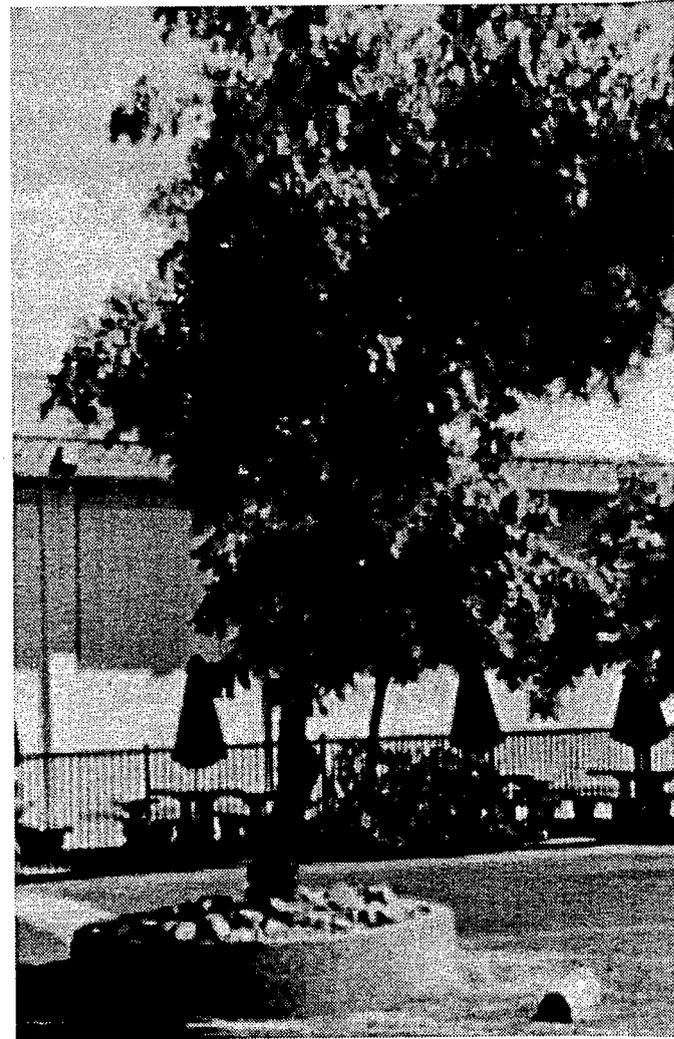
Figure 31: Raised round tree planted seen in University Mall Parking Lot.
