VOLUME 7 NUMBER 8

Red Mountain Creek Soil Bridge

Log Stringer Bridge Inspection and
Analysis in Alaska

AUGUST 1975

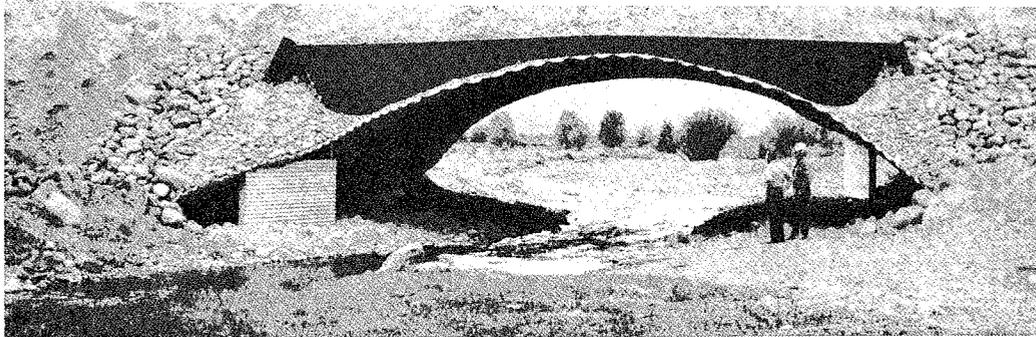
Figure 1. Completed 50 ft. x 10 ft. U.S. Steel Reinforced Soil Bridge across Red Mountain Creek. Note the end diaphragm protruding through the fill.

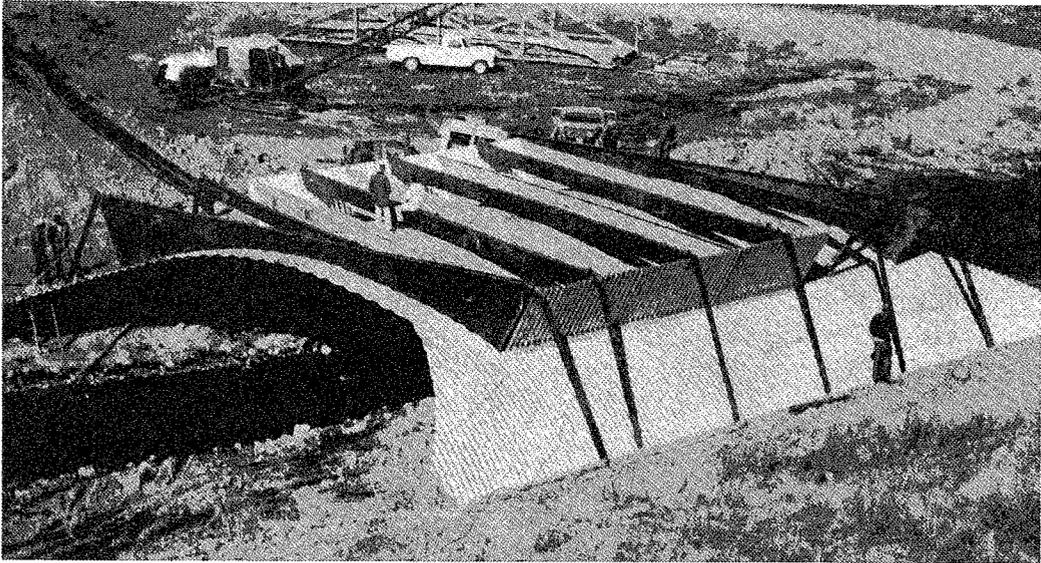
The original design envisioned arches without skew and bins fabricated square with both the arch and road centerlines. For the Red Mountain project, U.S. Steel fabricated the center bins square with the arch and added diaphragms, parallel to the road centerline on the ends, forming two triangular bins (fig. 3). These end diaphragms were not designed with end treatment in mind and they protrude through the fill slope (fig. 1). The original bins are galvanized and appear brighter in the photo than the added bins and end diaphragms, which are not galvanized (fig. 3).

Figure 3. Steel completely erected showing skewed diaphragms and triangular bins at the ends.

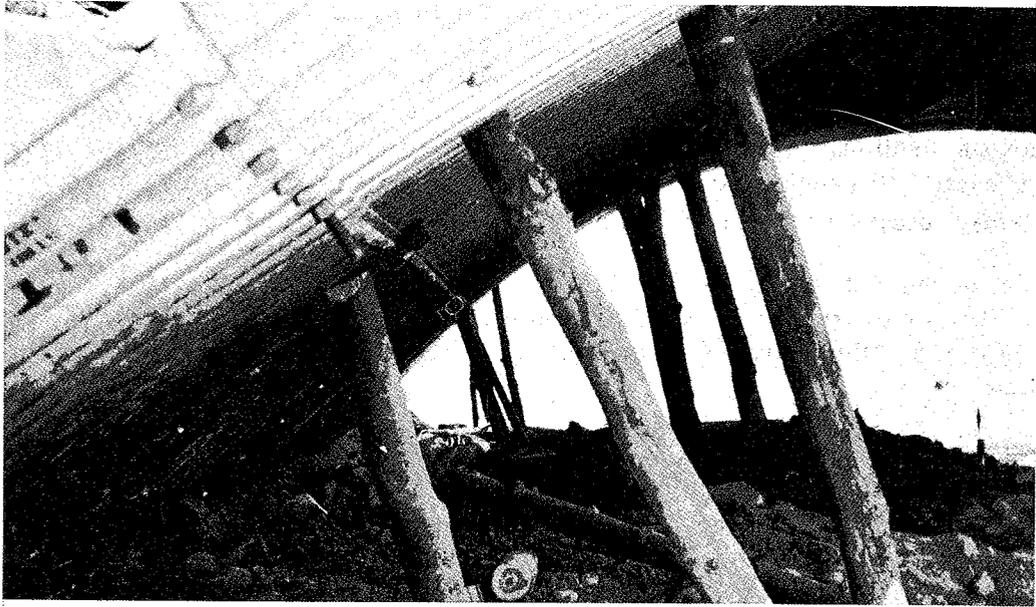
The design and construction of the concrete footings was conventional. The arch shell was erected with the aid of a 20-ton crane and native timber posts for shoring (fig. 5). Bins were bolted in place, completing the steel portion of the structure.

Figure 5. Native timber post shoring used during erection of the steel shell.

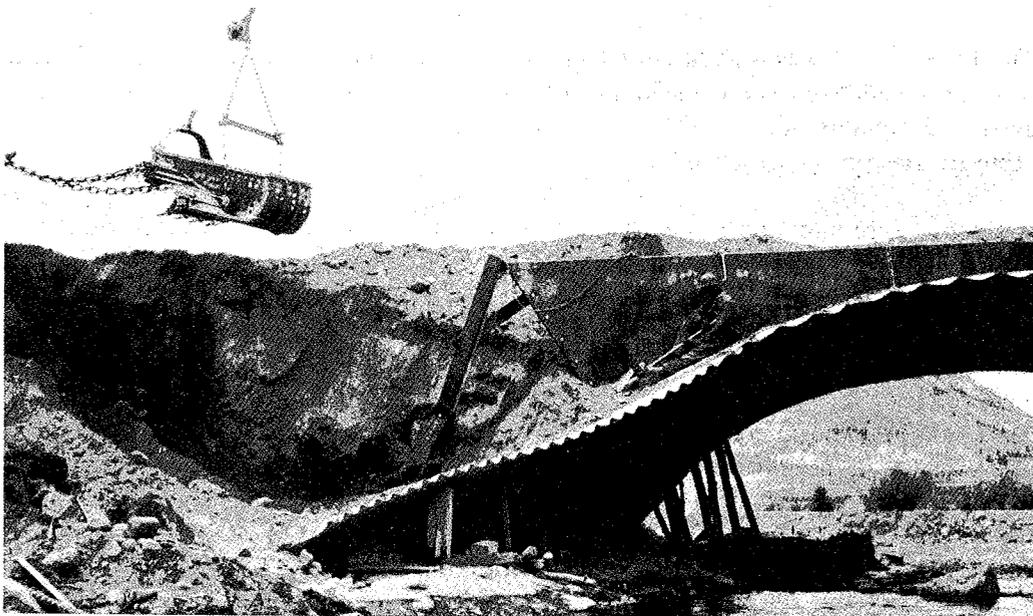
Because the steel arch is designed for minimum lateral loading, backfilling was critical. The procedure was to alternately backfill and compact the sides in shallow lifts (fig. 4), while monitoring peaking in the center. When the soil in the center rose one inch, the top and bins were loaded with earth, literally pushing the arch back down to the original shape (fig. 6). This alternating sidewall and crown loading was continued until backfill was complete. This procedure, while requiring care, proved satisfactory. The only instruments used were a surveyor's level and several plumb bobs.

Figure 6. Control of crown rise by loading top of structure with earth.

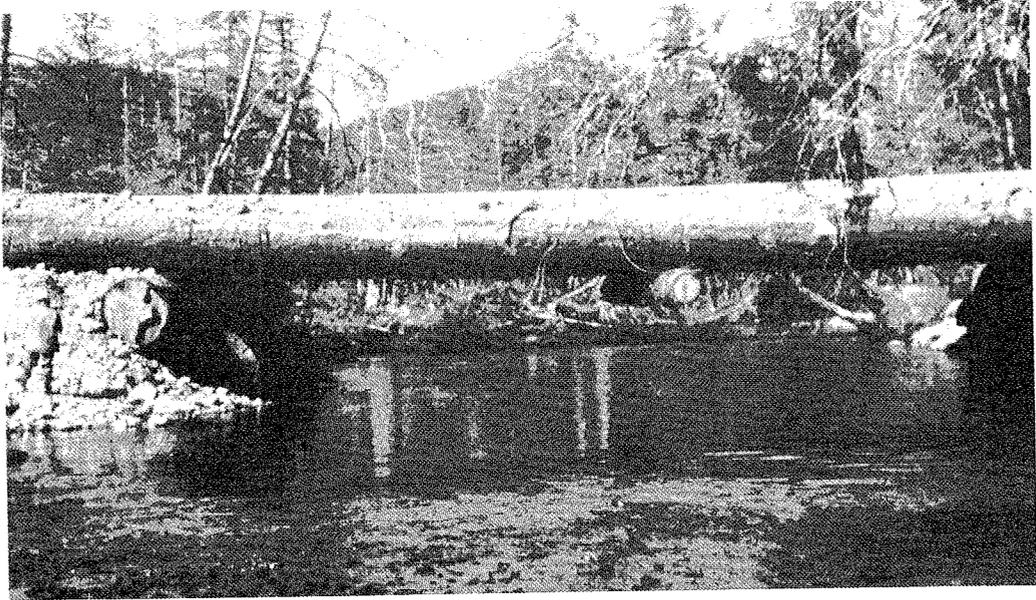
Figure 1. Log stringer bridge.

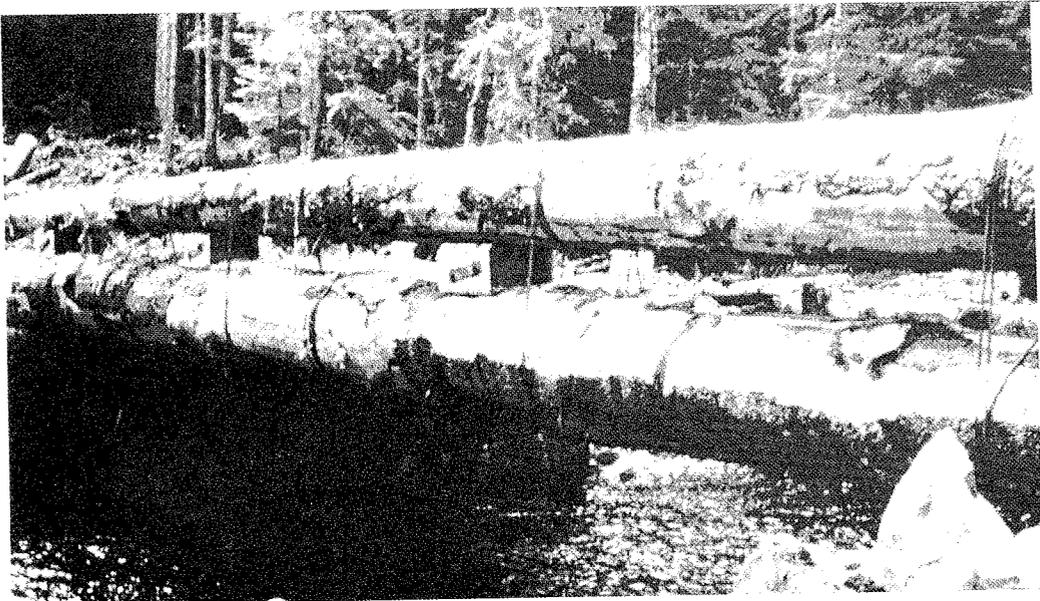
Figure 2. Staney Creek Bridge – 94 ft. simple span.

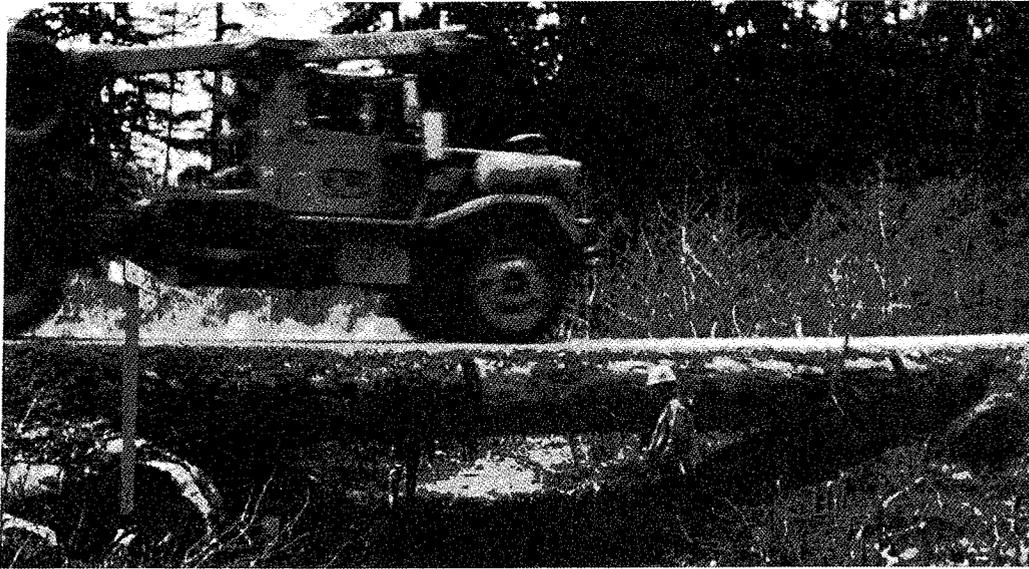
Figure 3. Short-span log stringer bridge.
