THE CRESCENT BYPASS: A RIPARIAN RESTORATION PROJECT ON THE KINGS RIVER (FRESNO COUNTY)¹

Jonathan A. Oldham and Bradley E. Valentine²

Abstract: The Kings River Conservation District planted over 1200 plants of 19 riparian species in the first of two phases of a riparian revegetation project in the San Joaquin Valley. To date, tree survival rates vary from 17 to 96 percent among species, with an overall rate of 62 percent. Shrub survival averages 57 percent and ranges from 23 to 73 percent. Factors affecting plant survival include soil quality, irrigation technique, climate, topography, weed competition, gopher and beaver depredation, vandalism, maintenance practices, and budget constraints.

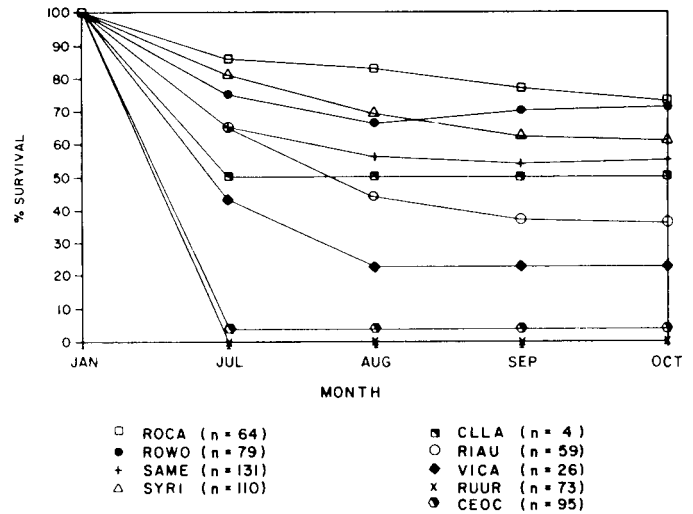
Figure 1— Shrub survival from time of planting to end of first growing season.

Phase I survival rates were substantially higher than those of the pilot planting. The survival rate for the shrub container stock was 57 percent after one growing season. Most plants (71 percent) died between the time of planting and July, while only 29 percent died over the summer (fig. 1). (Although irrigation started the beginning of June, survival data was not recorded until July.) We expected a higher mortality during the hot summer period. The shrub cuttings failed again despite increased care and maintenance. The short length of the cuttings combined with a lack of adequate water are likely causes. Because of the low survival of the cuttings, they are excluded from the survival rate calculations. Consequently, plant numbers between plots are inconsistent, ranging from 7 to 24 and averaging 17.5 plants per plot. Although the plants are still equally distributed along the length of the bypass, plots with few plants contribute to the large variation of interplot survival rates.

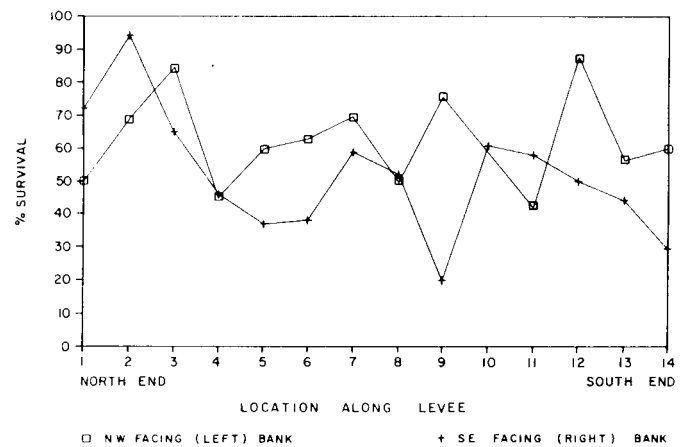
Figure 2— Shrub survival for each bank after first growing season.

Soils exceeding 2 mmhos/cm are considered saline and can adversely affect plant growth. Soils with EC values between 8 and 12, classified as highly to very highly saline, can reduce plant growth 30 to 50 percent (Dargan et al. 1982). Soil tests showed EC's of 8.7 and 10.8 mmhos/cm in two of 4 soil tests along the right bank. The average survival rate for the right bank was 52 percent, while the left bank averaged 62 percent (fig. 2).

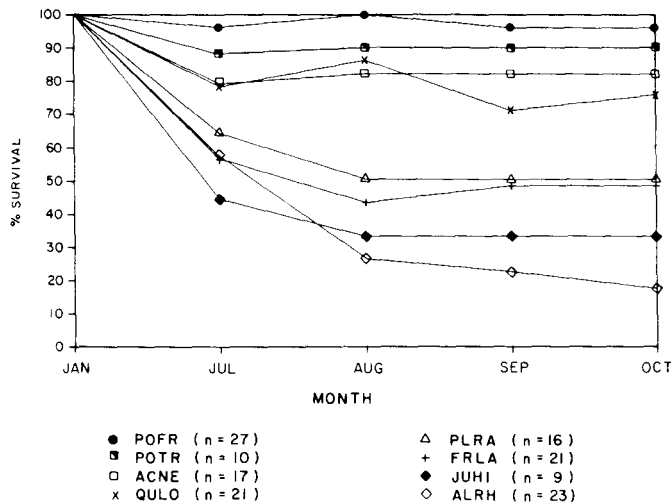
Figure 3— Tree survival from time of planting to end of first growing season.

Survival of containerized tree species was 62 percent. Of the mortalities, 83 percent died before July (fig. 3). Similarly, Anderson and others (1984) found that the majority of young POFR saplings on the Lower Colorado River died between November and July. POFRs and POTRs along the bypass survived better than other tree species. Beaver depredation was the only cause of their mortality. The beavers accessed trees by pulling down loose fitting screens. This prompted us to re-size the remaining screens. Fortunately, some of the stumps resprouted, resulting in increased mid-summer survival (fig. 3). With the exception of initial leaf burn on a POTR tree near a drain, the high salts and poor soil conditions have apparently not affected the cottonwoods. Once the roots reach the water table, growth and productivity is tremendous. Incidental observations of the POFR and SASP pole cuttings indicated similar growth with 2 to 3 ft branches by mid-summer. Similar results from Colorado were reported by Miller and Pope (1984). Unfortunately, most of our tree cuttings (unscreened) were depredated by beavers.
