# Geology and Geomorphology Diamond Lake Project Planning Area

## Diamond Lake Restoration Project

Larry Broeker, Geologist  
Umpqua National Forest

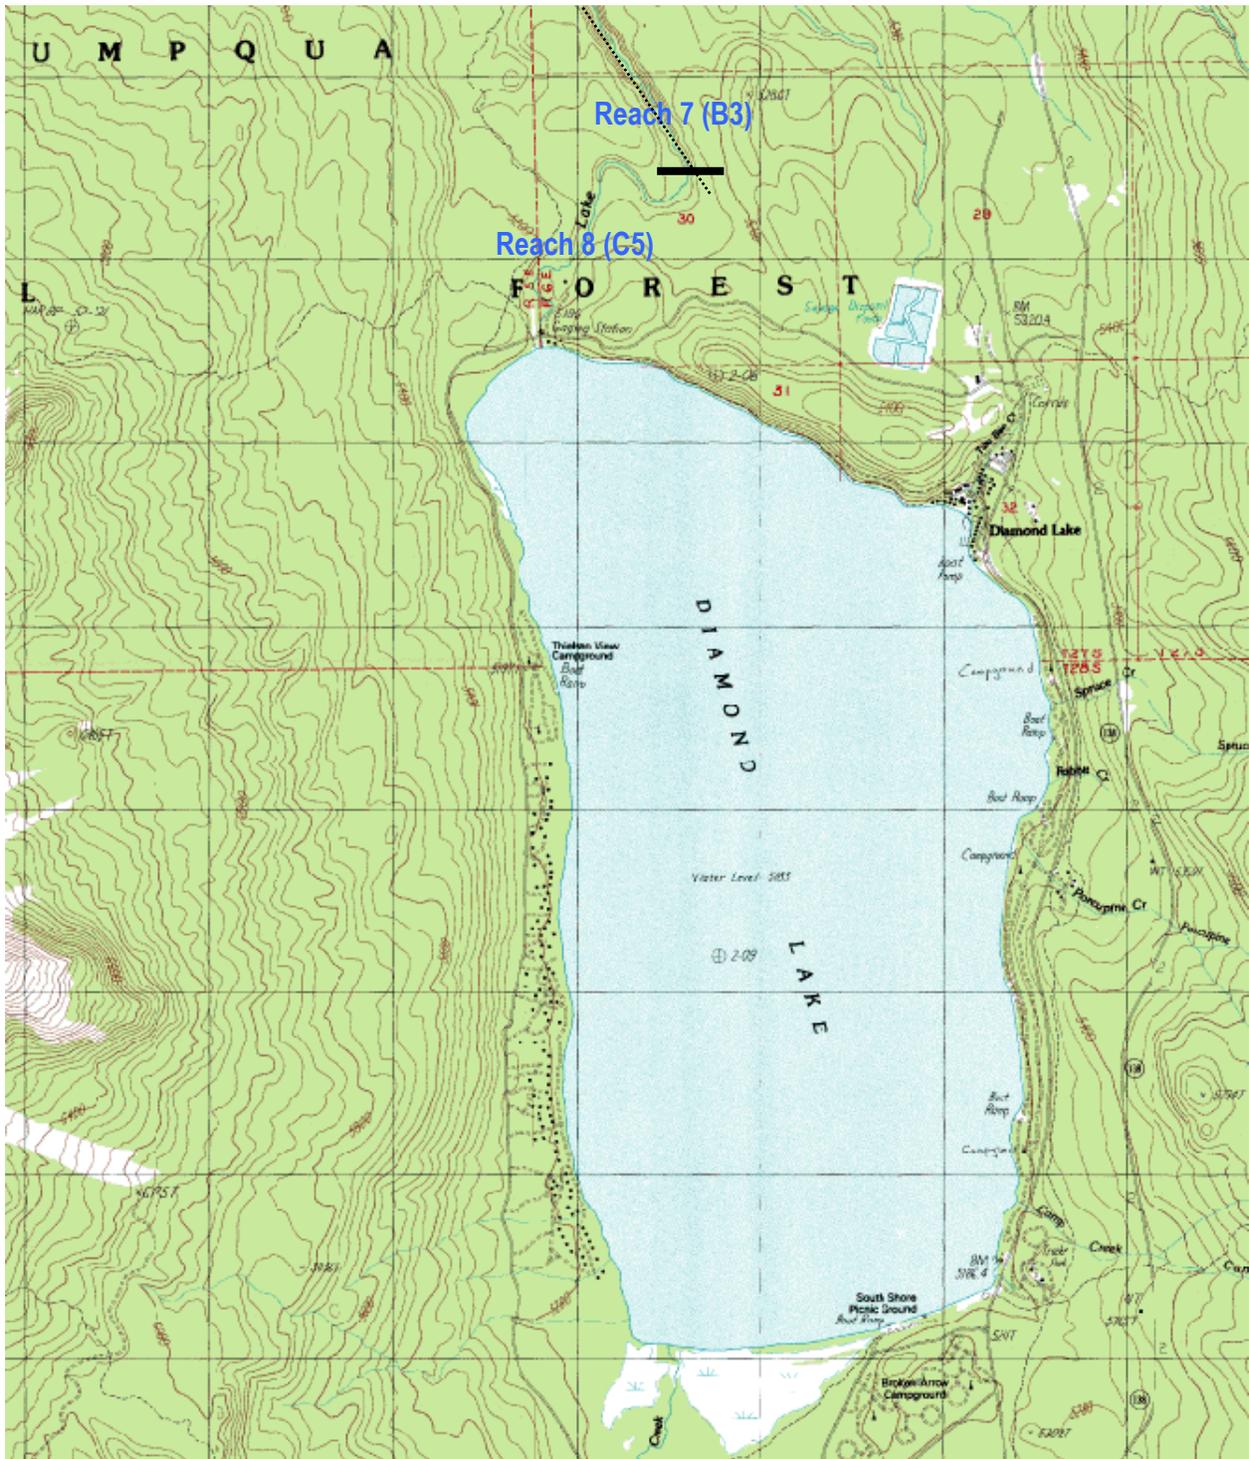
Figure 3c. Section of Lake Creek between gorge (Reach 7) and Diamond Lake.

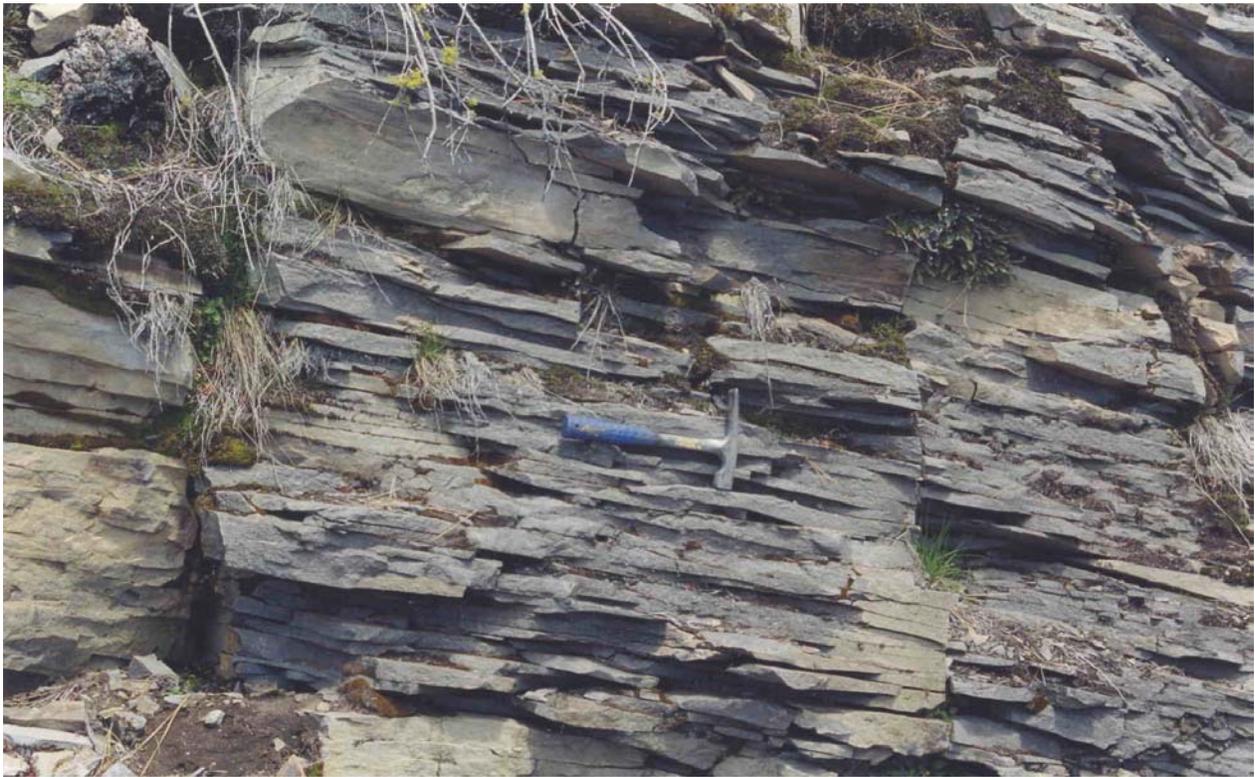
**Plate 1.** Platy fracturing basaltic andesite (Qoba) exposed on the Dellenback Trail approximately two thirds of a mile east of the Lake Creek outlet on the north shoreline of Diamond Lake. Photograph by Larry Broeker on May 16, 2003.

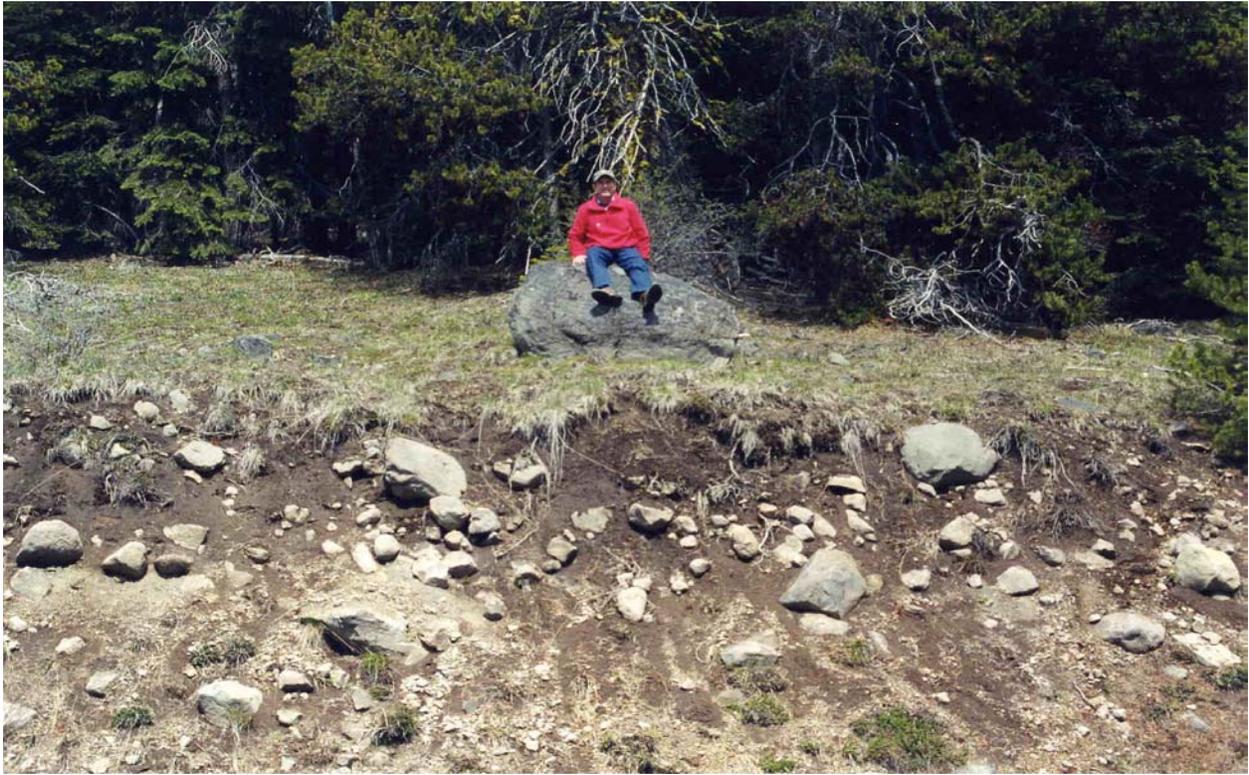
**Plate 3.** Deposit of loosely compacted cobble-boulder-rich glacial drift (Qgd) exposed in road cut (Forest 4795) several hundred yards to the south of Diamond Lake Resort. Steve Hofford, Forest Hydrologist provides scale. Photograph by Larry Broeker on May 16, 2003.

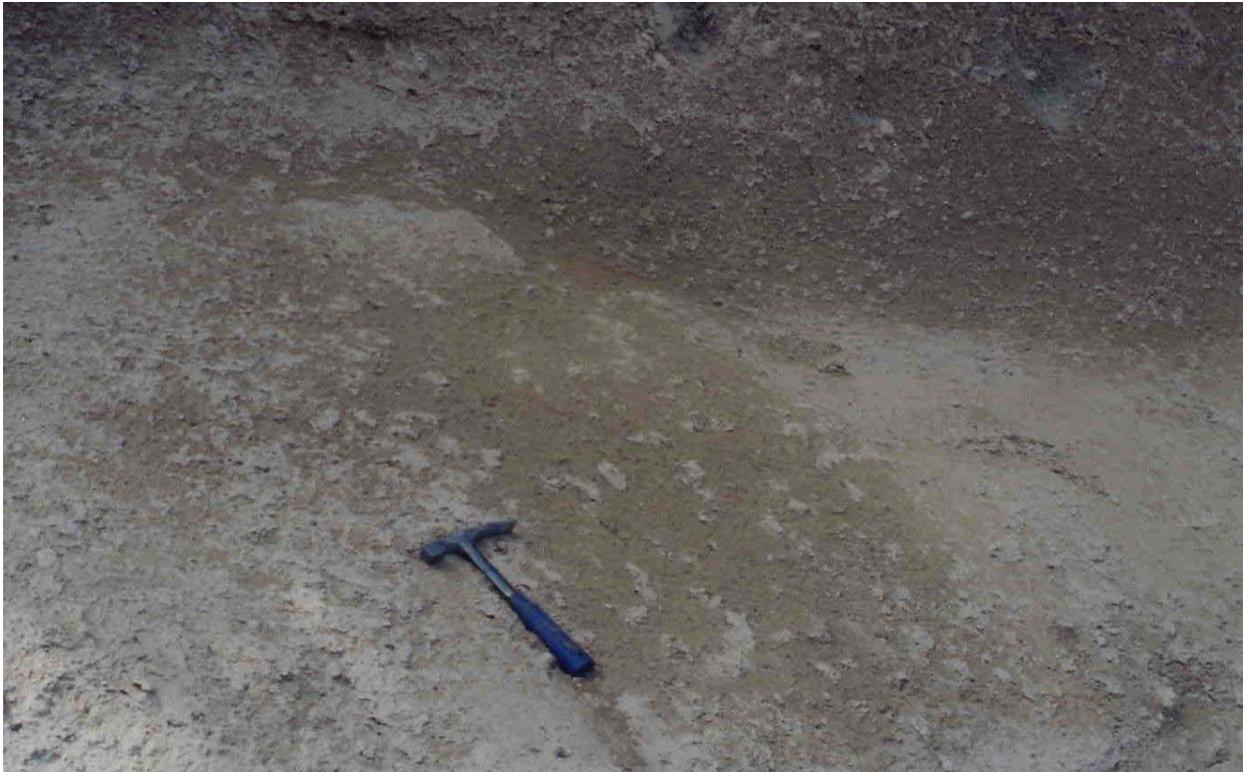
**Plate 4.** Mazama pumiceous ash-flow (Qaf) exposed in a nine foot high wave cut terrace along northwest shoreline of Diamond Lake about two hundred yards west of Lake Creek outlet. Photograph by Larry Broeker on May 16, 2003.

Sherrod (1991) speculates that Diamond Lake came into existence during the climatic eruption of ancestral Mt. Mazama when a massive pyroclastic ash-flow swept down its flanks burying and extensively altering existing stream networks within surrounding lowland valleys of the Rogue River, North Umpqua River, and Klamath basin (**Figure 2**). According to this hypothesis, a lobe of the ash-flow choked and blocked a section of stream channel that had once previously flowed through a broad valley now occupied by Diamond Lake. As the newly formed lake began to fill, a bedrock-controlled spillway, now known as Lake Creek outlet, became established several hundred yards to the east of the ancestral stream channel. If this inference is correct, the ancestral (pre-Mazama) stream channel is projected to lie beneath the thickly timbered flat situated in the extreme northwest corner of Diamond Lake directly west of the present day Lake Creek outlet. Mazama ash-flow extensively blankets this locality and wave action along the northwest shoreline of the lake has cut a 9-foot high terrace into this deposit (**Plate 4**).

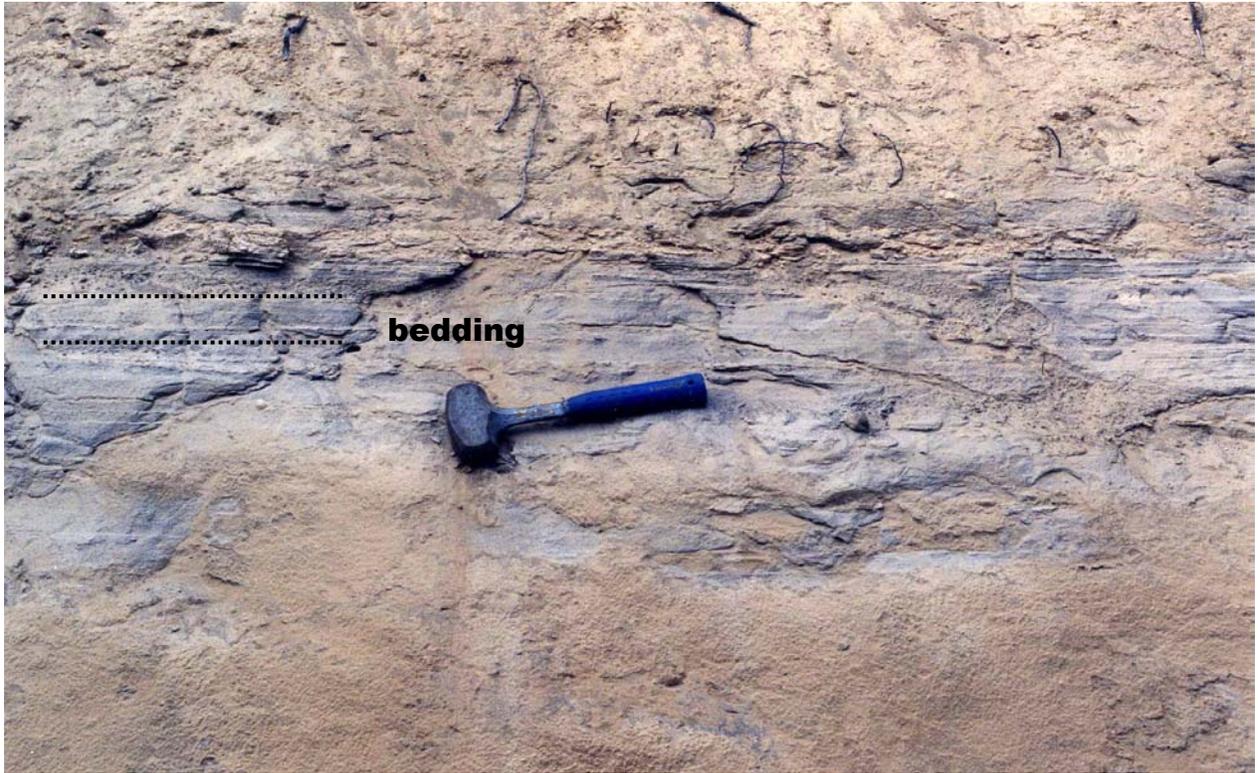
**Plate 5.** View of poorly consolidated and stratified lacustrine sand and gravel deposit (Ql) representing fluviially 'reworked' Mazama ash-flow exposed in road cut (Forest 4795) along the western side of Diamond Lake near the access road leading into cabin sites 40, 42, 47, 48, and 52. Bedding (stratification) in deposit is near horizontal. Photograph by Larry Broecker on October 18, 2003.

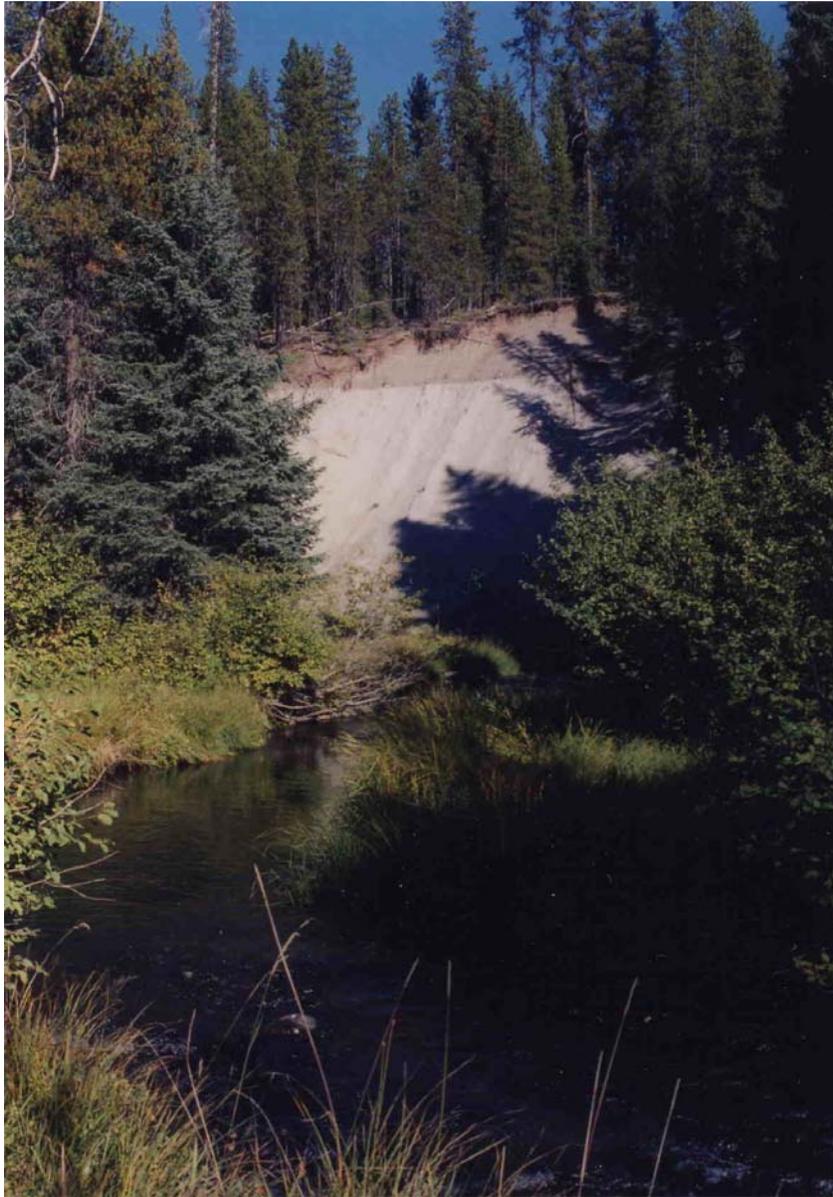
**Plate 7.** Mass wasting feature (landslide) along Lake Creek that measures roughly 35 yards (length), 30 yards (height), and 2 yards (average depth) deriving a volume of about 2,000 cubic yards of delivered sediment. Age of landslide feature is unknown but appears on B&W 1966 (1:12,000-scale) aerial photo. Valley wall is composed of light colored Mazama pumiceous ash-flow with a darker cap of stratified fluviually reworked Mazama ash (sand). This reach of Lake Creek impinges on and undermines the valley wall. This mass wasting feature corresponds to Site No. 4 in Table 3. Photograph by Larry Broeker on September 23, 2003.

Lake Creek is currently eroding the toe of the mid-level terrace at three closely spaced sites situated about one-half mile distance north of the Pit Lake No. 2 borrow source. Two of the three sites are landslides, the third site is an incipient mass wasting feature (**Figure 3a, Plate 6**). All three sites occur along outcurve reaches. Fine sediment (sand) is being delivered into Lake Creek during low base level flow conditions at both landslide sites. The larger landslide feature is depicted in **Plate 7**.

The largest landslide feature observed in the field occurs along a section of Reach 2 where Lake Creek encroaches into and undermines the toe of a steep west-facing slope (mid-level terrace) formed of poorly consolidated Mazama ash-flow (**Plates 6, 7**). Based upon its approximate lateral and vertical extent, this landslide feature is estimated to have delivered roughly 2,000 cubic yards of pumice-rich sand into the stream channel over an undetermined period of time. Slope failure is interpreted as being incremental (not a single failure) that likely resulted from many peak flow storm events occurring over the past couple centuries.
