CULVERT HYDRAULICS RELATED TO UPSTREAM JUVENILE SALMON PASSAGE

Patrick D. Powers, P.E.

LANDS AND RESTORATION SERVICES PROGRAM
Environmental Engineering Services

September 1, 1997

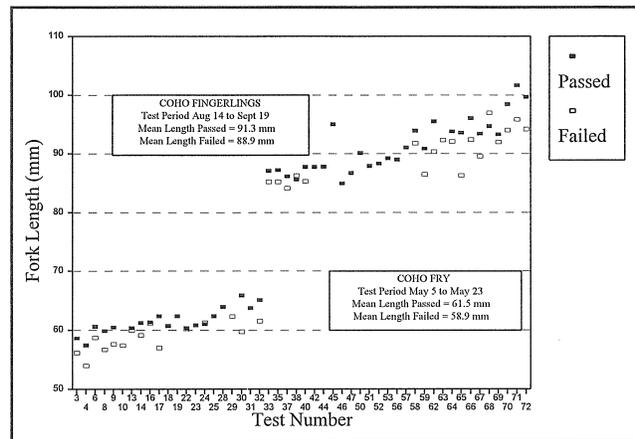
Figure 1 - Fork lengths of fish that passed and failed for the two test periods.

This study was performed in the spring and summer of 1995 at the Skookumchuck Salmon Hatchery near Tenino, Washington. On May 3, 1995, 40,500 zero+ coho salmon, *onchorynchus kisutch*, were transferred into two 8 ft by 80 ft vinyl raceways from the Skykomish Hatchery for the subsequent series of tests. Tested fish were returned to a separate pond and were not used again. Tests covered two size ranges of coho salmon (Figure 1) which correspond to the observed upstream migration cycle: 55-65 mm (fry) and 85-95 mm (fingerlings) (Peterson, 1982 and Cederholm, 1988). Coho fry were tested in the spring (May 1995) and the fingerlings tested in the summer (August 1995). The times were selected based on desired fish length. Water temperature during testing for these two time periods ranged from 48°F to 56°F.

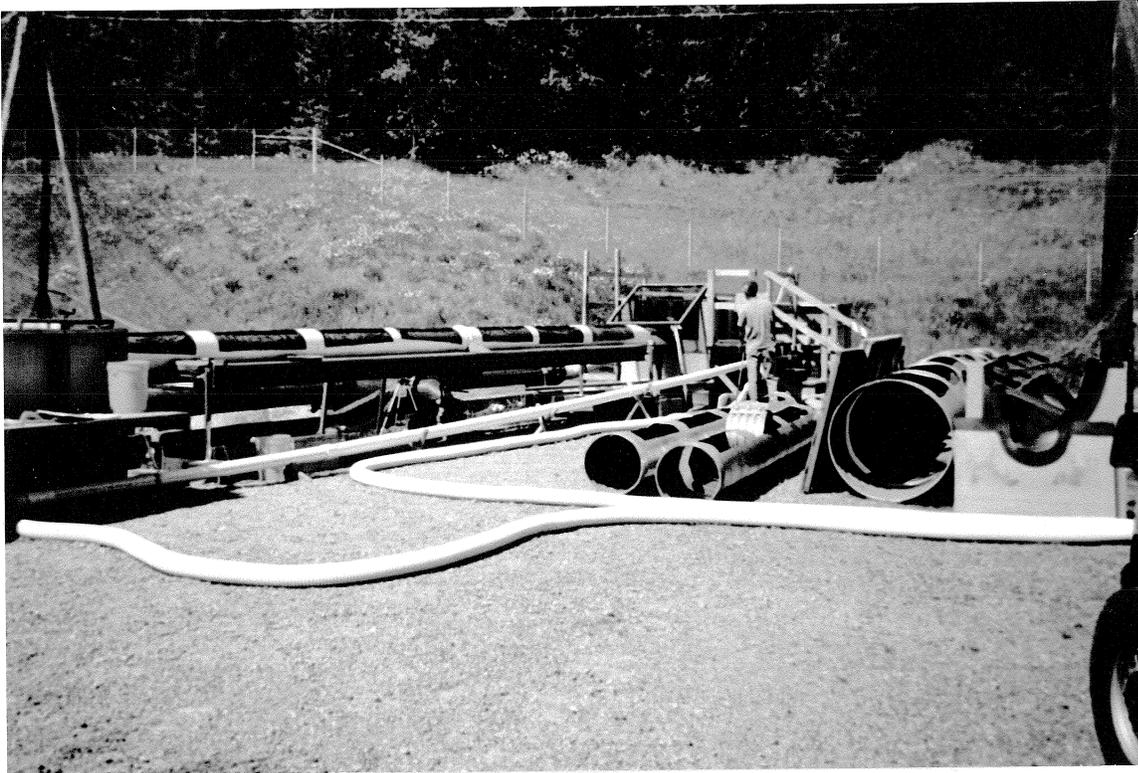
Photo 1. - Testing apparatus setup shown with 40 foot long -12 inch diameter smooth pipe in place. Flow in from right to left. The 18 inch and 36 inch culverts are shown to the right. Observation ports are covered with black vexar screens to reduce shading.

The testing apparatus consisted of an upper box, culvert and lower box (Photo 1). The upper box contained an inflow pipe with a flow control valve, energy dissipators, a flow measuring weir and screens for holding the fish once each test was complete. In addition, cover structures were installed in the upper box to provide refuge areas so fish would not fall back downstream. All of the culverts were 40 feet long. The slope was adjusted with trailer jacks. Screens were fitted inside the culvert to contain the fish during acclimation and testing. The lower box had, a flow measuring weir, a tailwater control weir and an outlet pipe. Pipes were open at the top, but shaded from the direct sunlight for daytime testing (Photo 2).

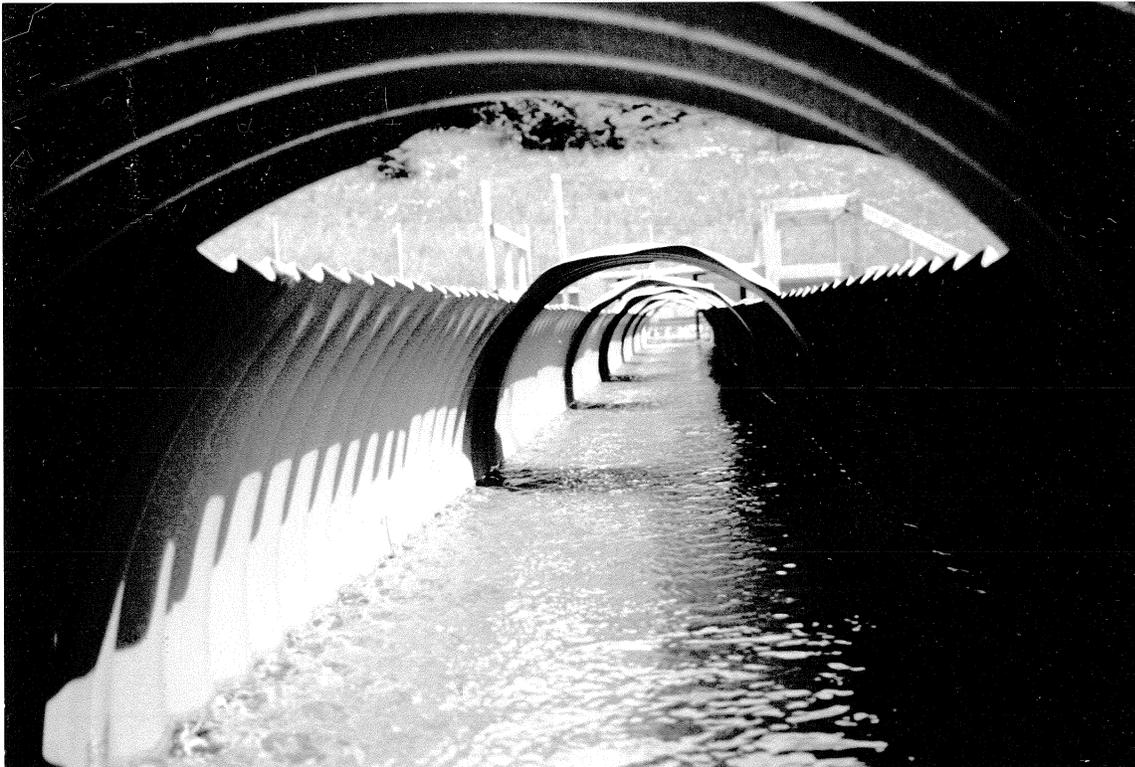
Photo 2. - View looking upstream through 40 foot long 18 inch diameter spiral corrugated culvert. Observation ports are shown on top. Note turbulence along the culvert wall on the left side of the picture.

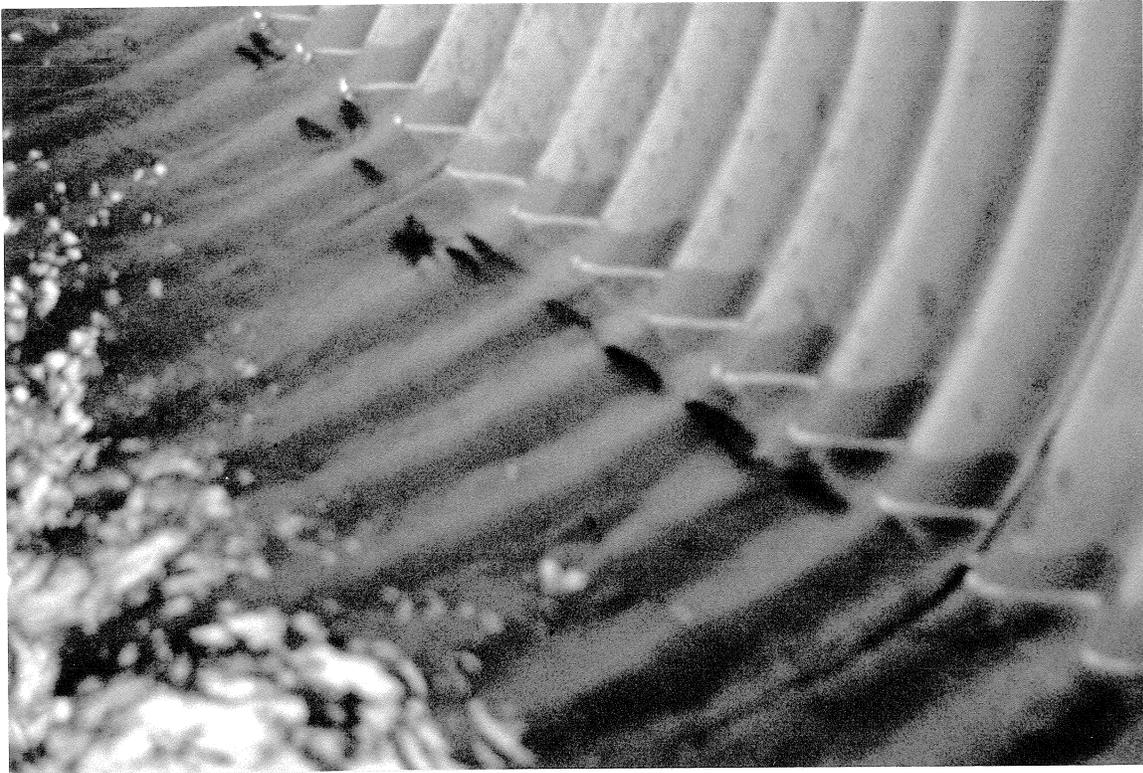
Photo 3. - Coho fry swimming upstream in a reduced velocity boundary layer along the culvert wall.

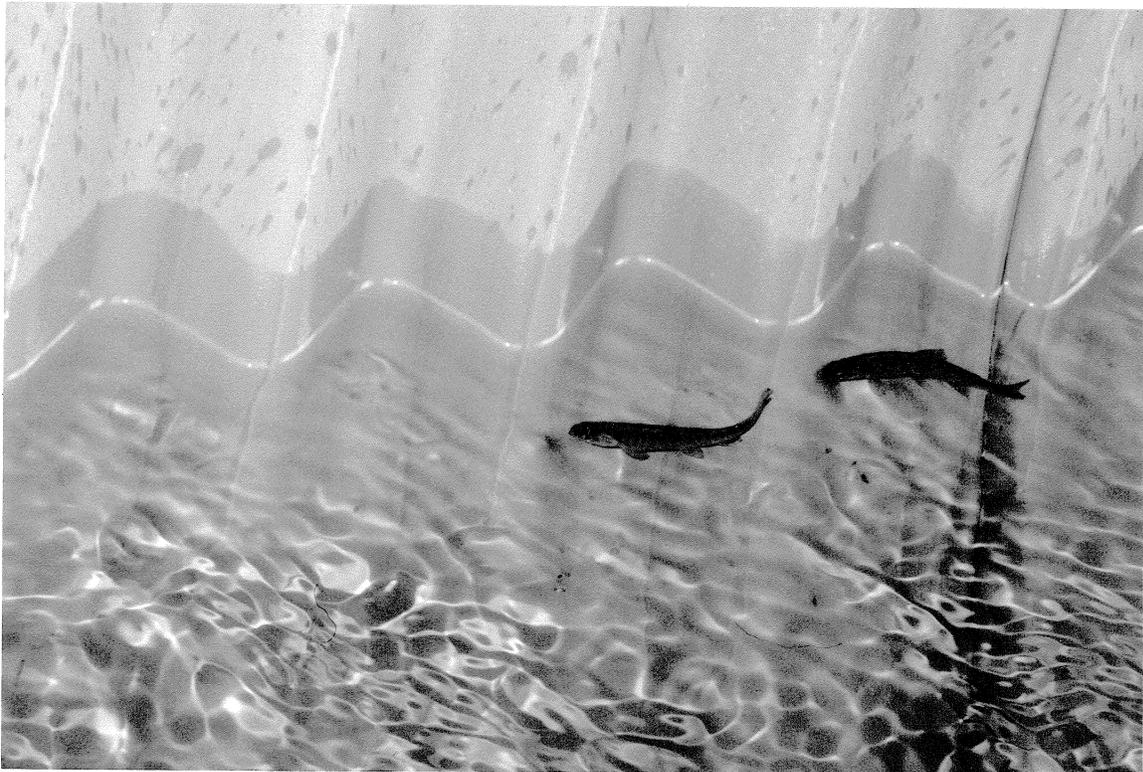
Photo 4. - Coho fry holding in the boundary layer next to the culvert wall. Fish were observed moving upstream in this area and holding.

For the pipes tested with roughness, fish were swimming or holding near the culvert wall (Photo 4) and just below the surface. With the smooth pipe fish were distributed throughout the water column. For the rough pipes this occupied area was defined vertically as $0.8d$, and horizontally 1.5 inches away from the culvert wall. The water velocity in this area was defined as V_{occ} (velocity occupied), and was recorded for each test. There was a fair correlation for some of the culvert/corrugation types, but not as good as the correlations to V_{max} . In general, as roughness increases, V_{occ} values to maintain the same level of passage success had to decrease. This again suggests that turbulence in the boundary layer may hinder passage success.

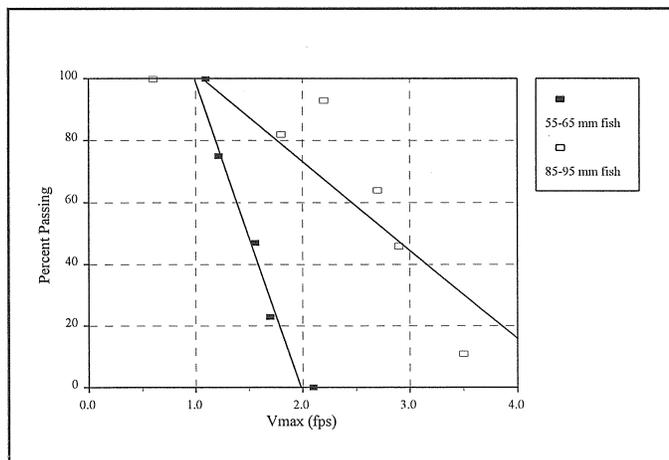
Figure 2 - Percent of juvenile coho salmon passing through a 40 foot long smooth pipe versus V_{max} .

For the second objective, control tests were also run with a smooth pipe to determine the velocities that fish can pass without roughness and turbulence as a variable. Since any significant slope created a velocity barrier, the flow was adjusted along with the tailwater control to provide the desired test velocities. This created a hydraulic gradient and depths that were not uniform for the full length of the culvert. The maximum velocity (V_{max}) was plotted versus number of fish passed. The V_{max} values shown in Figure 2 are measured at the culvert half way point. For example, in test # 30-0 (Test number 30 with the smooth (0) pipe), V_{max} was reported as 1.6 fps, but it actually varied from 1.5 at the culvert inlet to 1.7 at the outlet. For the coho fry the full range of passage (from 0 to 100 percent) was from 1.0 to 2.0 fps, and for the fingerlings 1.1 to 4.6 fps.

Fish did use the boundary layer when passing through the roughened culverts, but the results in Table 1 indicate passage success was better for the smooth pipes in most cases, especially for the larger fish and high velocities. Clearly, the larger fish (which had a much higher swimming ability from Figure 2) did not use the corrugations for passage as well as the fry. This again points to a possibility of turbulence hindering upstream movement (see discussion).

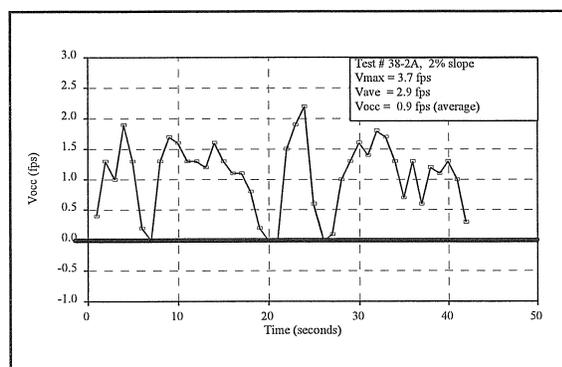
Figure 3 - V_{occ} values for Test 38-2A taken on one second intervals to show fluctuation in values near culvert wall.

The maximum and occupied velocity were determined from velocity contour mapping. V_{\max} values correlated best to passage success. Reported V_{occ} values are average values taken over some time but vary greatly because of turbulence in the boundary layer. Figure 3 shows the variability in V_{occ} measured on one second intervals. The average V_{occ} values (which was the one reported in the test results) was 0.9 fps, but from Figure 3 the values range from 0 to 2.2 fps. These velocity fluctuations may be an indicator of turbulence in the boundary layer for this type of roughness. Barber and Downs (1996) in a companion hydraulic study found also that velocity measurements taken near the corrugations were widely scattered.

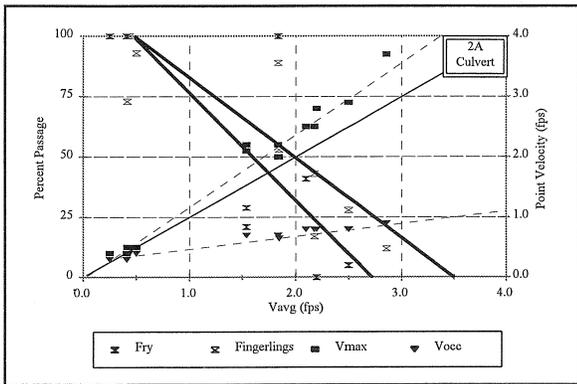
Figure 4a - Data points and regression lines for percent passage and velocity for the 2 inch annular corrugations.

Three different velocities were recorded for each test, the maximum velocity (V_{\max}), the average velocity (V_{avg}) and the occupied velocity (V_{occ}). The average velocity was computed as (Q/A) . The relationships between these three variables are shown in Table 2. There was a good correlation for all pipes tested, except for the 1S culvert with the spiral corrugations. Figures 4a through 4e show how the percent passage varies as a function of the three velocity variables. Data points and regression lines are shown. The heavy lines sloping down to the right are percent passage. The heavy line furthest to the left is for the fry, and the line to the right is for the fingerlings, except for Figure 4b, which is only for the fingerlings (fry were not tested). The light type lines sloping up are velocity. The solid line is V_{ave} , and the dashed lines are V_{\max} and V_{occ} .

For example: Figure 4a (pipe with the largest roughness), at a percent passage rate of 80 percent for the fingerlings, $V_{\text{ave}} = 1.2$ fps, $V_{\max} = 1.3$ fps and $V_{\text{occ}} = 0.5$ fps. Moving down to a passage success rate of 20 percent, $V_{\text{ave}} = 2.8$ fps, $V_{\max} = 3.4$ fps and $V_{\text{occ}} = 0.9$ fps. In Figure 4e (smooth pipe) at the same passage percent levels, $V_{\text{ave}} = 1.4$ fps, $V_{\max} = 1.8$ fps and $V_{\text{occ}} = 1.3$ fps. At the 20 percent passage level $V_{\text{ave}} = 3.3$ fps, $V_{\max} = 3.9$ fps and $V_{\text{occ}} = 3.2$ fps. Clearly these figures show that as the average velocity increases, passage success decreases even though V_{occ} values remain within the swimming ability of both size ranges of fish.

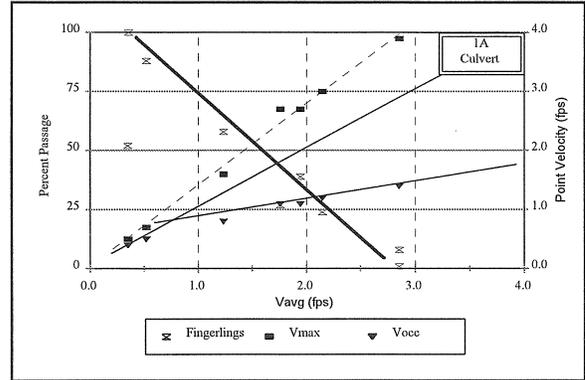
Figure 4b - Data points and regression lines for percent passage and velocity for the 1 inch annular corrugations.

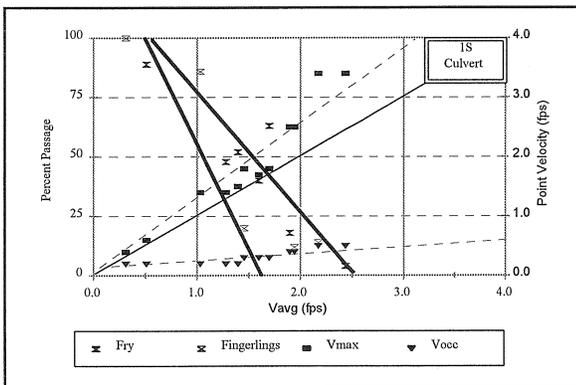
Figure 4c - Data points and regression lines for percent passage and velocity for the 1 inch spiral corrugations.

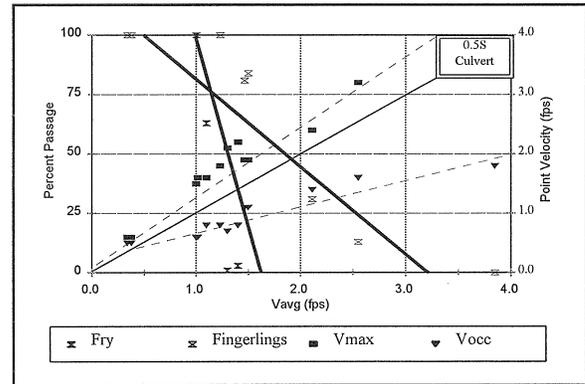
Figure 4d - Data points and regression lines for percent passage and velocity for the 1/2 inch spiral corrugations.

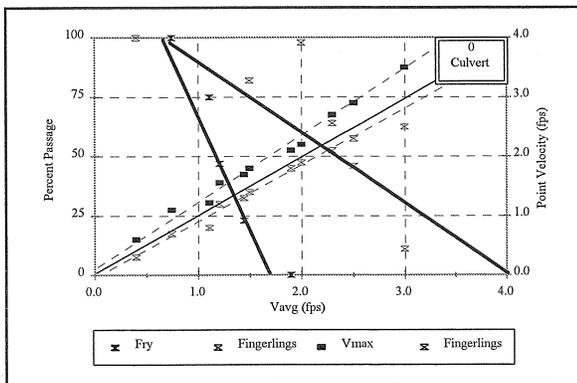
Figure 4e - Data points and regression lines for percent passage and velocity for the smooth pipe.

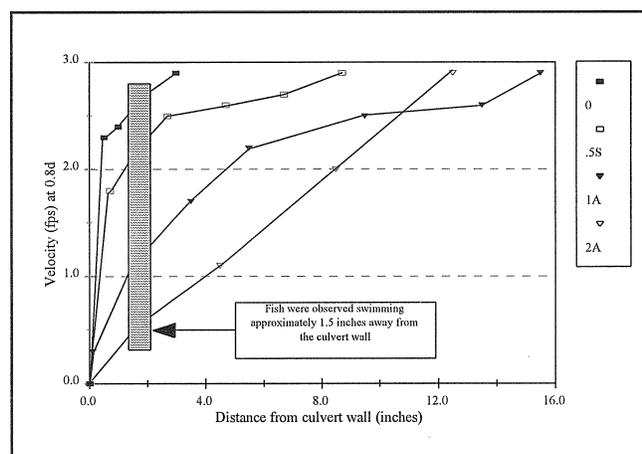
Figure 5 - Velocity profiles at 0.8 x depth for four different roughness types with a common V_{max} of 2.9 fps.

A main objective of this study was to test the premise that juvenile fish will use the low velocity zone in a roughened pipe to pass upstream. With baseline criteria developed for smooth pipes on the swimming ability of juvenile coho, the next step was to test these fish in a pipe with a roughened boundary. The low velocity zone can be shown graphically in Figure 5, which is a plot of horizontal velocity profiles from the culvert wall out 16 inches, for four different roughness types at a common V_{max} of 2.9 fps. During all tests with corrugations, fish were observed swimming very close to the wall (estimated from observation to be within 1.5 inches out from the top of the corrugations (Photos 3 and 4). Figure 5 does show a small boundary layer for the smooth (0) culvert, but fish were not observed using this area.

Figure 5 shows that at a common V_{max} of 2.9 fps, the velocity 1.5 inches from the wall varies from 2.6 fps for the smooth (0) culvert to 0.5 fps for the culvert with the most roughness (2A).
