**Case Study 16. Sibley Creek Vented Ford**

Washington. Mt Baker-Snoqualmie National Forest. Mt Baker Ranger District. Cascade River Road (County Road No. 15, Milepost 10.2).

## Appendix A—Case Study **16**

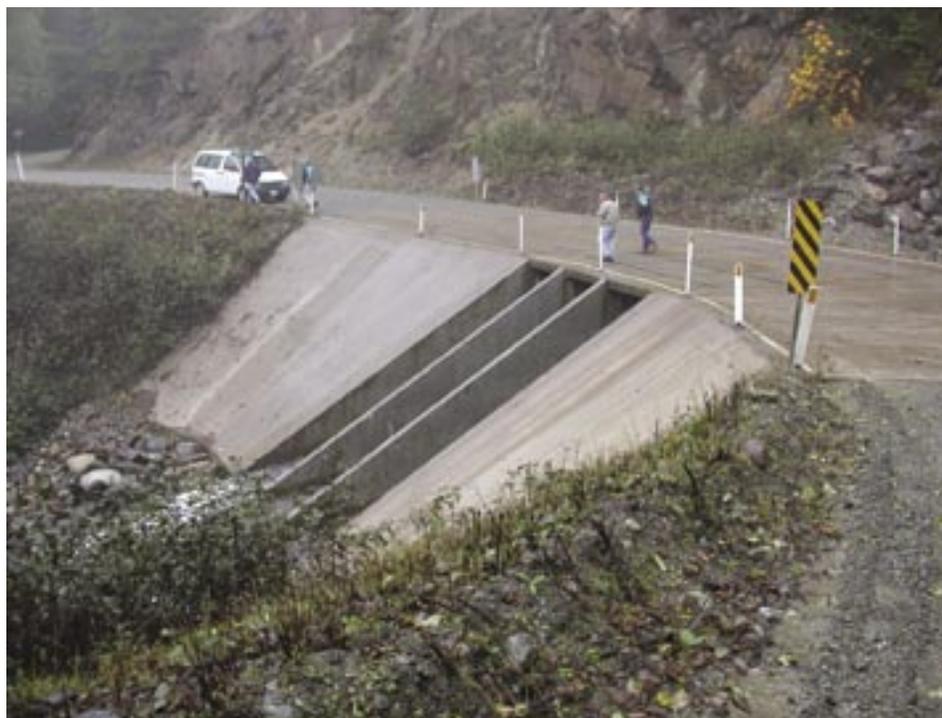
Figure A105. Sibley Creek vented ford.

This massive vented ford was constructed in 1997, after rain-on-snow floods washed out the crossing. The stream is very steep and prone to debris torrents, and previous drainage structures have failed repeatedly over the years. The road is closed in winter, but is a major access route to North Cascades National Park, and long-term traffic interruptions (which occur when this crossing washes out) are not desirable. The structure is a large concrete edifice with three box culverts with removable concrete tops (figure A105). The design allows it to pass large rocks and debris over the top, and to withstand the high stream power at this location.

**Structure:** This is a cast-in-place reinforced concrete ford with three 7-foot-wide by 5-foot-high box culverts. Together the boxes convey the 100-year flood (water only). The ford itself has a 6-percent grade on the approach slabs and is designed to convey 1½ times the 100-year event over the concrete top, in case debris plugs the inlet (figure A107). The I-beam trash rack slopes at 6:1 to allow large debris to pass over the top in case of a debris torrent (figure A108). The tops of the boxes are covered by level precast concrete slabs that can be lifted to remove smaller debris. The bottoms of the boxes are set at such a steep grade (20 percent) that high velocity water removes cement and fine aggregates until the coarse aggregates are exposed. As they are exposed, the 3-inch aggregates used in the concrete produce roughness and protect the concrete against further degradation.

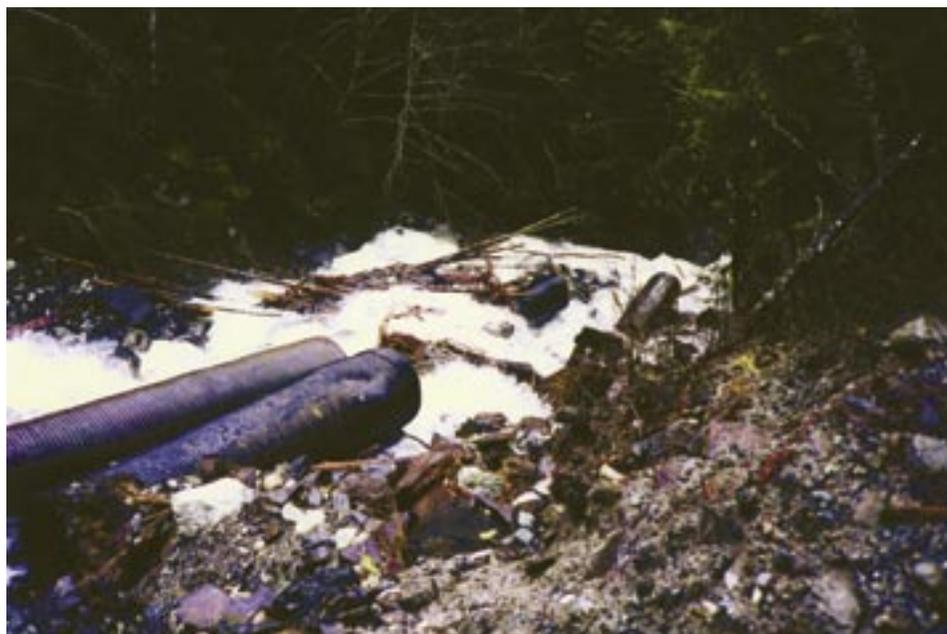
Figure A106. Two-culvert crossing on Sibley Creek blew out in November 1995.

Previous structures at this site have included multiple culverts, which have been washed out at least 6 times since 1960 (1962, 1976, 1988, 1989, 1990, and 1995) (figure A106). Those events had resulted in significant sediment deposition of roadfill material in coho salmon spawning areas in lower Sibley Creek, as well as temporary loss of public recreation access.

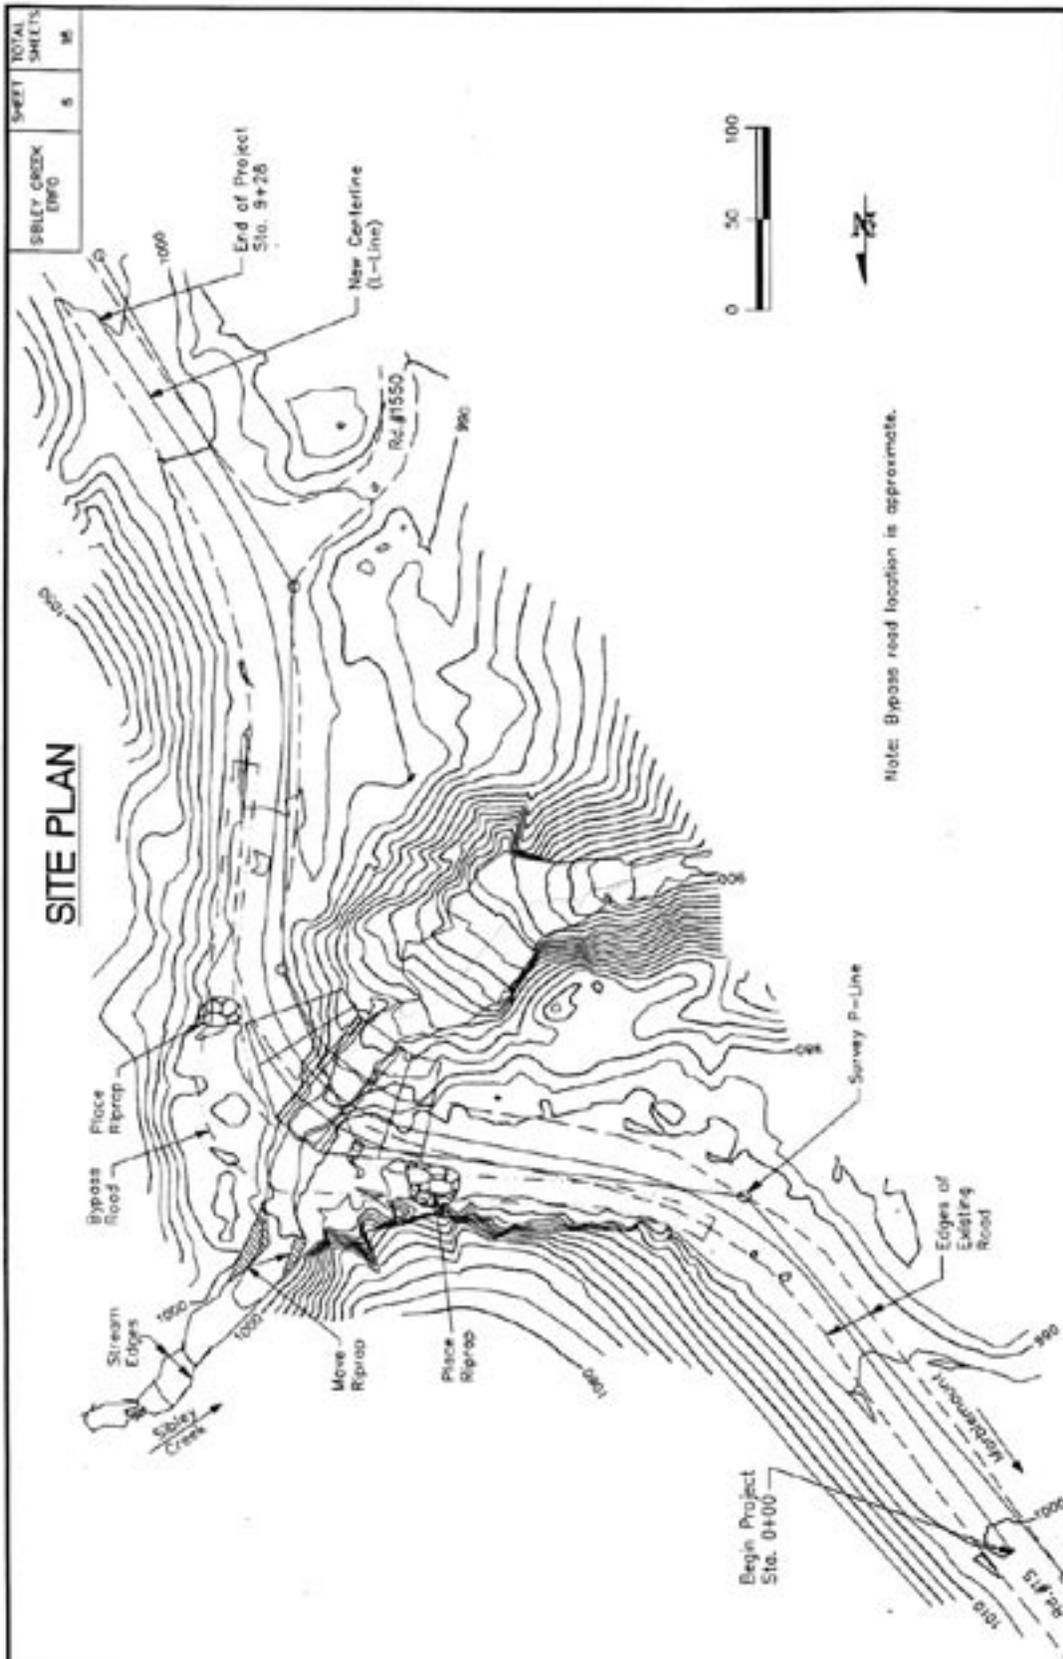
Figure A107a. Site plan map.

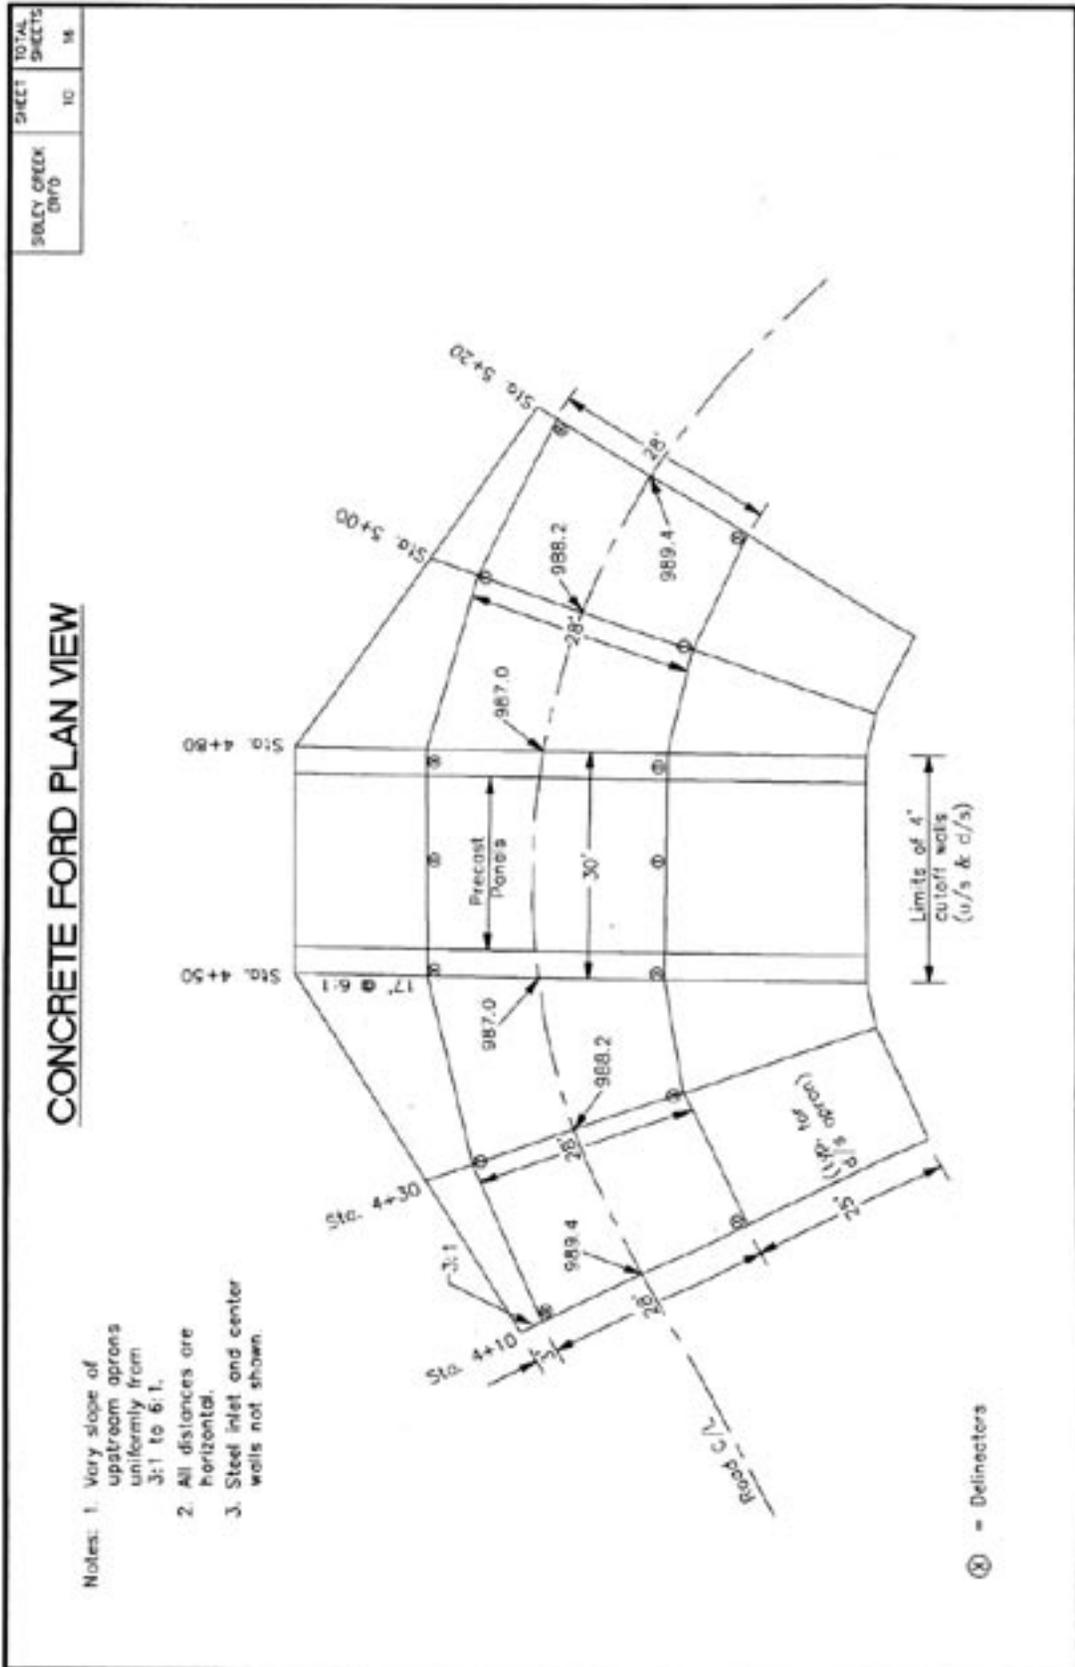
Figure A107b. Ford plan view.

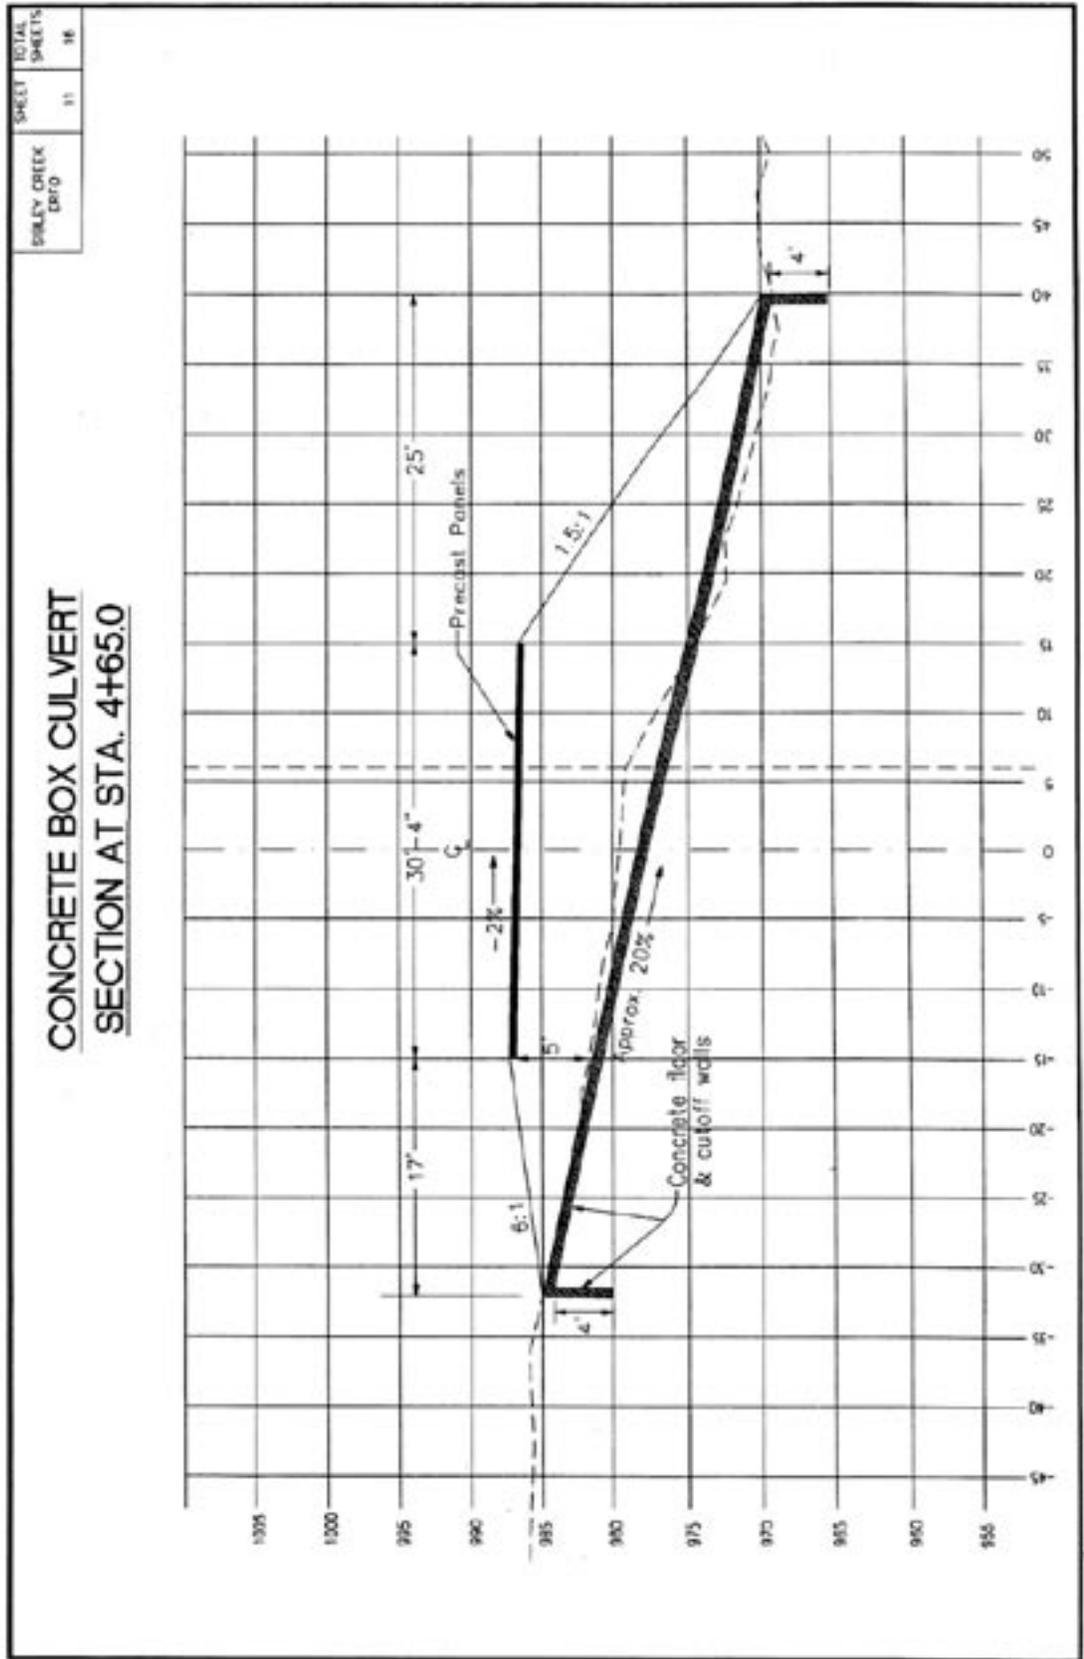
Figure A107d. Detail drawings.

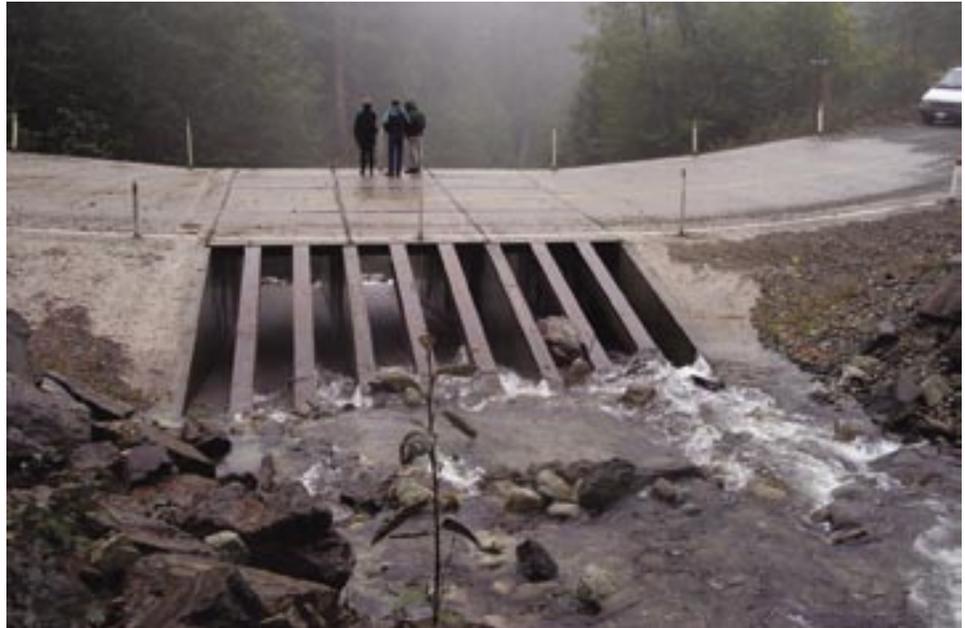
Figure A108. Looking downstream at the ford.

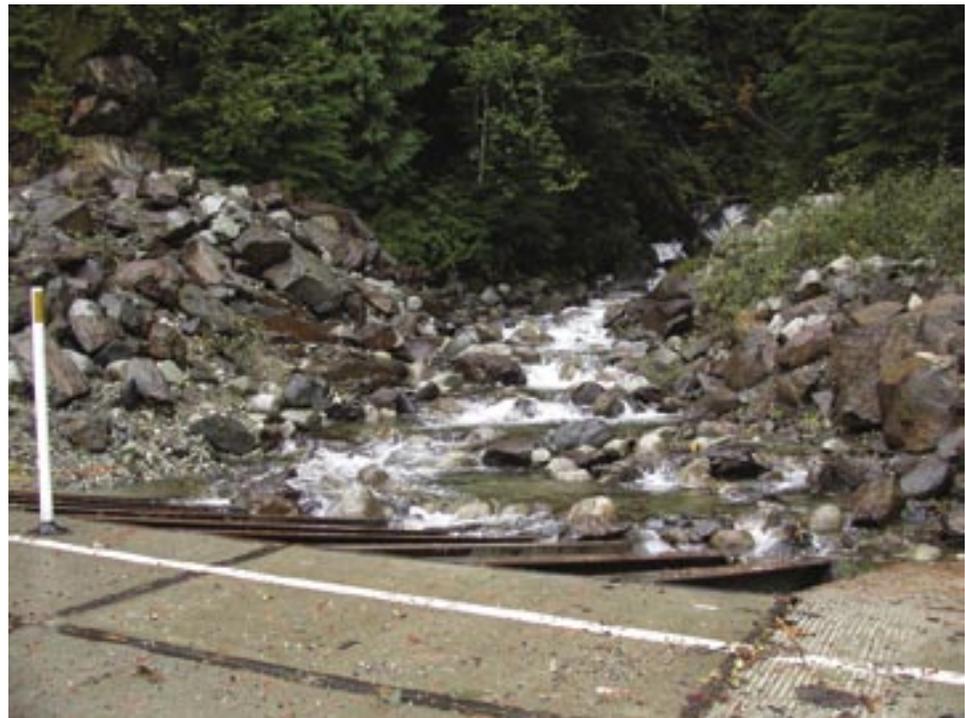
Figure A109. Sibley Creek currently approaches the inlet at a slight angle.

**Bank stabilization and approaches:** The graveled road approaches slope at between 3 and 6 percent into the ford. Riprap was used above the inlet to stabilize the streambanks, which may erode somewhat because the structure is not aligned perfectly perpendicular to the stream (figure A109). In this location where deposition is expected during major storms, the riprap is a temporary solution until the next major event. Downstream, large rock was placed at the toe of the concrete apron to avoid undermining.

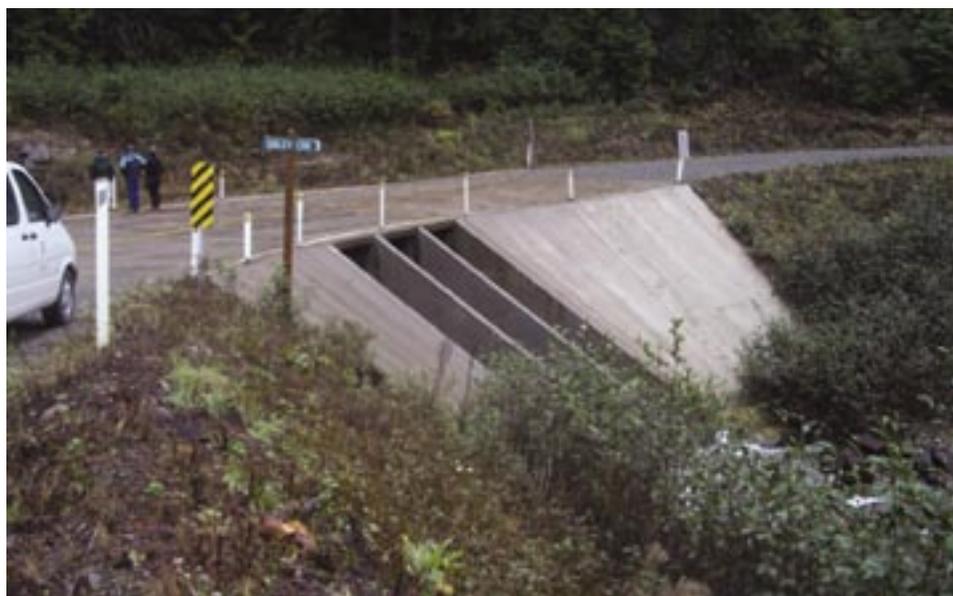
Figure A110. Safety markers on ford and approaches.

**Safety:** Delineator posts define the road edges and type III object markers are at both ends and both sides of the ford to focus traffic toward the road center (figure A110).

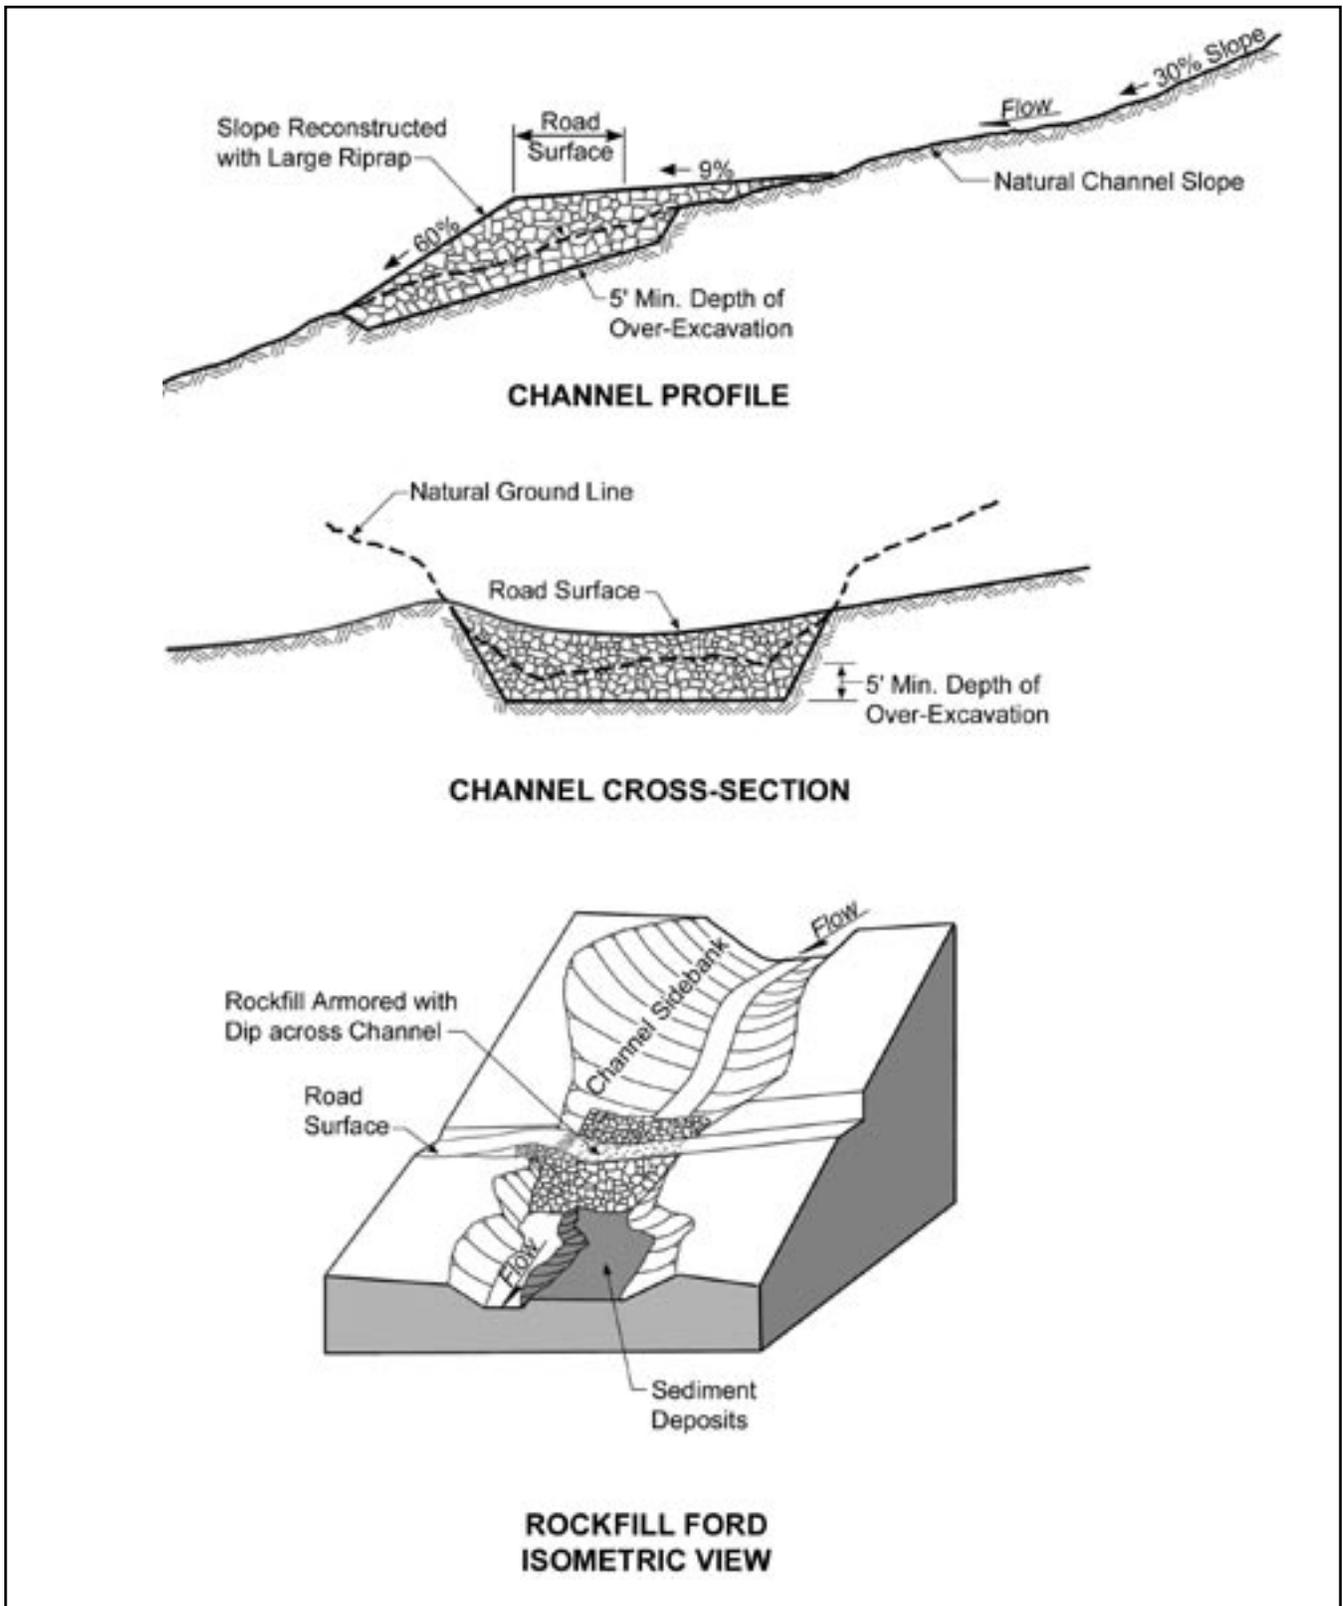
Figure A111. Stream and ford longitudinal profile, Catherine Creek, Vancouver, B.C. Redrawn from Askin 1992.

Robert Askin (Askin 1992) describes a rockfill ford on a similar channel in the Catherine Creek watershed on Vancouver Island, British Columbia. The ford was designed for a new (1992) logging road to cross a channel that had a 27-percent slope and a serious risk of debris torrents. Objectives were to keep costs low, pass water and debris, and avoid diverting flood flows down the road. After overexcavating the channel bed below the predicted depth of scour, large riprap was interlocked to construct a foundation, and the structure was built up to grade using coarse fill materials (figure A111). The crossing surface is about 8 feet above the natural channel bed, and it is outsloped at 9 percent to permit debris to move over the surface. Low flows move either through or over the permeable ford.

Askin's 1992 paper discusses how he estimated the volume of debris that could come down in a debris torrent and be trapped behind or on the structure, and it provides details on costs and materials volumes. It is another excellent example of designing for geomorphic processes at a site.
