Case Study 9. Mesman Slotted Concrete Slab Ford**Location**

South-central Oregon. Fremont National Forest. Thomas Creek crossing on Forest Road 3724. 15 miles Northwest of Lakeview, Oregon.

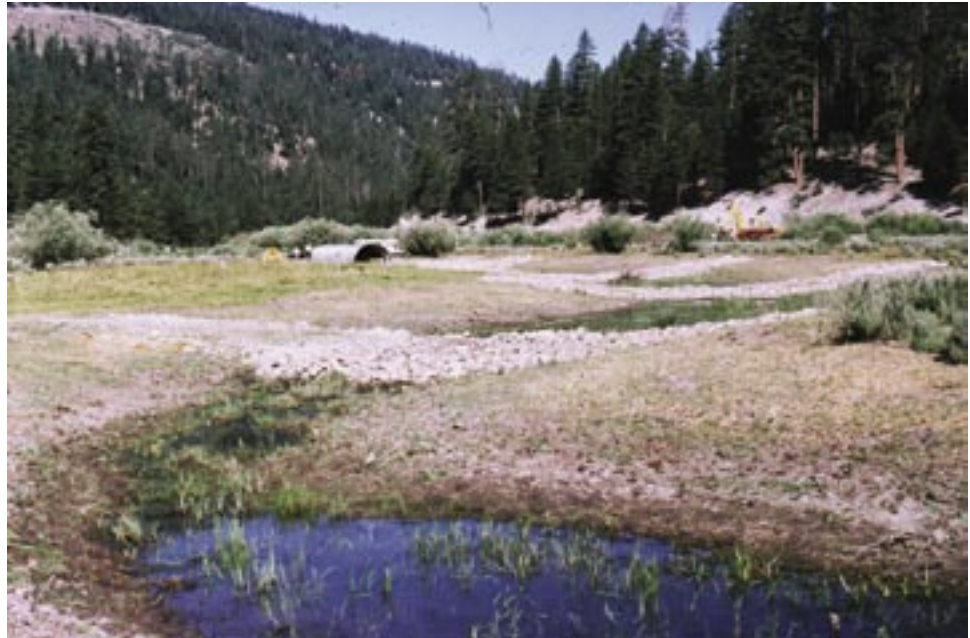
Figure A55. Looking upstream at the rehabilitated channel during placement of the culvert in 1988.

Restoration objectives were to reestablish the natural overbank flow regime, narrow the channel, restore natural vegetation, and improve trout habitat. Shortly thereafter the open-bottom arch culvert that later failed was installed (figure A55).

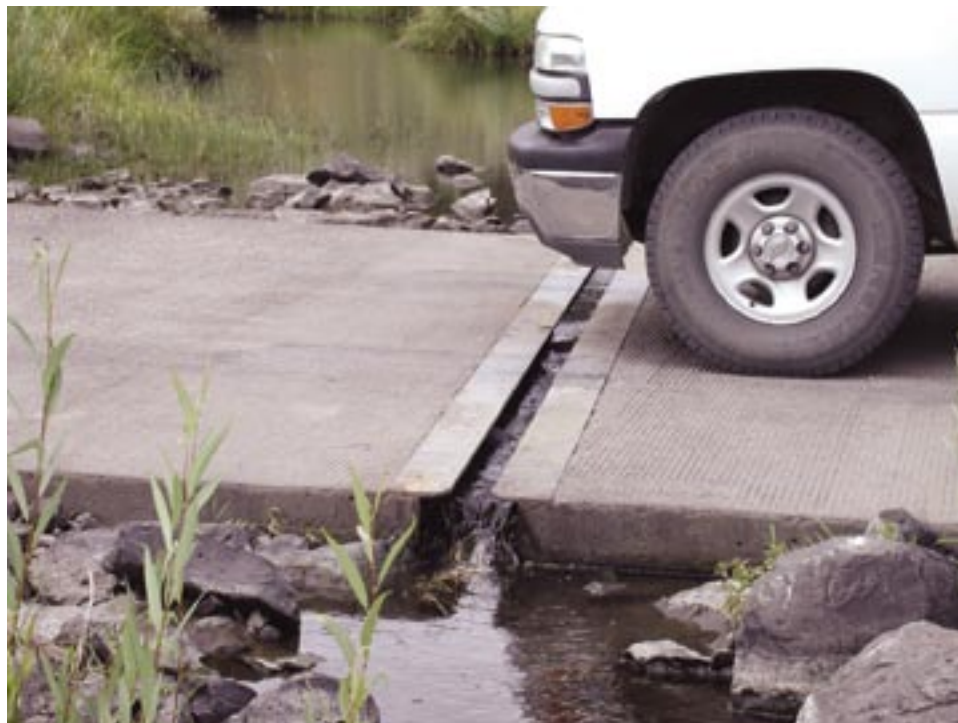
Figure A56. View of the slot with gravel bottom, August 2006.

Structure: The driving surface of the ford is reinforced concrete. Two parallel W-flanges with tops set flush into the concrete run across the ford perpendicular to the roadway. These create an open slot box (9½ inches wide by 10½ inches high), with a 4-inch opening at the top to allow cleaning with hand tools. The slot passes low flows, fish, and possibly other aquatic species. It was designed for a velocity of less than 2 feet per second and a depth of at least 4 inches during normal summer flows to allow passage of both juvenile and adult fish. The ford and the slot slope downstream at 0.5 percent, which is flatter than the stream, and sand and gravel retained in the slot provide at least a partial natural bottom (figure A56).

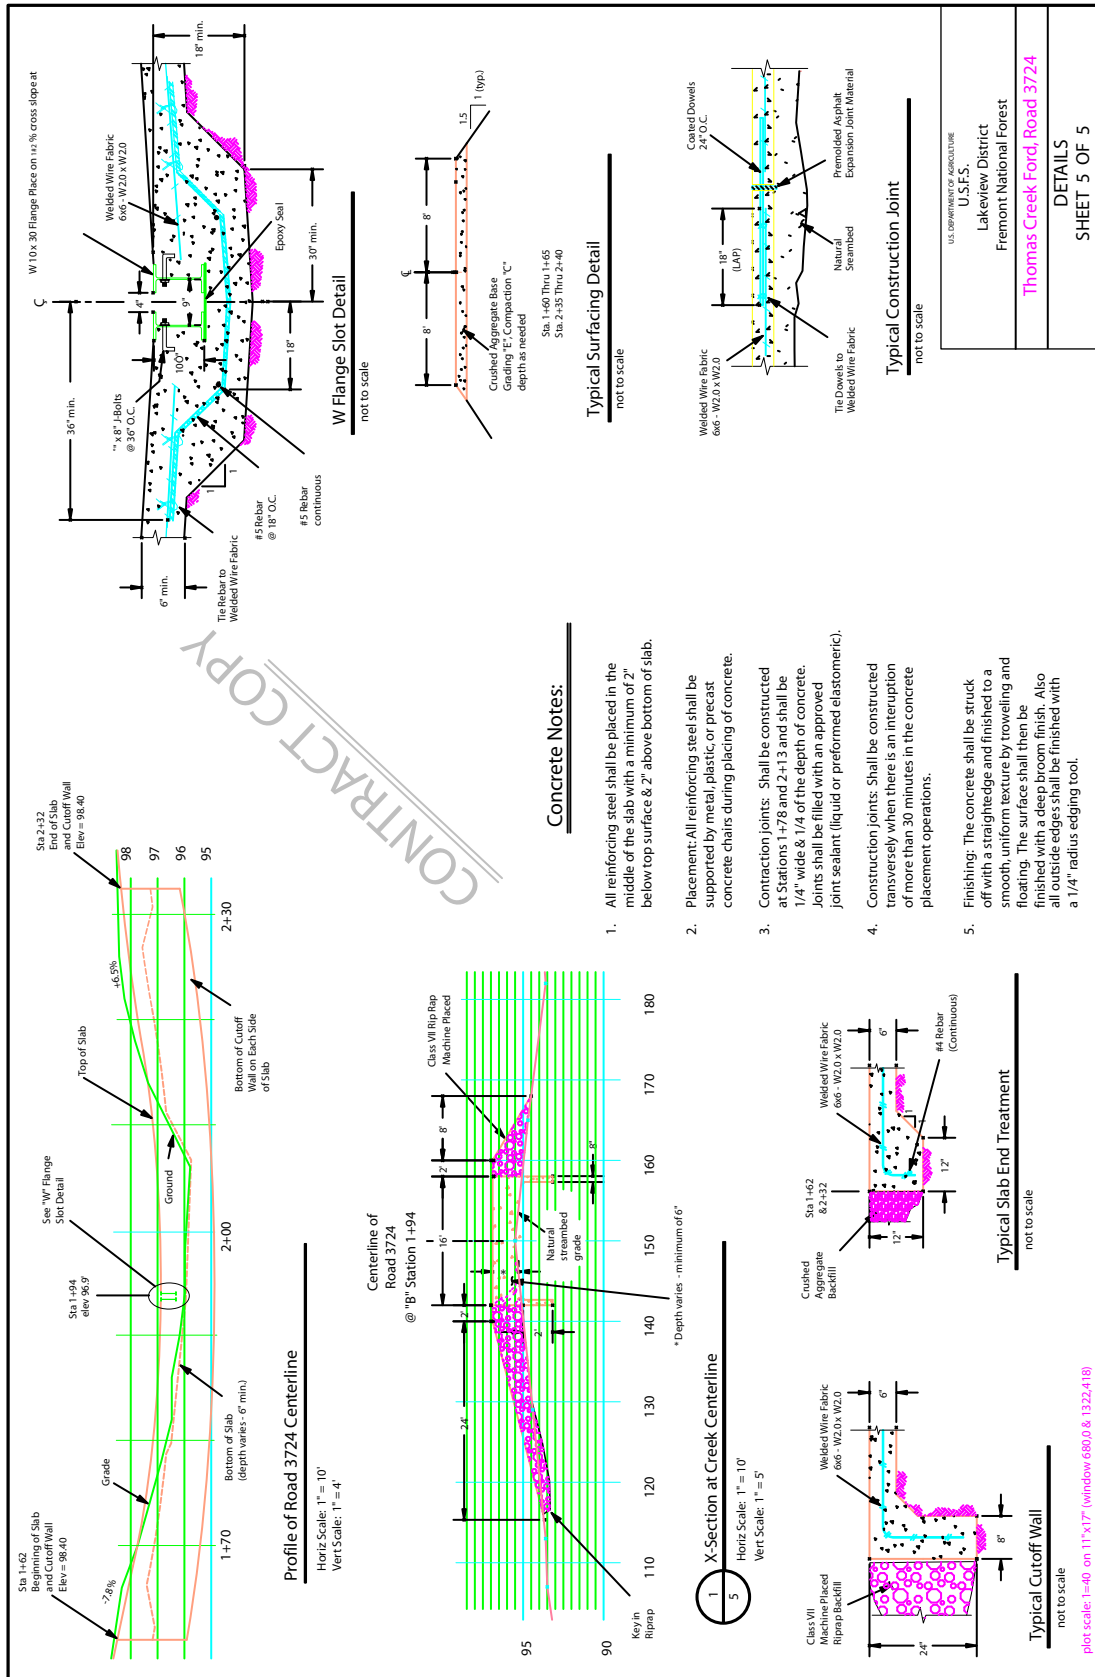
Figure A57b—Thomas Creek ford contract drawings sheet 5: road profile, slot detail, cross section along creek. (Designed by Jerry Panter, 6/28/1996) A full size drawing may be found on the CD included in the back of this publication.

Since at least the 1980's, objectives for the crossing have included preventing upstream migration of a large headcut moving up through the valley. Today the crossing is part of a restoration project aimed at restoring flood plain and channel connections in the incised reach of stream. The roadway is elevated about 2 feet above stream grade. Class VII riprap faces both the upstream and downstream sides. For specific dimensions, see figure A57.

Thomas Creek is susceptible to scour, so 24-inch-deep cutoff walls on the upstream and downstream sides were part of the design (figure A57b).

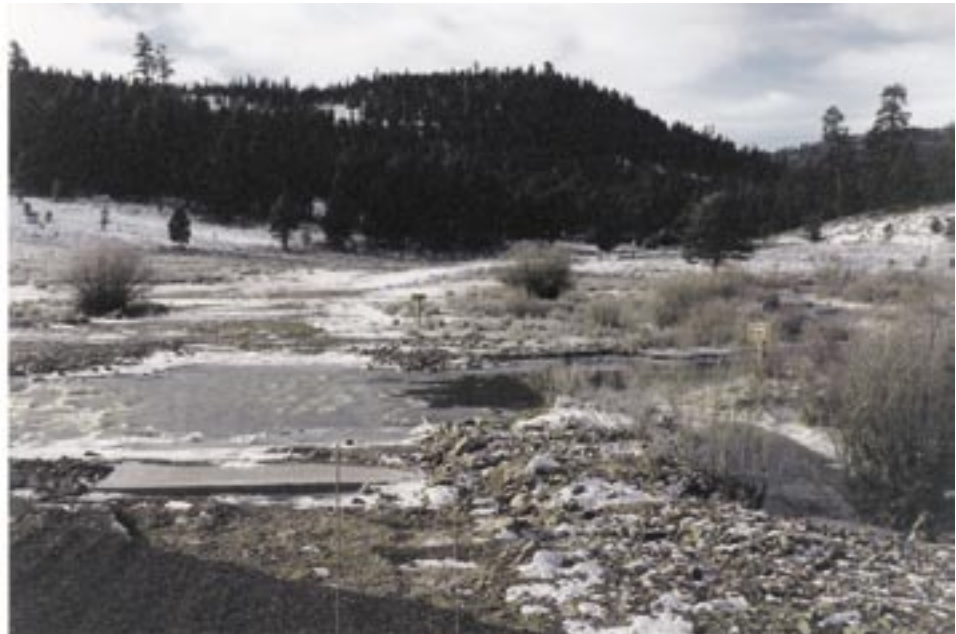
Figure A59. Shortly after the 1997 New Year's Day flood. Some gravel washed from the approaches (in foreground) was the only damage from the largest flood on record.

In 1997, a flood estimated to exceed a 100-year event sent 3,000 cubic feet per second over the ford and submerged the entire flood plain. Other than the loss of a few cubic yards of gravel surfacing from the approaches, no damage occurred (figure A59). In the 10 years the ford has existed, no other maintenance has been required.
