United States Department of Agriculture  
Forest Service

National Technology & Development Program • 7700—Transportation Mgmt • 1177 1810—SDTDC • December 2012

# **Decision Analysis Guide for Corrugated Metal Culvert Rehabilitation and Replacement Using Trenchless Technology**

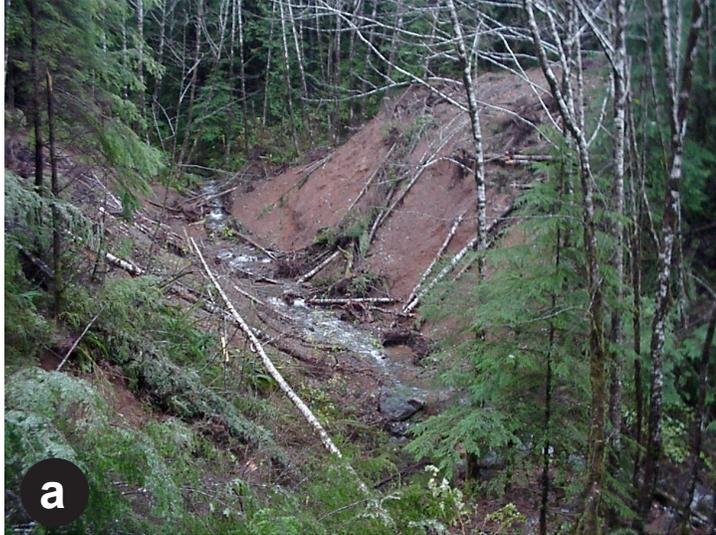
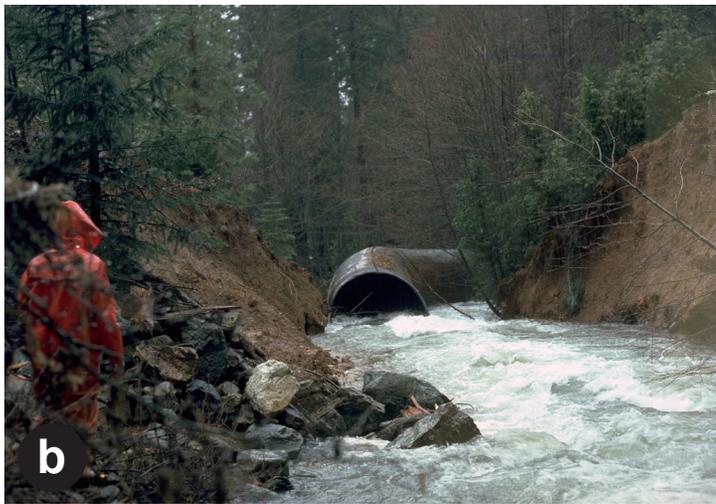
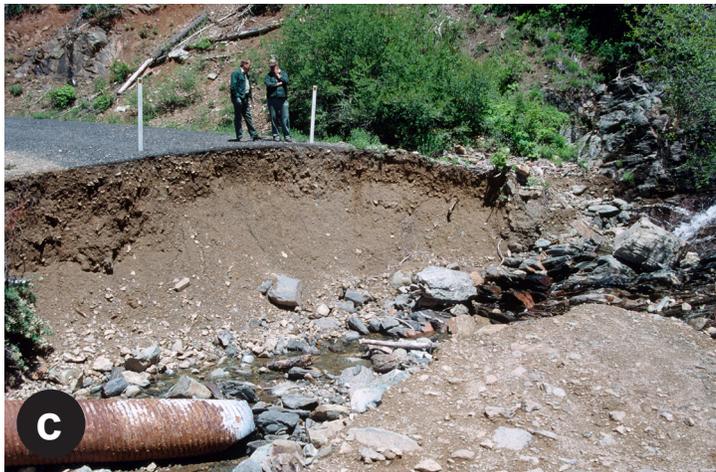
*Figure 1—Culvert blowouts—a. Culvert blowout along a national forest road, b. Culvert blowout (Gordon Keller, Forest Service), c. Culvert blowout Cold Water Creek (Gordon Keller, Forest Service).*

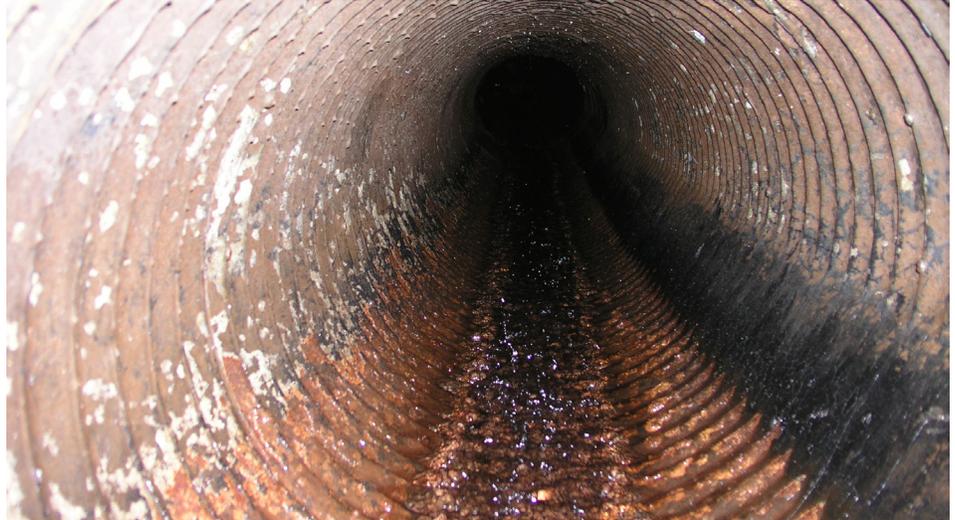
Minor corrosion and abrasion can cause superficial rust and minor pitting and can be rehabilitated with a nonstructural method (figure 3a).

Figure 3a—Minor corrosion occurring in a corrugated metal culvert.

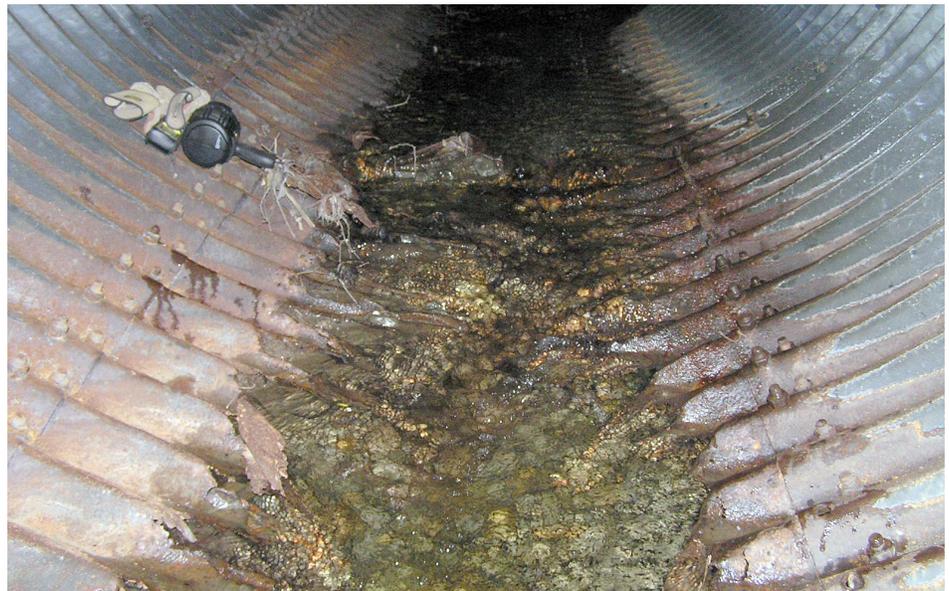
Medium corrosion leads to scattered heavy rusting and deep pitting and can be addressed with a semistructural rehabilitation method (figure 3b).

Figure 3b—Medium corrosion occurring in a corrugated metal culvert.

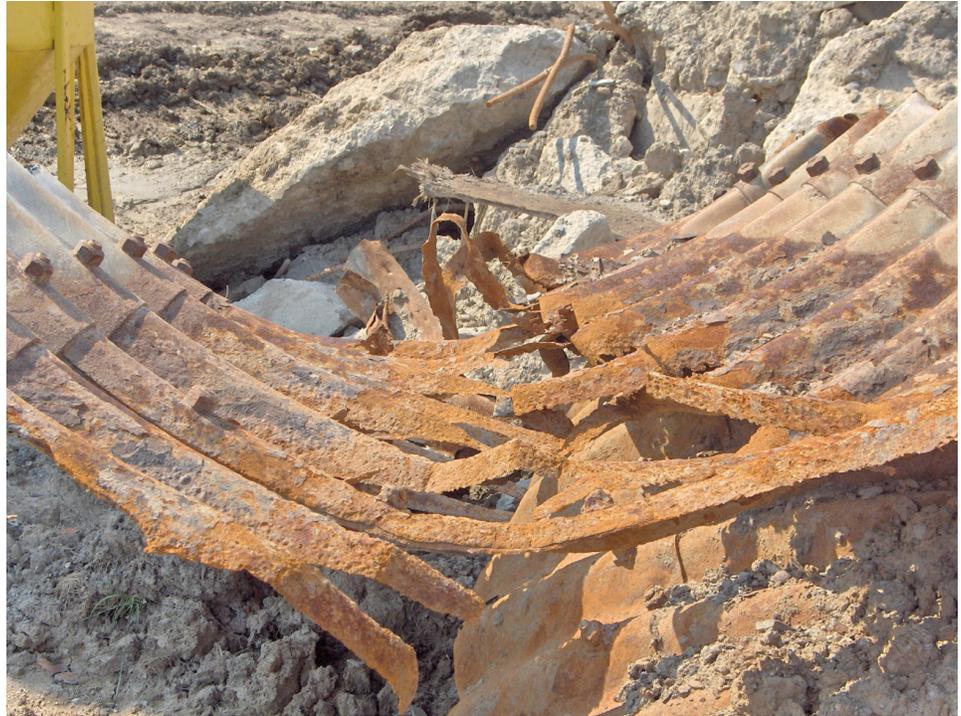
Major corrosion can cause structural failure and collapse due to extreme rusting and deep pitting perforations and needs a fully structural rehabilitation method (figure 3c).

Figure 3c—Major corrosion occurring in a corrugated metal culvert (D.A. Van Dam and Associates and Ohio Department of Transportation).

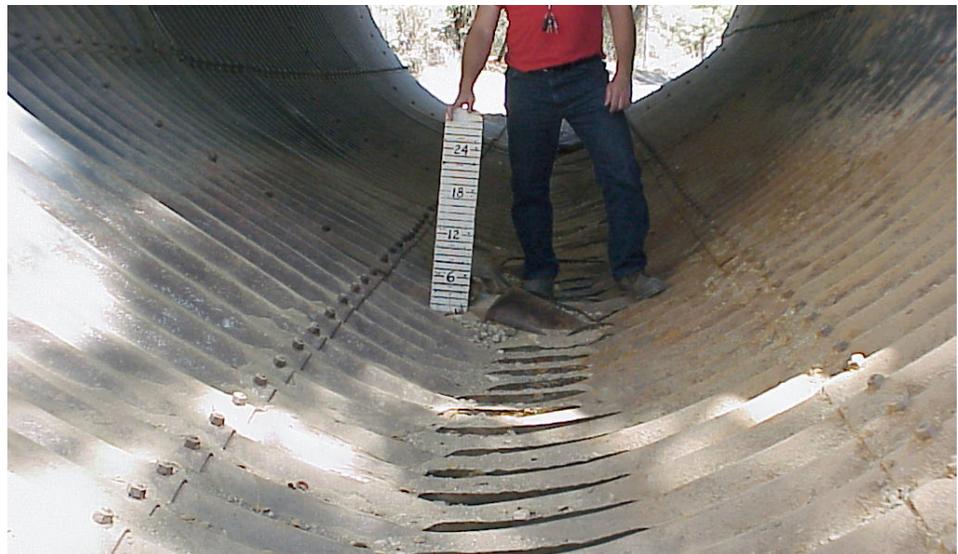
A culvert pipe that has a corroded or abraded invert (the bottom of the culvert) (figure 4) or a pipe that is severely pitted and perforated still may be capable of supporting its backfill and cover, but it constitutes a high risk of failure and requires a prompt repair or replacement (National Cooperative Highway Research Program 1978). Significant flattening of the invert also will require attention to prevent further deterioration.

Figure 4—Invert deterioration occurring in a corrugated metal pipe (Caltrans).

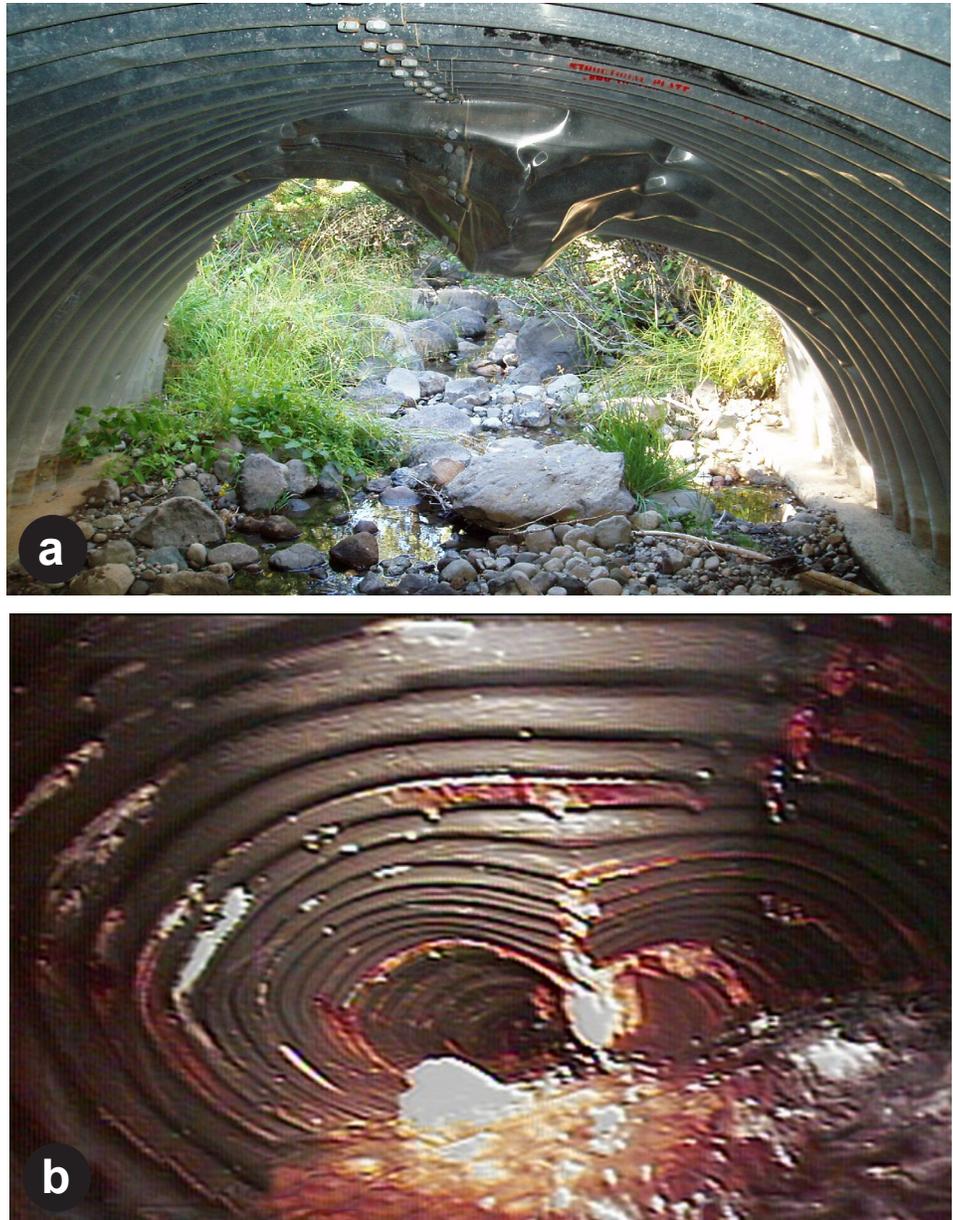
If a culvert is partially or fully collapsed, as shown in figure 5, then lining methods will not be applicable and an inline replacement, such as pipe splitting or a complete open-cut installation will be required.

Figure 5—Collapsed/punctured corrugated metal pipe—a. Punctured corrugated metal pipe (Gordon Keller, Forest Service), b. Collapsed corrugated metal pipe.

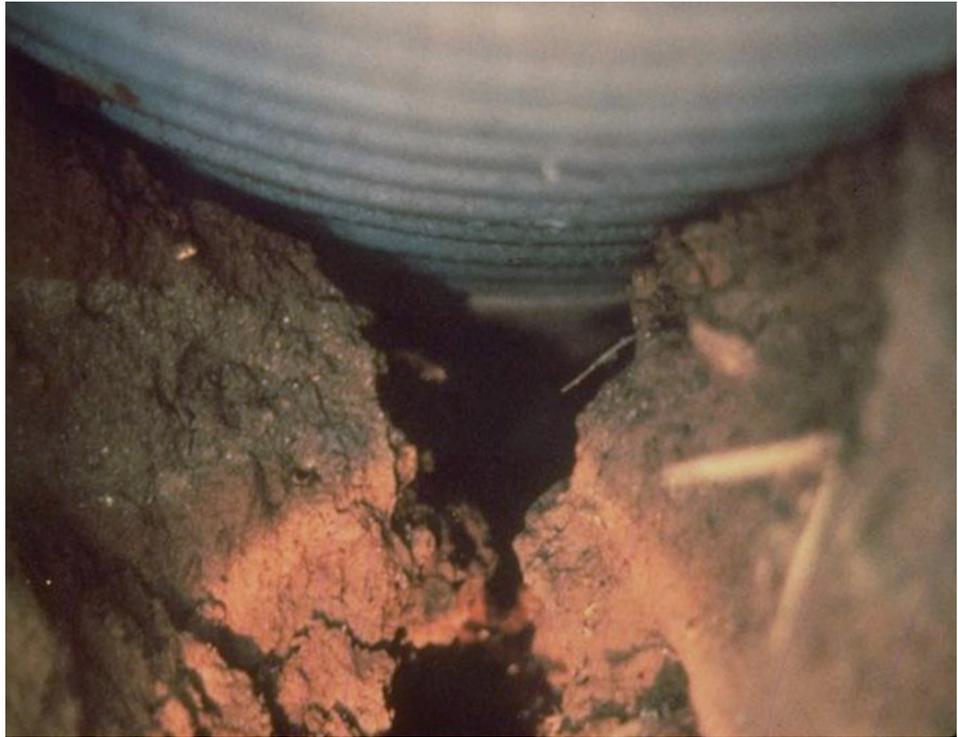
Erosion voids, sometimes referred to as piping (figure 6), can spread and reach the ground surface. Not only does this adversely impact the stability of buried metal culverts, but it can pose a potential loss of life if a void forms under a pavement. Typically, preventative measures include proper compaction practices and seepage collars.

Figure 6—Piping beneath a culvert.

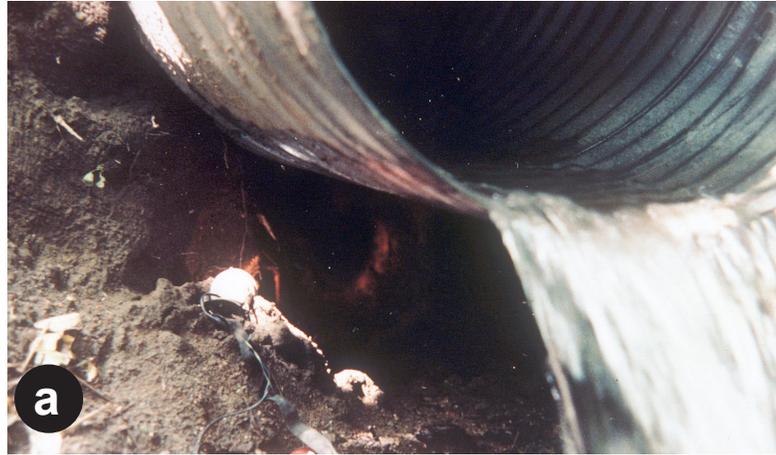
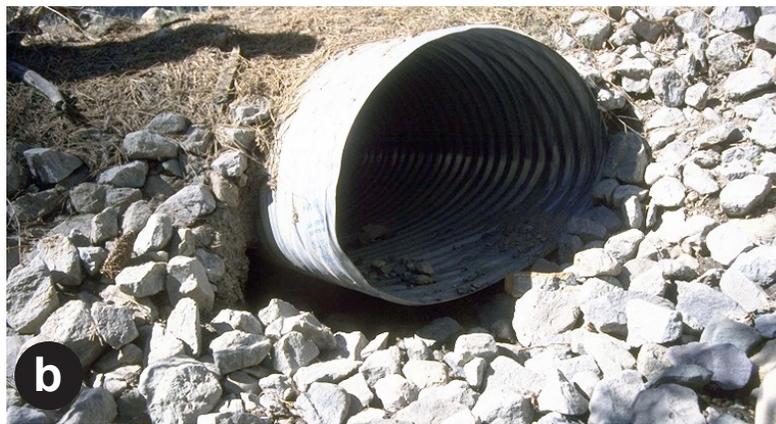
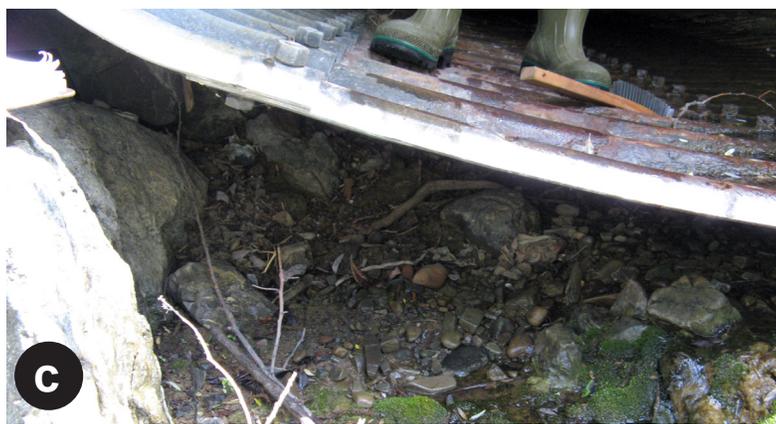
A normal outcome of metal culvert pipe corrosion that has produced perforation is undermining (i.e., the formation of erosion voids in the embedment soil below and beside the structure) (figure 7). These voids, typically adjacent to severe corrosion, are due to ingress of water through the corroded zones and infiltration of backfill material under hydrostatic pressure. Undermining results in a loss of soil support for the culvert. Without an adequate soil envelope around the pipe, metal culverts have relatively little bending stiffness and are likely to deflect and exhibit shape distortion or sags and joint opening.

*Figure 7—Undermining of a corrugated metal pipe—a. Voids around a corrugated metal pipe (Gordon Keller, Forest Service), b. Undermining (Gordon Keller, Forest Service), c. Undermining (Caltrans).*

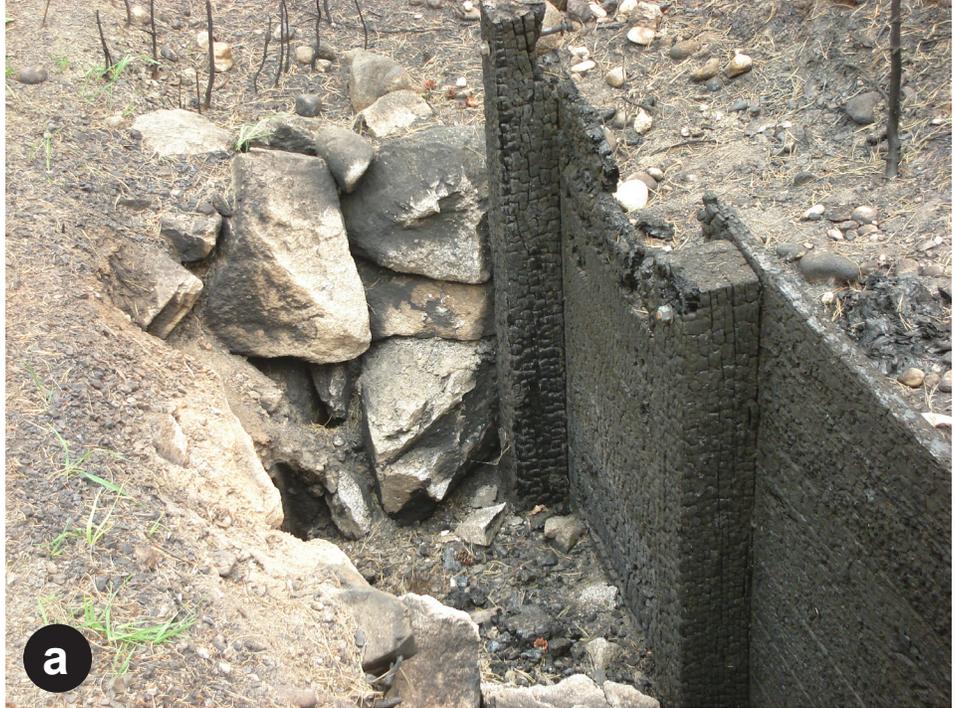
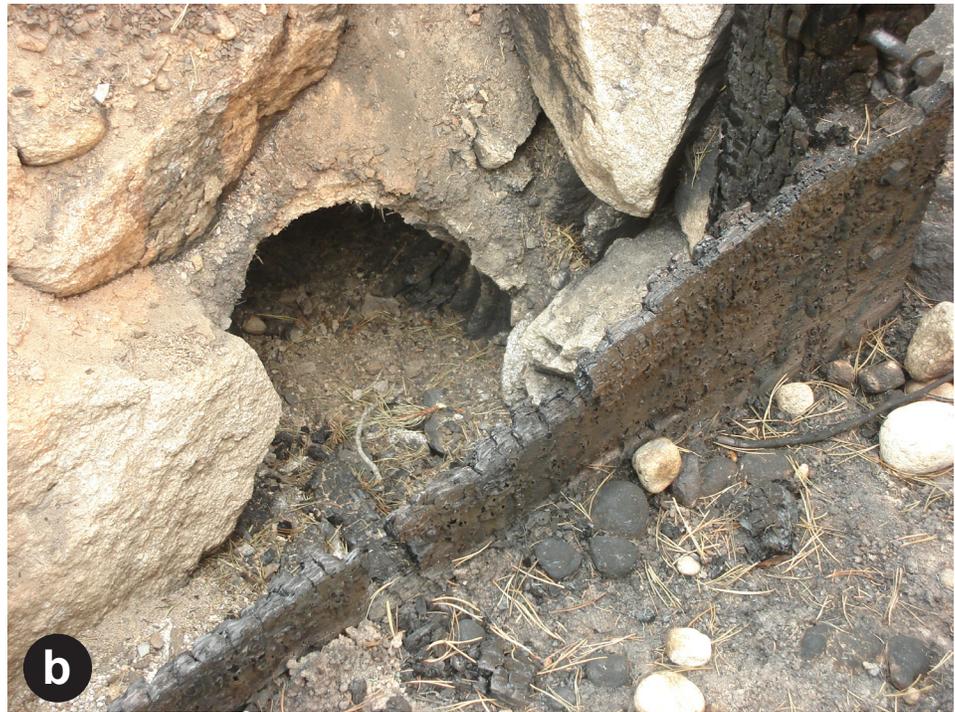
In 2007, the Cascade Complex fires in the Payette National Forest in Idaho resulted in the destruction of 142 high-density polyethylene culverts ranging in diameter from 18 to 36 inches, 41 wood culvert inlet headwalls, and 50 high-density polyethylene culvert downspouts (figure 9). The Forest Service and the FHWA recommend concrete or masonry headwalls for flammable plastic culverts and liners in forest environments where fire is a possibility.

*Figure 9—Cascade complex fire, Idaho (Charlie Showers, Forest Service)—a. Catch basin with timber lag headwall. b. Burned off culvert inlet in a catch basin with timber lag headwall, top view.*

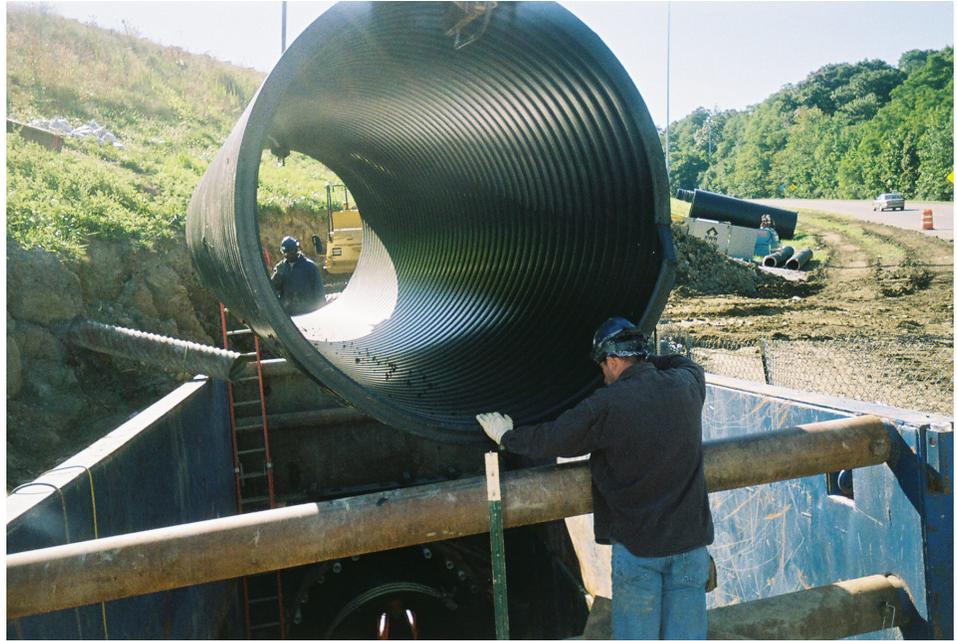
Ohio Department of Transportation reported sliplining a corrugated metal pipe culvert under a highway with a pressure-rated high-density polyethylene culvert liner. The existing culvert was 102 inches in diameter and 835 feet long, and the high-density polyethylene pipe was 72 inches in diameter. The slipliner pipe was delivered to the site in sections, and after aligning, the individual segments were welded from the inside. After welding, the pipe was inserted into the culvert and the annular space grouted.

*Figure 10—Sliplining corrugated metal pipe in Ohio (D. A. Van Dam & Associates).*

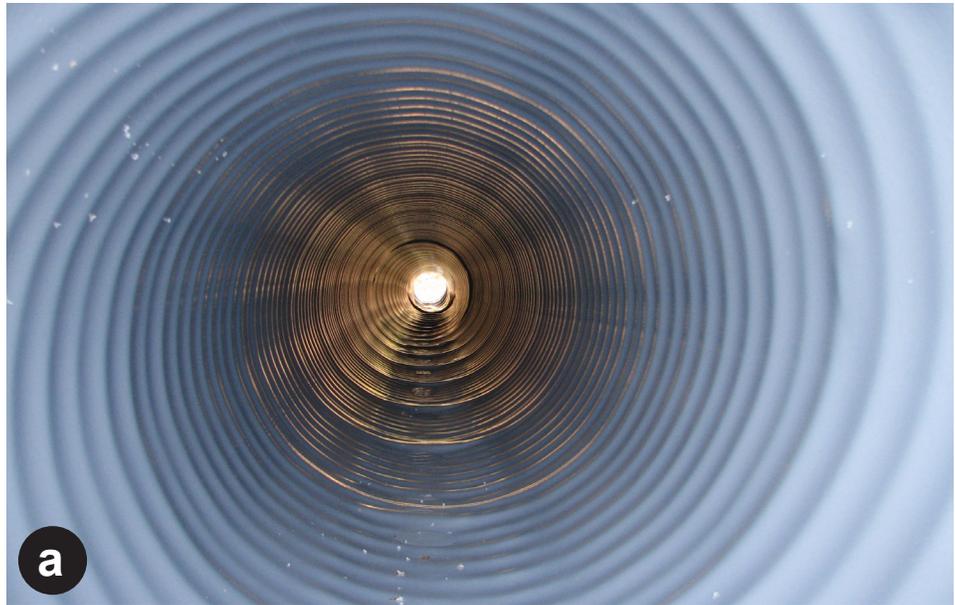
**a**

Fold-and-form liners are made of polyvinyl chloride. For installation, the liner is deflected into a U shape during the manufacturing process so it can be easily pulled inside the pipe; steam or air pressure is used to expand the liner to fit closely the size and shape of the host pipe (figure 13).

*Figure 13—Installation of fold-and-form liner (Ultraliner)—a. Looking down the center of a culvert in which a fold and form liner has taken on the shape of the host culvert. b. The folded pipeliner is pulled through a culvert under a road, then the pipeliner is plugged and expanded under steam pressure.*

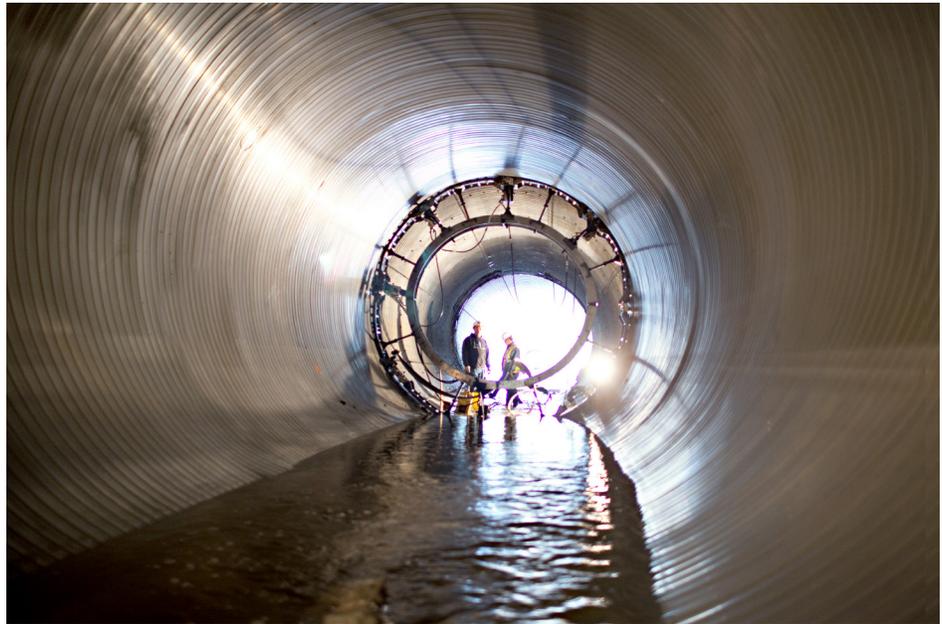
Spiral-wound liners are fabricated in the field from a continuous plastic strip with male and female edges. During the winding process, the male and female edges self-interlock and form a leak-tight joint. With this method, an annular space between the host pipe and the liner is created, which generally is grouted with a cementitious material. The strip can be made of polyvinyl chloride (with or without steel reinforcement) or high-density polyethylene, can have external ribs to increase the stiffness, and can anchor in the cement grout injected in the annulus space between liner and host pipe.

*Figure 14—Spiral winding of a 14-foot corrugated metal storm sewer (Sekisui SPR).*

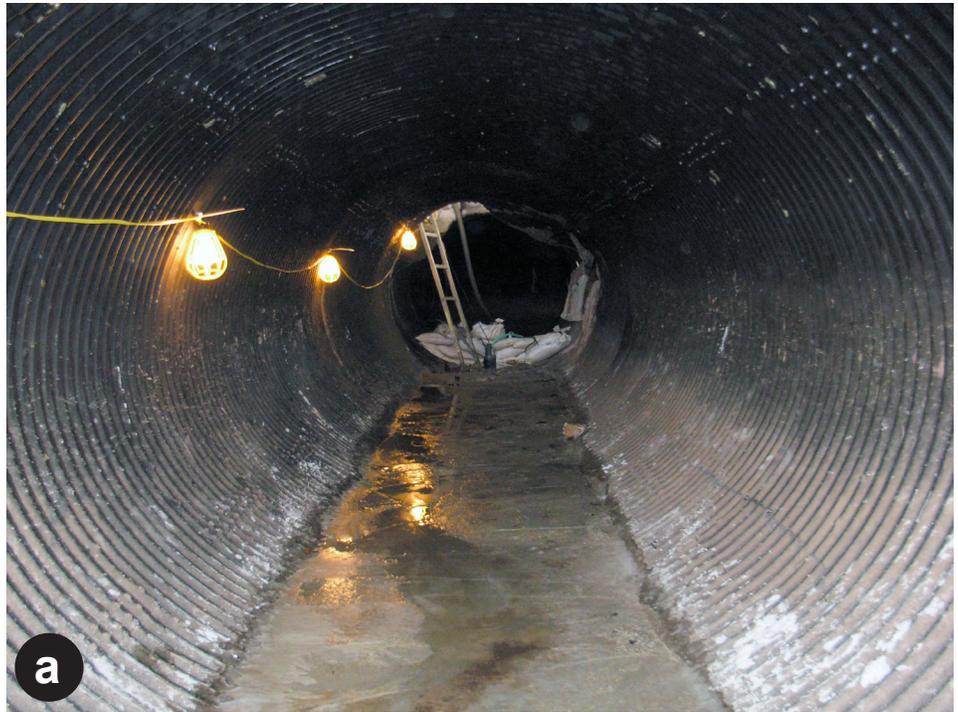
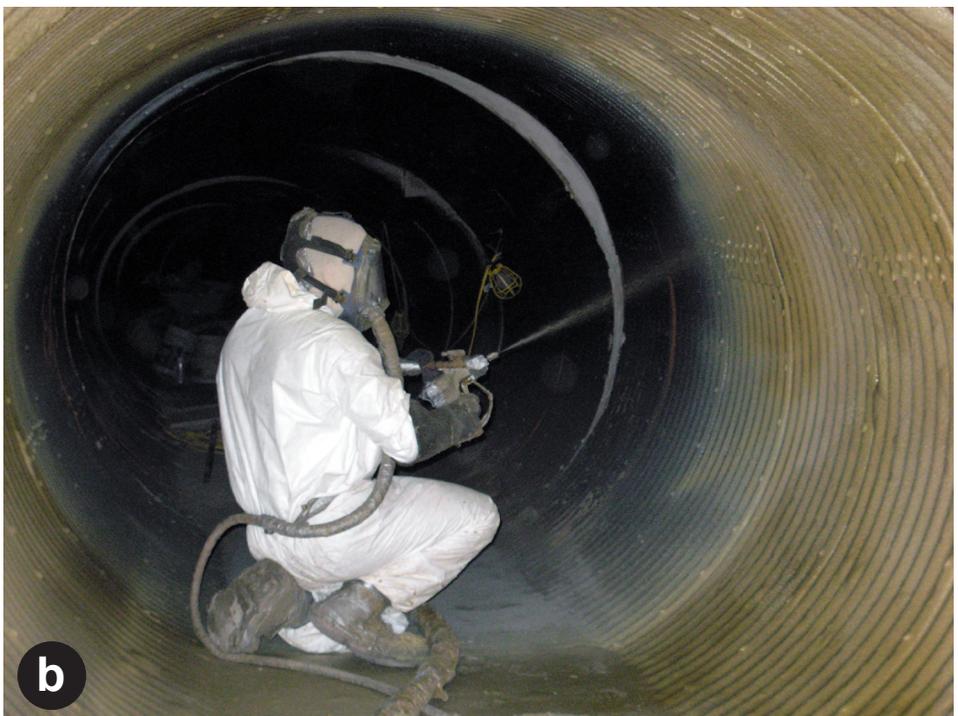
In 2007, in Norristown, PA, a galvanized corrugated steel pipe culvert 60 inches in diameter and 1,800 feet long was spray-relined with polyurethane. The lining was sprayed in one coating (thickness 300 mils) with a proprietary heated plural component spray system. The application required a very clean and very dry surface. The applied surface preparation procedure is proprietary for the systems used (Jerry Gordon, Sprayroq, Inc., personal communication).

*Figure 16—Polyurethane spray (Sprayroq, Inc.)—a. Culvert in Norristown, PA, before rehabilitation, b. Culvert during application of SprayWall® (Sprayroq Inc).*

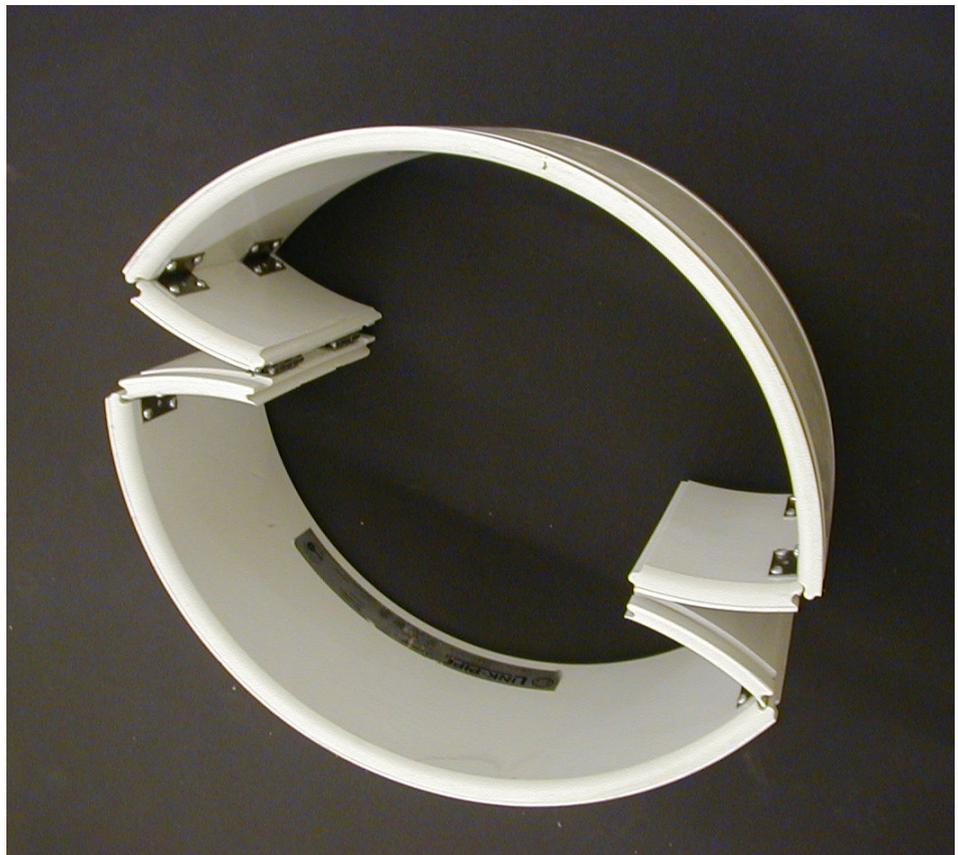
Localized damaged areas within corrugated metal pipes can be repaired by applying prefabricated stainless steel or polyvinyl chloride sleeves. The sleeves come in various diameters and standard lengths (e.g., Link-Pipe™ polyvinyl sleeves are available in diameters from 36 to 108 inches with standard lengths of 18, 24, and 36 inches). Although multiple adjacent sleeves can be used, this method typically is used to repair relatively short sections of long culverts. They can repair structurally damaged culverts but also can be used to restore missing pipe sections without excavation or to provide infiltration sealing of joints. The sleeves are positioned inside the culvert while folded (figure 18) and jacked (snapped) into expanded shape.

Figure 18—Polyvinyl chloride sleeve <<http://www.linkpipe.com>>.

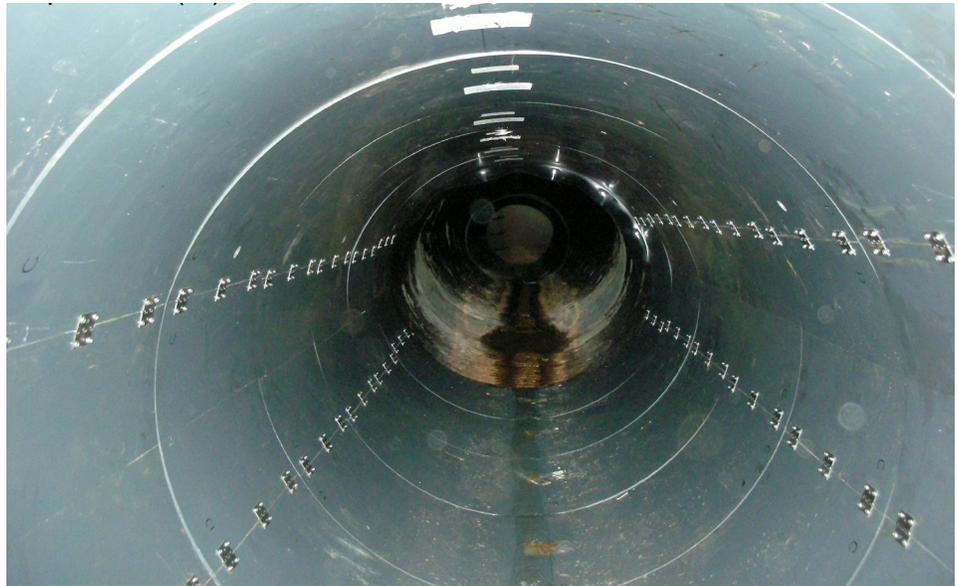
In 2007, in Atlanta, GA, a 60-foot long, 47-inch-diameter corrugated metal pipe was repaired (Link-Pipe polyvinyl sleeve) using multiple, back-to-back, polyvinyl chloride sleeves <<http://www.linkpipe.com/culverts.htm>>.

Figure 19—Polyvinyl chloride sleeve used in Atlanta, GA <<http://www.linkpipe.com/culverts.htm>>.

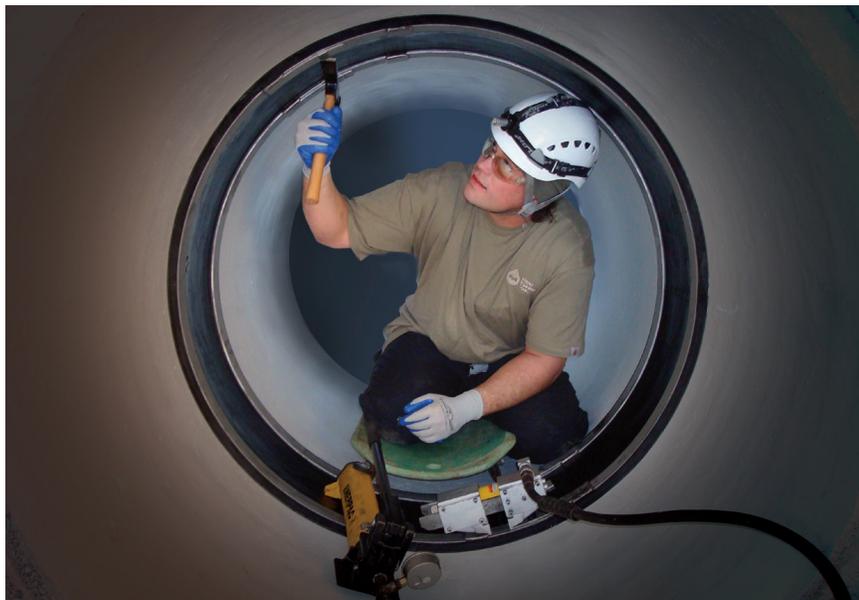
Individual leaking joints in man-entry corrugated metal pipes can be repaired effectively with flexible rubber seals. Such seals ensure a noncorrosive, bottle-tight connection around the full inside circumference of the pipe joint area (figure 20).

Figure 20—Internal joint sealing with flexible rubber seals (Miller Pipeline Corporation).

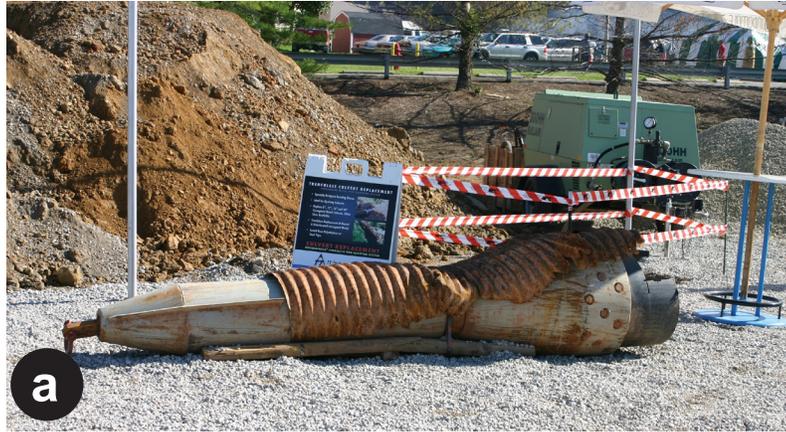
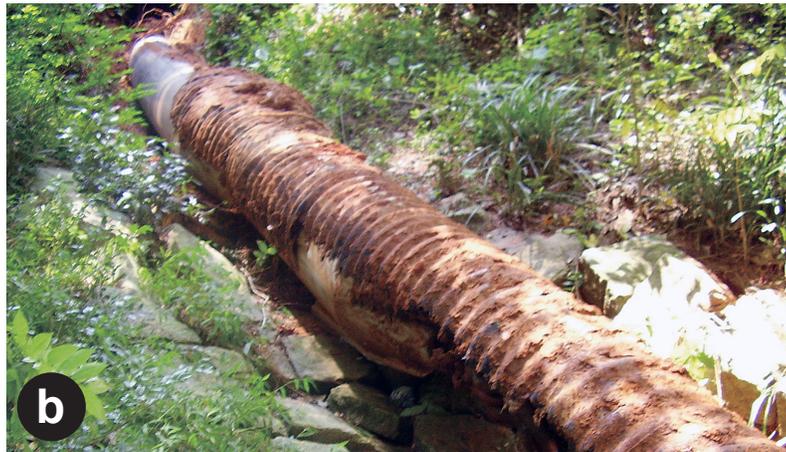
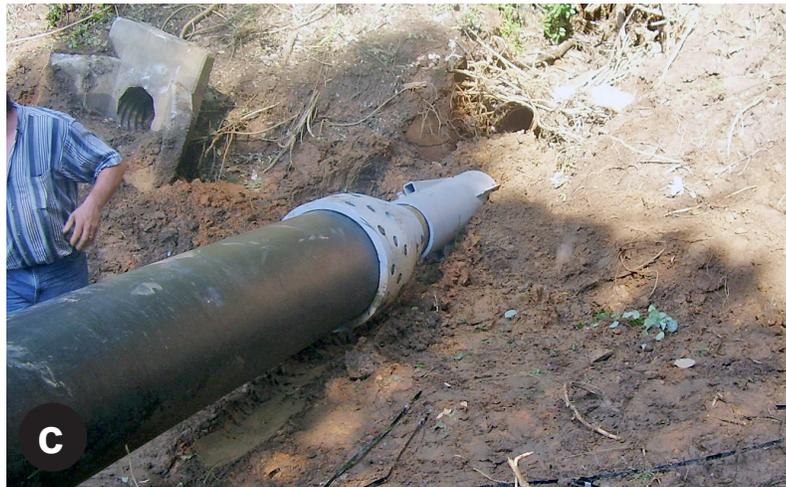
In 2005, DeKalb County, GA, reports having burst a 10-foot-long 15-inch-diameter corrugated metal pipe using a 14-inch Grundocrack Koloss with a 24-inch rear expander. It was upsized with a 24-inch high-density polyethylene pipe (figure 21). The original corrugated metal pipe culvert, sheared opened and expanded, remained in the ground except for the last 8-foot-long section, which was pushed out (Eddie Ward, personal communication).

Figure 21—Bursting (TT Technologies)—a. Bursting head with cutting sleeve and rear expander (TT Technologies), b. Pipe bursting/pipe splitting of a corrugated metal culvert, c. Pipe bursting with an upsized of a culvert.

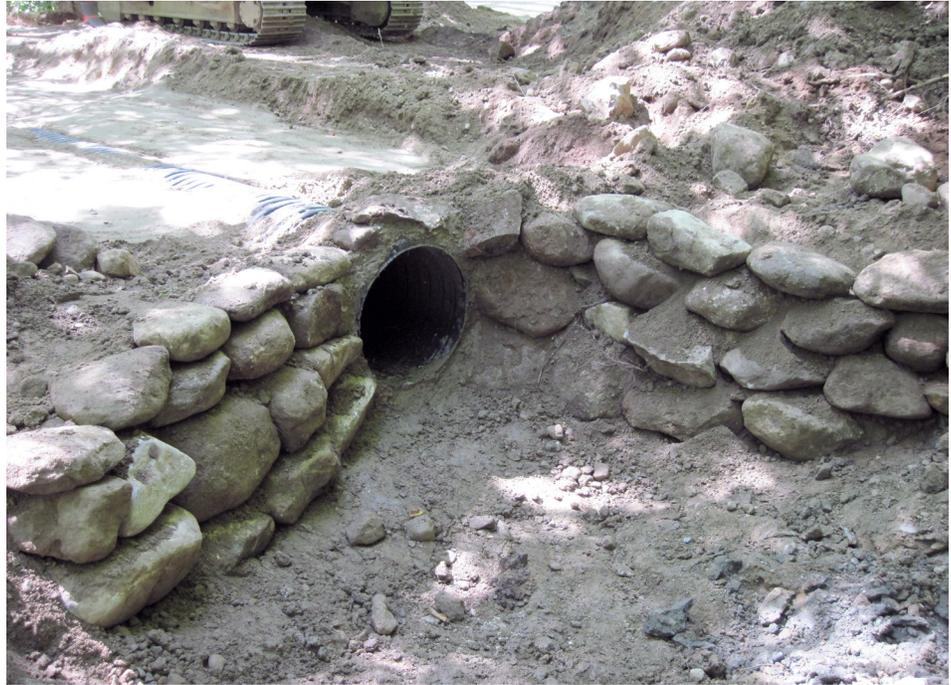
In some cases, a complete (conventional) open-cut replacement will be necessary to repair the highly corroded or collapsed corrugated metal pipe culvert structure. This construction method uses traditional and conventional means and is outside the scope of this report.

Figure 22—Conventional open-cut trench (Scott Kelman, Forest Service).

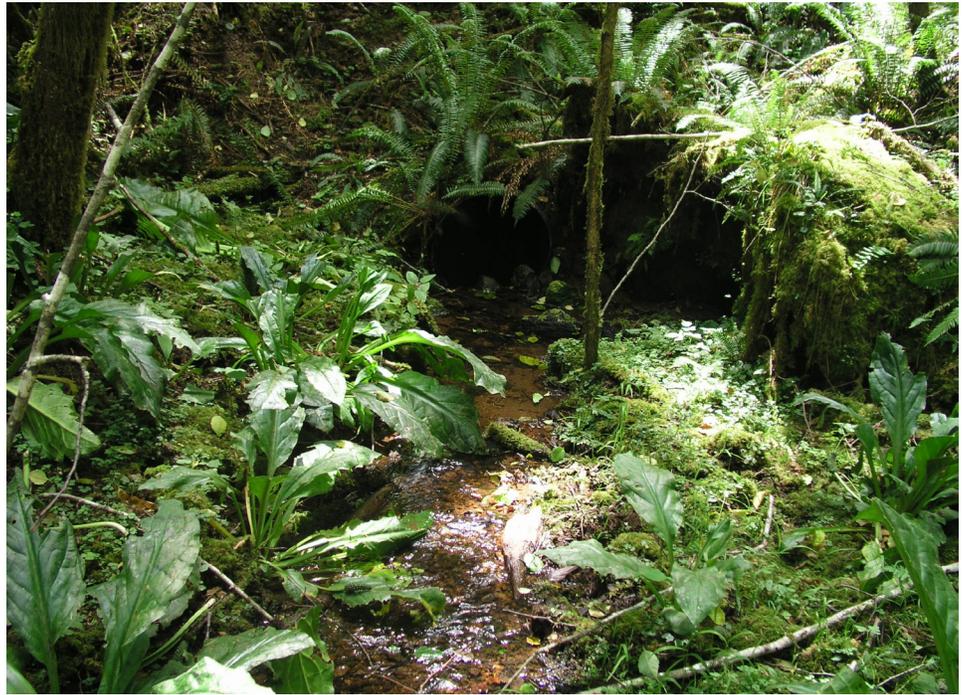
The photos in figures B.1 through B.4 were taken during a routine inspection:

*Figure B.1—Looking at the culvert inlet.*

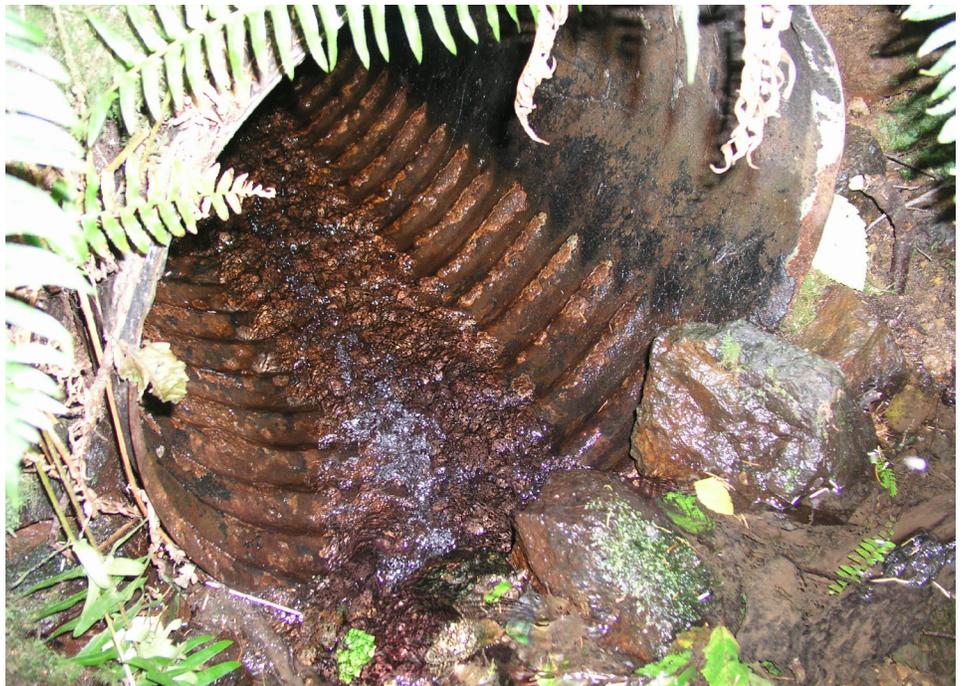
*Figure B.2—Looking closely at the inlet of the 24-inch corrugated metal pipe.*

A casual observer would likely assume that this old culvert on Road 1924 at milepost 0.1 is fine, but the Forest Service inspector looks closely to observe the pipe's condition.

Note that the culvert invert (bottom) has lost the bituminous coating and galvanizing due to scour and the steel is rusted (figures B.2 and B.3), but generally appears sound. Tapping on the steel with a hand pick confirms that this is true. The shape is normal (i.e., round). The pipe is nearly 140 feet in length, so even with a strong flashlight it is not possible to see the middle portion of the pipe. Also, note that no light is visible from the opposite end (figures B.3 and B.4). The apparent reason for this is that the pipe is sagging along its midportion, apparently due to settlement under the deep embankment (the ends are under a shallow embankment, so they have not settled). It is possible that during construction, the culvert was placed without the normally required camber, thus contributing to the sag. It is also possible that when this culvert was installed, insufficient care was given to subexcavating the weak organic soil overlaying the valley bottom and backfilling with incompressible aggregate bedding. The water drops from the outlet into a plug pool, but the standing water near the downstream third of the culvert (figure B.4) reinforces the belief that this pipe has an extreme belly in it.

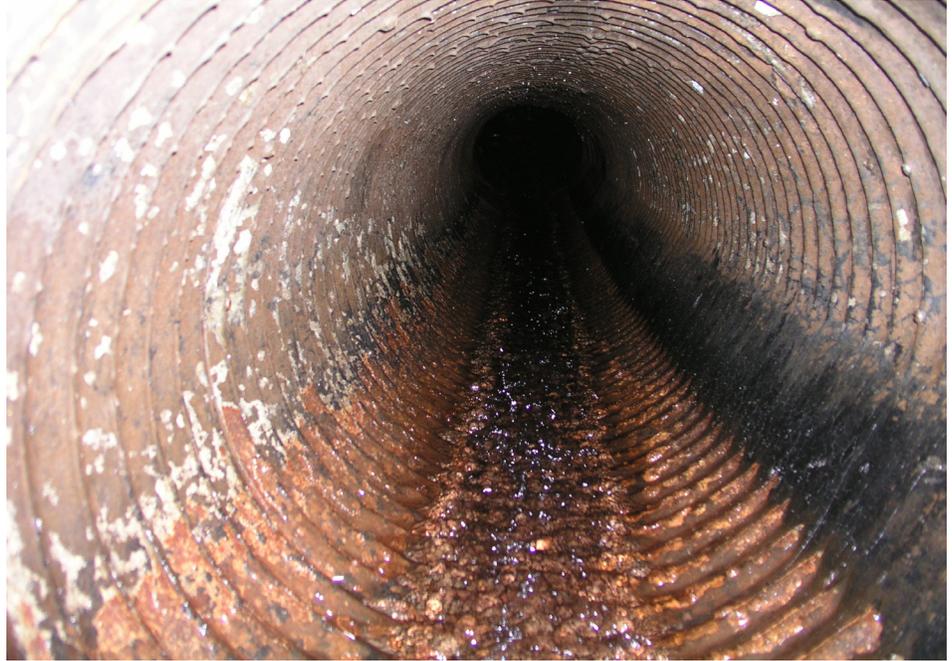
*Figure B.3—Looking into the inlet using strong light.*

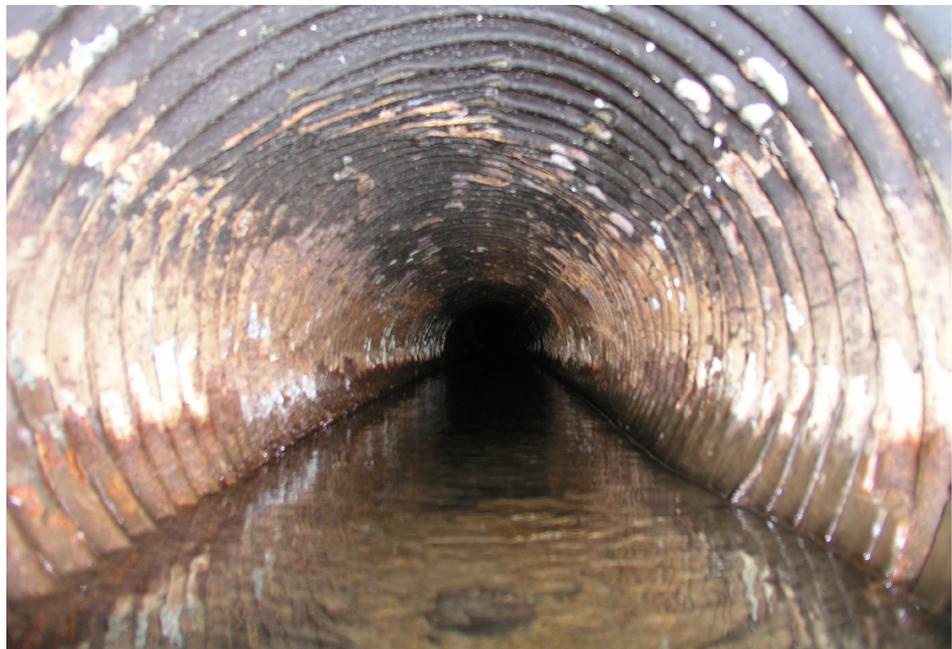
*Figure B.4—Looking into the outlet using strong light.*

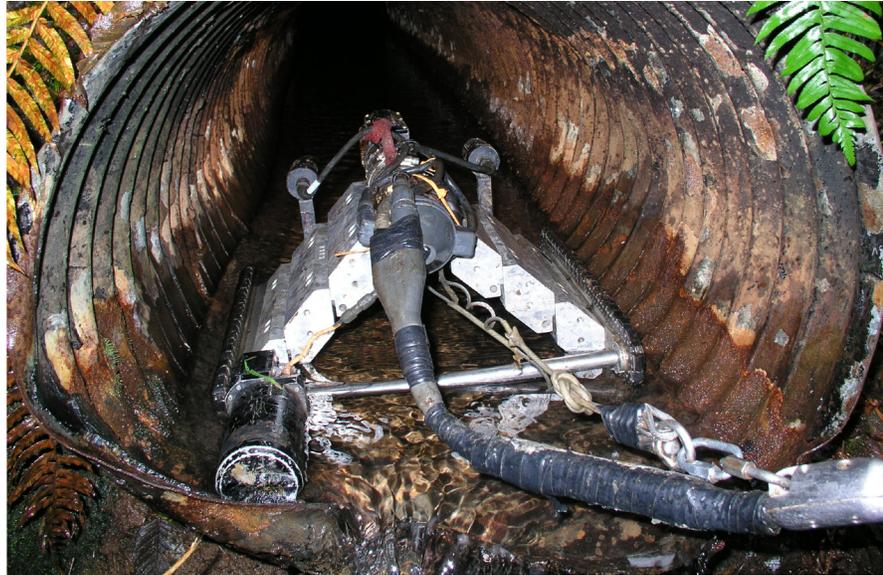
The most critical portion of the pipe is along the middle third where the loading on the culvert is greatest. When the embankment is high, the pipe is typically too long to see the middle portion, as is the case with this pipe. Also, it is not safe to crawl down this pipe to take a closer look. Therefore, a contractor was hired to video the inside of the culvert (figures B.5 through B.8).

*Figure B.5—Camera (with leg extensions) entering outfall.*

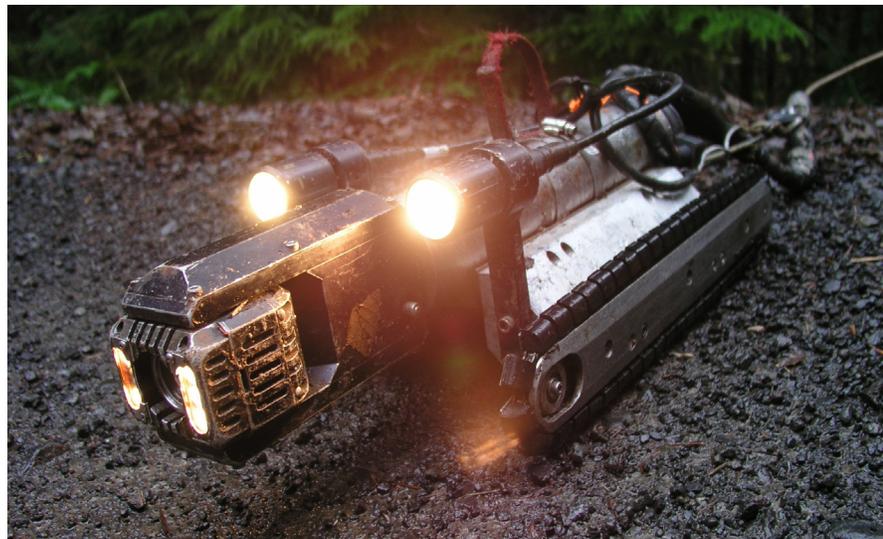
*Figure B.6—Looking closed circuit television camera on roadway.*
