Building Analysis & Adaptive Reuse Plan *for* **Halfway Ranger Station**

January 29, 2013
Revised August 8, 2014

Prepared by Leone A. Graf
1640 Camp Lake Road, Ely, MN 55731
218.343.3744

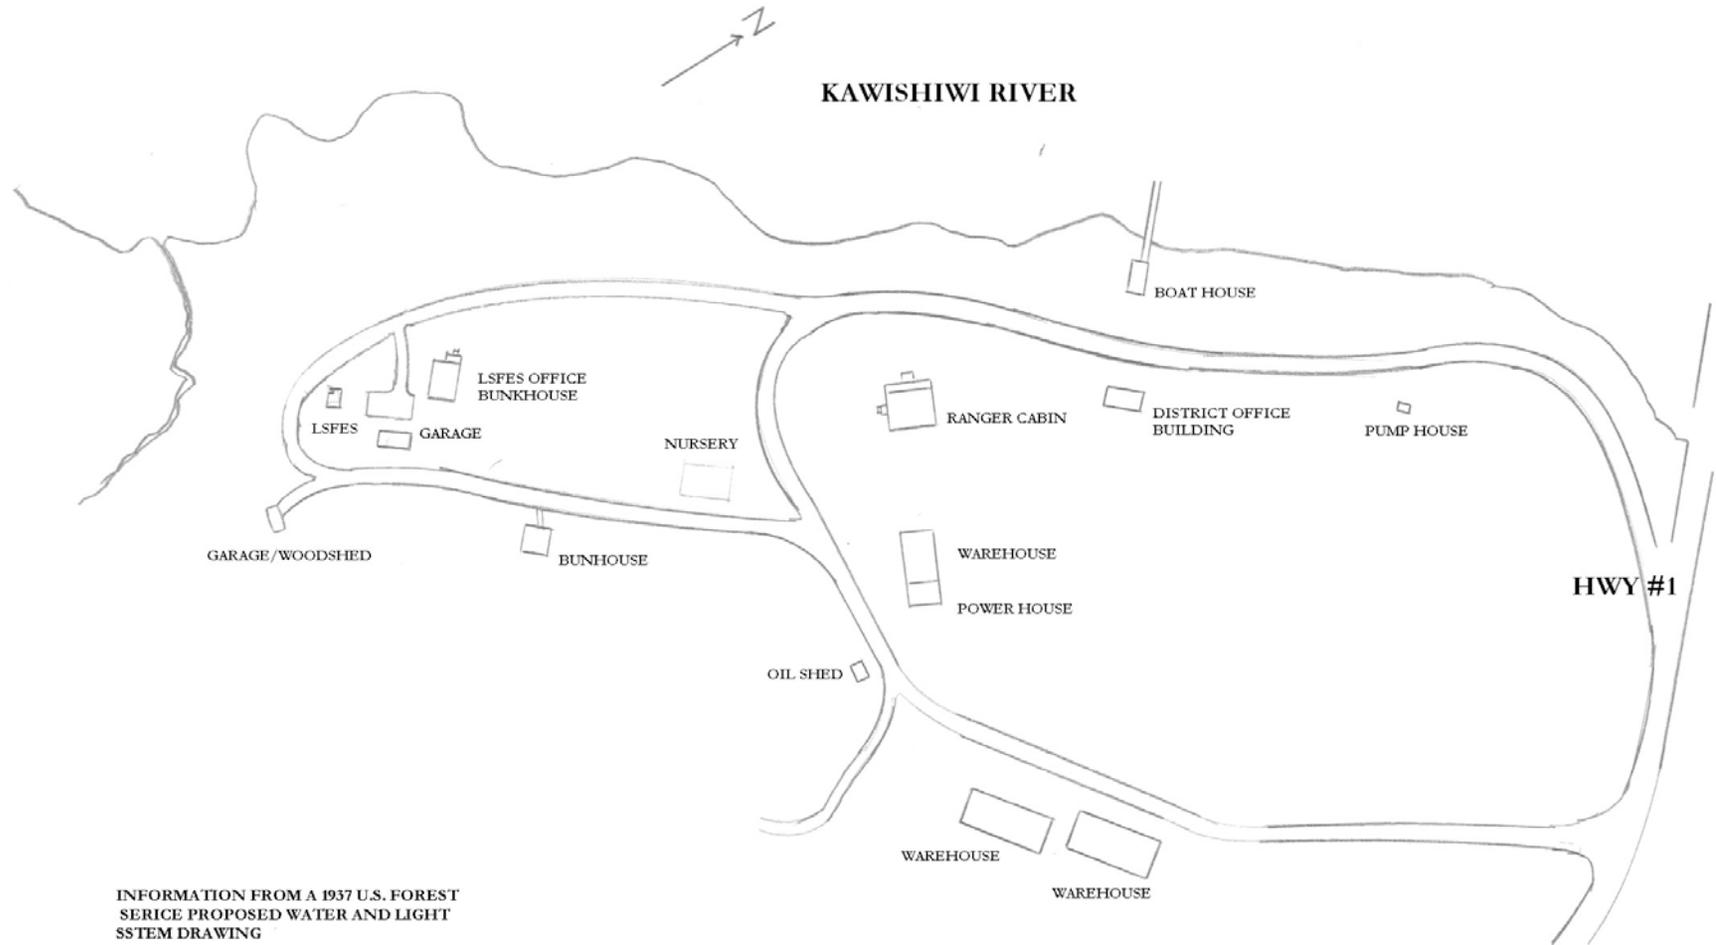
**DRAWING #1 - 1937 SITE PLAN
HALFWAY RANGER STATION/LSFES**

INFORMATION FROM A 1937 U.S. FOREST
SERVICE PROPOSED WATER AND LIGHT
SYSTEM DRAWING

The following site plans reflect both the historic site rehabilitation and the proposed.

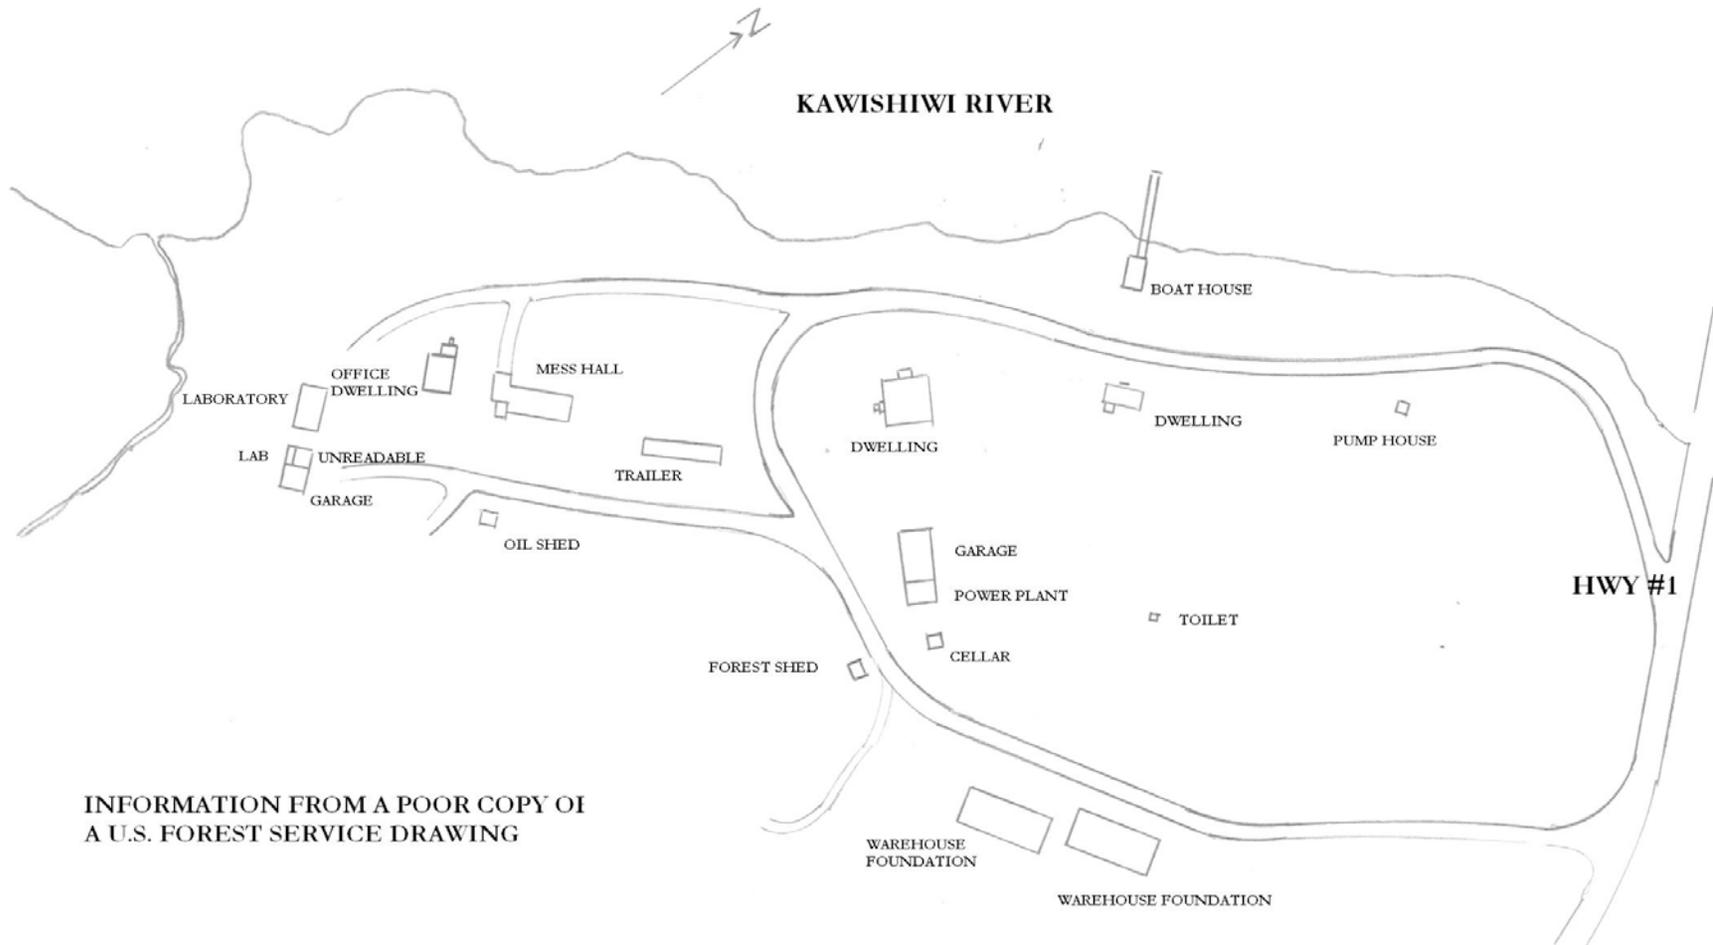
DRAWING #2 - 1965 SITE PLAN
HALFWAY RANGER STATION/LSFES

INFORMATION FROM A POOR COPY OF
A U.S. FOREST SERVICE DRAWING

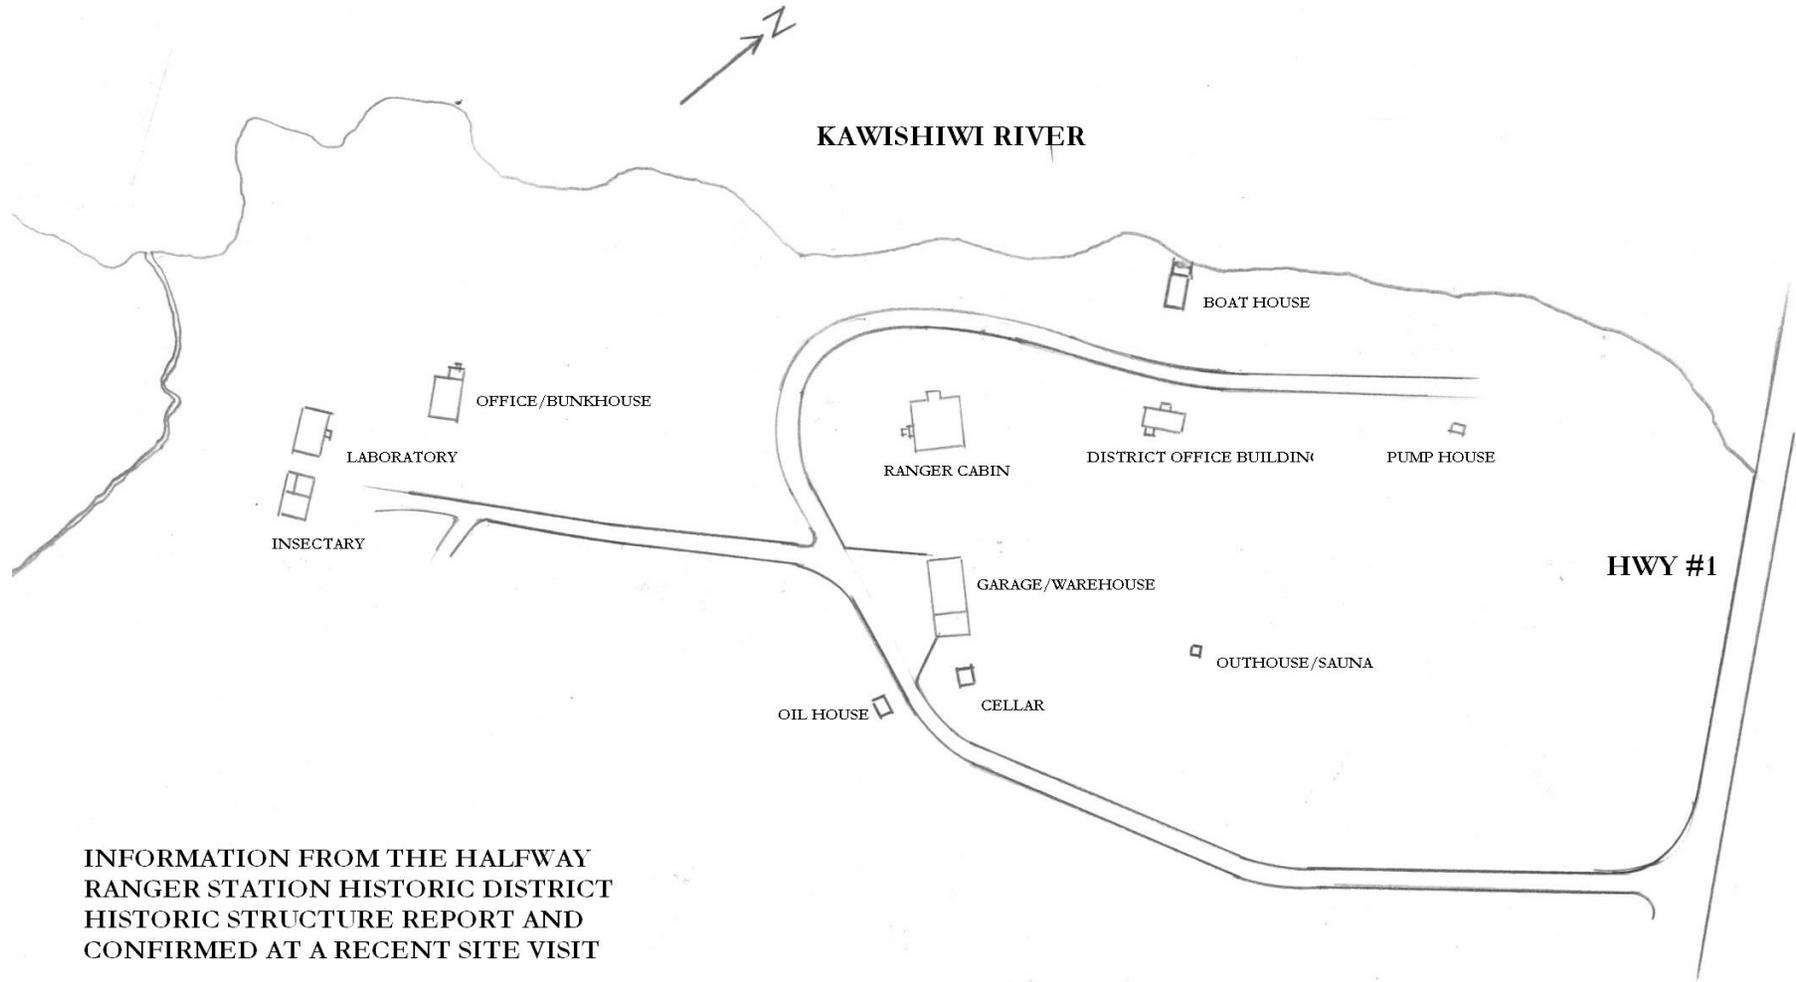
**DRAWING #3 - 2012 SITE PLAN
HALFWAY RANGER STATION/LSFES**

INFORMATION FROM THE HALFWAY RANGER STATION HISTORIC DISTRICT HISTORIC STRUCTURE REPORT AND CONFIRMED AT A RECENT SITE VISIT
