# JUNIPER FOR STREAMBANK STABILIZATION IN EASTERN OREGON<sup>1</sup>

Guy R. Sheeter and Errol W. Claire<sup>2</sup>

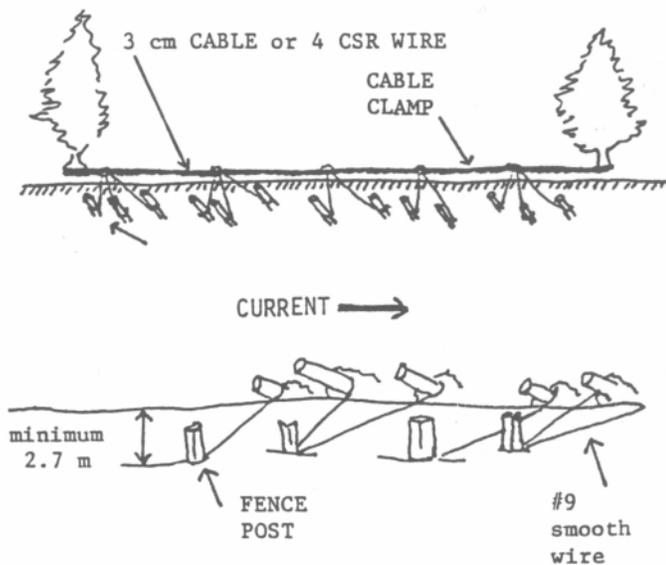
**Figure 2** — Methods for installing juniper revetment along a streambank.

3. Juniper trees should be green and full limbed with a heavy crown and in a "Christmas tree" or cone configuration.
4. The minimum tree butt diameter should be 15 to 30 cm d.b.h..
5. Trees should be placed in a shingled, overlapped pattern beginning downstream and working upstream (fig. 2).
6. Trees should be packed tightly and placed firmly against the bank.
7. Trees should form a downstream angle between the tree and the bank of about 45 degrees and be placed about 1 to 1.5 m apart.
8. The top of the tree should extend into the stream

7. Tree butts should rest on top of the streambank but should not extend above the top of the bank by more than 0.3 m.
  1. A 1814 to 2721 kg (2 to 3 tons) tilt-bed truck or flatbed trailer with solid sideboards was most practical for hauling trees.
  2. Anchoring
    - A. Steel fence posts should be driven back from the bank edge no less than 2.7 m from the top edge of the streambank in undisturbed soil.
    - B. Posts should be driven so the top of the post is 5 cm below the ground.
    - C. Post length should be 1 m. Full size posts were cut in half for use.
    - D. Final wire position should lie flat on the ground to reduce hazards to humans, livestock and wildlife. Scrap powerline wire (4 CSR) was used extensively in place of cable to reduce costs.

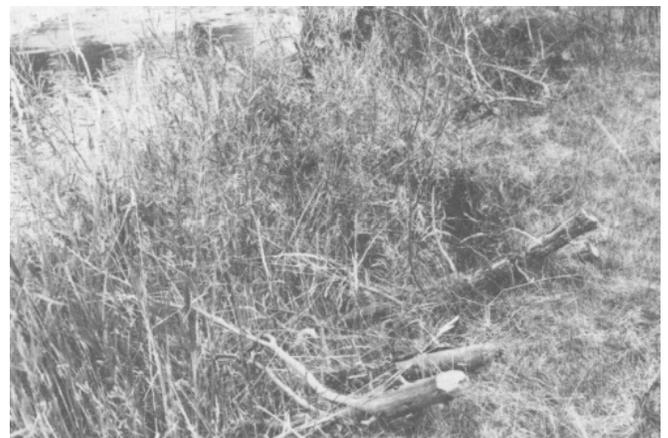
**Figure 3** — Juniper revetment 8 years after placement. Trees were sodded in and barely visible.

Juniper revetment was successful on 2,697 m (96 percent) of eroded streambanks. The average water velocity at one site evaluated was 0.28 m/sec before treatment and decreased to 0.08 m/sec after treatment. Many sites had tree tips buried under 0.6 m of silt the first year after placement. A slope below the vertical bank was formed by siltation and inhabited by species indicative of early stages of plant succession (fig. 3).

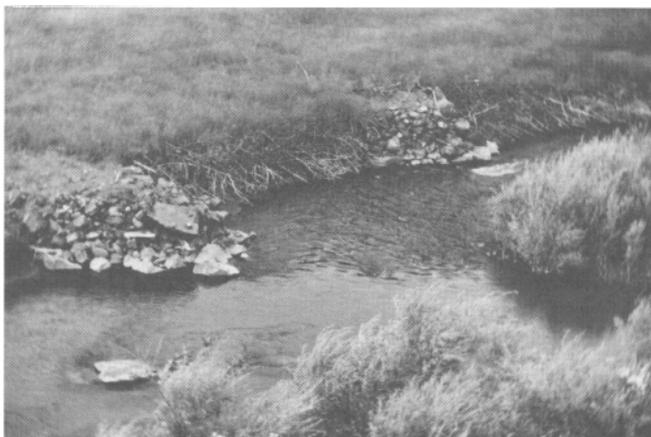
**Figure 4** - Juniper revetment used in combination with rock deflectors.
