**CHECKLIST OF INFORMATION REQUIRED TO COMPLETE APPLICATION FOR A
NATIONWIDE GENERAL PERMIT VERIFICATION**

Location: Kerber Creek Restoration Site: Latitude 40.15N, Longitude 42.33E near Villa Grove, Colorado. The USGS hydrologic unit code is 1301000302. See Figures 1 and 2.

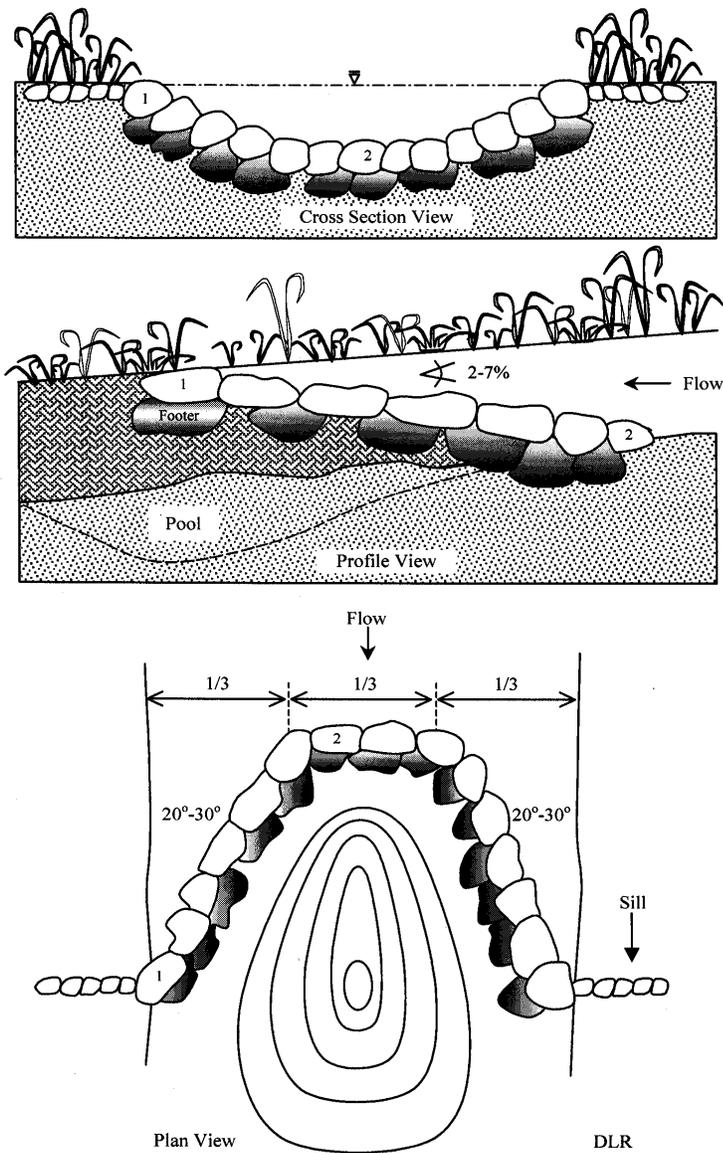
Figure 4. Specification for cross vane structures (From: The Cross-Vane, W-Weir and J-Hook Vane Structures...Their Description, Design and Application for Stream Stabilization and River Restoration, D. L. Rosgen, P.H.)

Figure 3. Cross section, profile and plan view of a Cross-Vane

- The purpose and need of the project is to remove mine tailings along Kerber Creek, stabilize the channel, restore and preserve the riparian system, and re-establish fisheries. The project would consist of removing tailings adjacent to Kerber Creek, stabilizing stream banks using rock and native vegetation, J-hook vanes with supporting bank rip rap to deflect flow away from stream banks, and re-establish riparian habitat. Figure 3 depicts an example of a boulder project. If the project does not occur, than mine tailings will continue to leach into Kerber Creek, bank erosion will continue, riparian and fisheries habitat will not be re-established. Rosgen structures will be utilized to increase fish habitat and Figures 3 and 4 are examples of the in-stream structures to be placed in Kerber Creek.

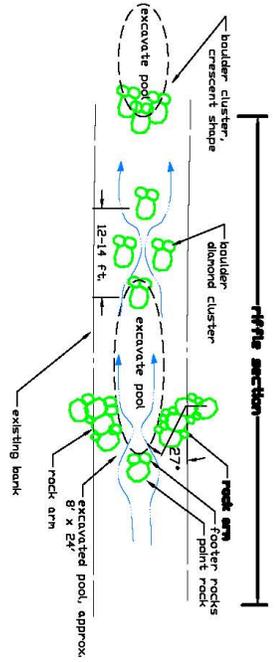
PLAN VIEW

STANDARD ROCK CONFIGURATIONS

- CONSTRUCTION NOTES:**
- 1 - Any rock arm shall always point upstream, 20-30 degrees from the bank.
 - 2 - Any boulder configuration shall be in the middle third of the creek unless adjacent bank protection is installed with the boulders.
 - 3 - Footer rocks shall be used with every rock structure unless instu material is 12 inch diameter or greater.
 - 4 - Boulder configurations shall not contain rocks that are 6 inches higher than the low water level.
 - 5 - Pools shall be excavated adjacent to the downstream side of every rock structure as shown on the drawings.
 - 6 - Whenever possible, install willow clumps along the bank, adjacent to rock structures.

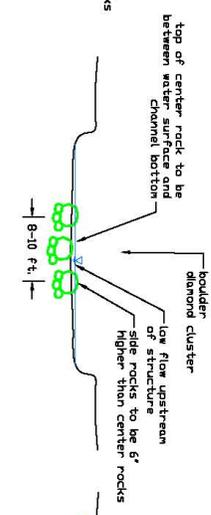
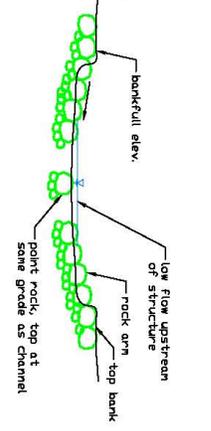
SECTION VIEWS

STANDARD ROCK CONFIGURATIONS
