ATV Trail Work on the Allegheny National Forest, Summer 2000

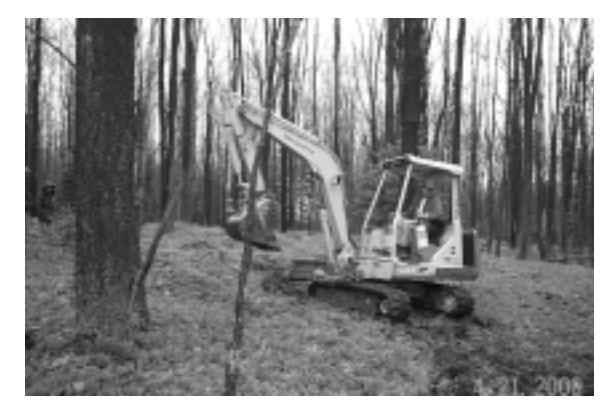
The Forest Service shaped the tread, installed structures, and restored trail sections, using mini excavators that are 5.4 feet wide, are powered by a 3-cylinder, 33-horsepower diesel engine, and weigh approximately 3.8 tons. Most previous trailwork had been done by using small bulldozers or skid steer loaders equipped with dozer blades. This was the first time mini excavators had been used on the ANF trail system; they proved to be quick and efficient. The excavators often used their bucket to loosen the soil and then used the blade to level and move it off to the side. The mini excavators were capable of building new trail at the average rate of 0.4 miles per day.

Figure 1. Using mini excavators proved to be quick and efficient.

The mini excavator disturbs much less ground than a dozer or skid steer does when installing sediment traps, removing stumps, etc., because its arm reaches out to do the work. This feature results in less seeding and mulching. The mini excavator also costs less to rent and operate than does a small dozer.

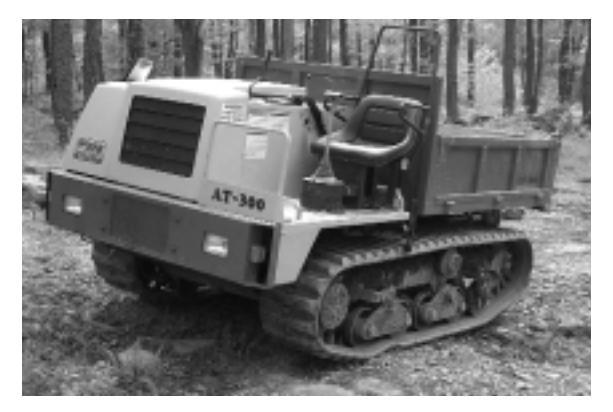
To harden up the tread surface, the Forest Service placed 4,600 tons of commercial gravel on various portions of the Marienville Bike Trail, using minitracked trail dumpers to transport the stone to those sections of trail. The trail dumpers are 5.2 feet wide and are powered by a 4-cylinder, 46-horsepower Kubota diesel engine. They weigh 2.3 tons and are capable of hauling 3 tons of stone.

Figure 2. A minitracked trail dumper.

Because the trail dumpers can be driven with the operator facing either way by reversing the seat, if there is no room along the trail to turn the dumper around, it can be driven in either direction easily. The dumper is operated by a "T" handle, which is pushed either forward or backward for direction and speed of travel and is twisted to turn to the left or right.

This maintenance and reconstruction effort also was the first time that these trail dumpers had been used on ANF trails. They proved to be efficient and durable. Some of the "carries" were up to 1.5 miles one way along the trail, and the dumpers made good time on these long hauls over rough trails. A 3-mile round trip delivering 3 tons of stone to the worksite took about 40 minutes.

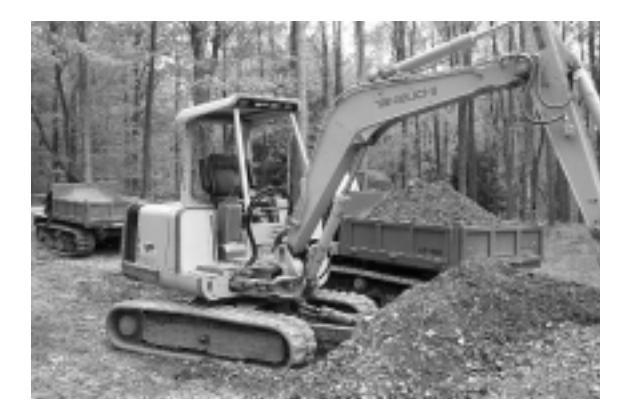
Figure 3. A mini excavator in action.

Both the mini excavator and trail dumper use rubber tracks, which are a definite advantage over steel-tracked equipment. On rocks and boulders, steel tracks tend to "skate" and slip, while rubber tracks have good traction.
