REVEGETATION OF RIPARIAN TREES AND SHRUBS ON ALLUVIAL SOILS ALONG THE UPPER SACRAMENTO RIVER, 1987-1988¹

Steven P. Chainey, F. Jordan Lang, and Skip Mills²

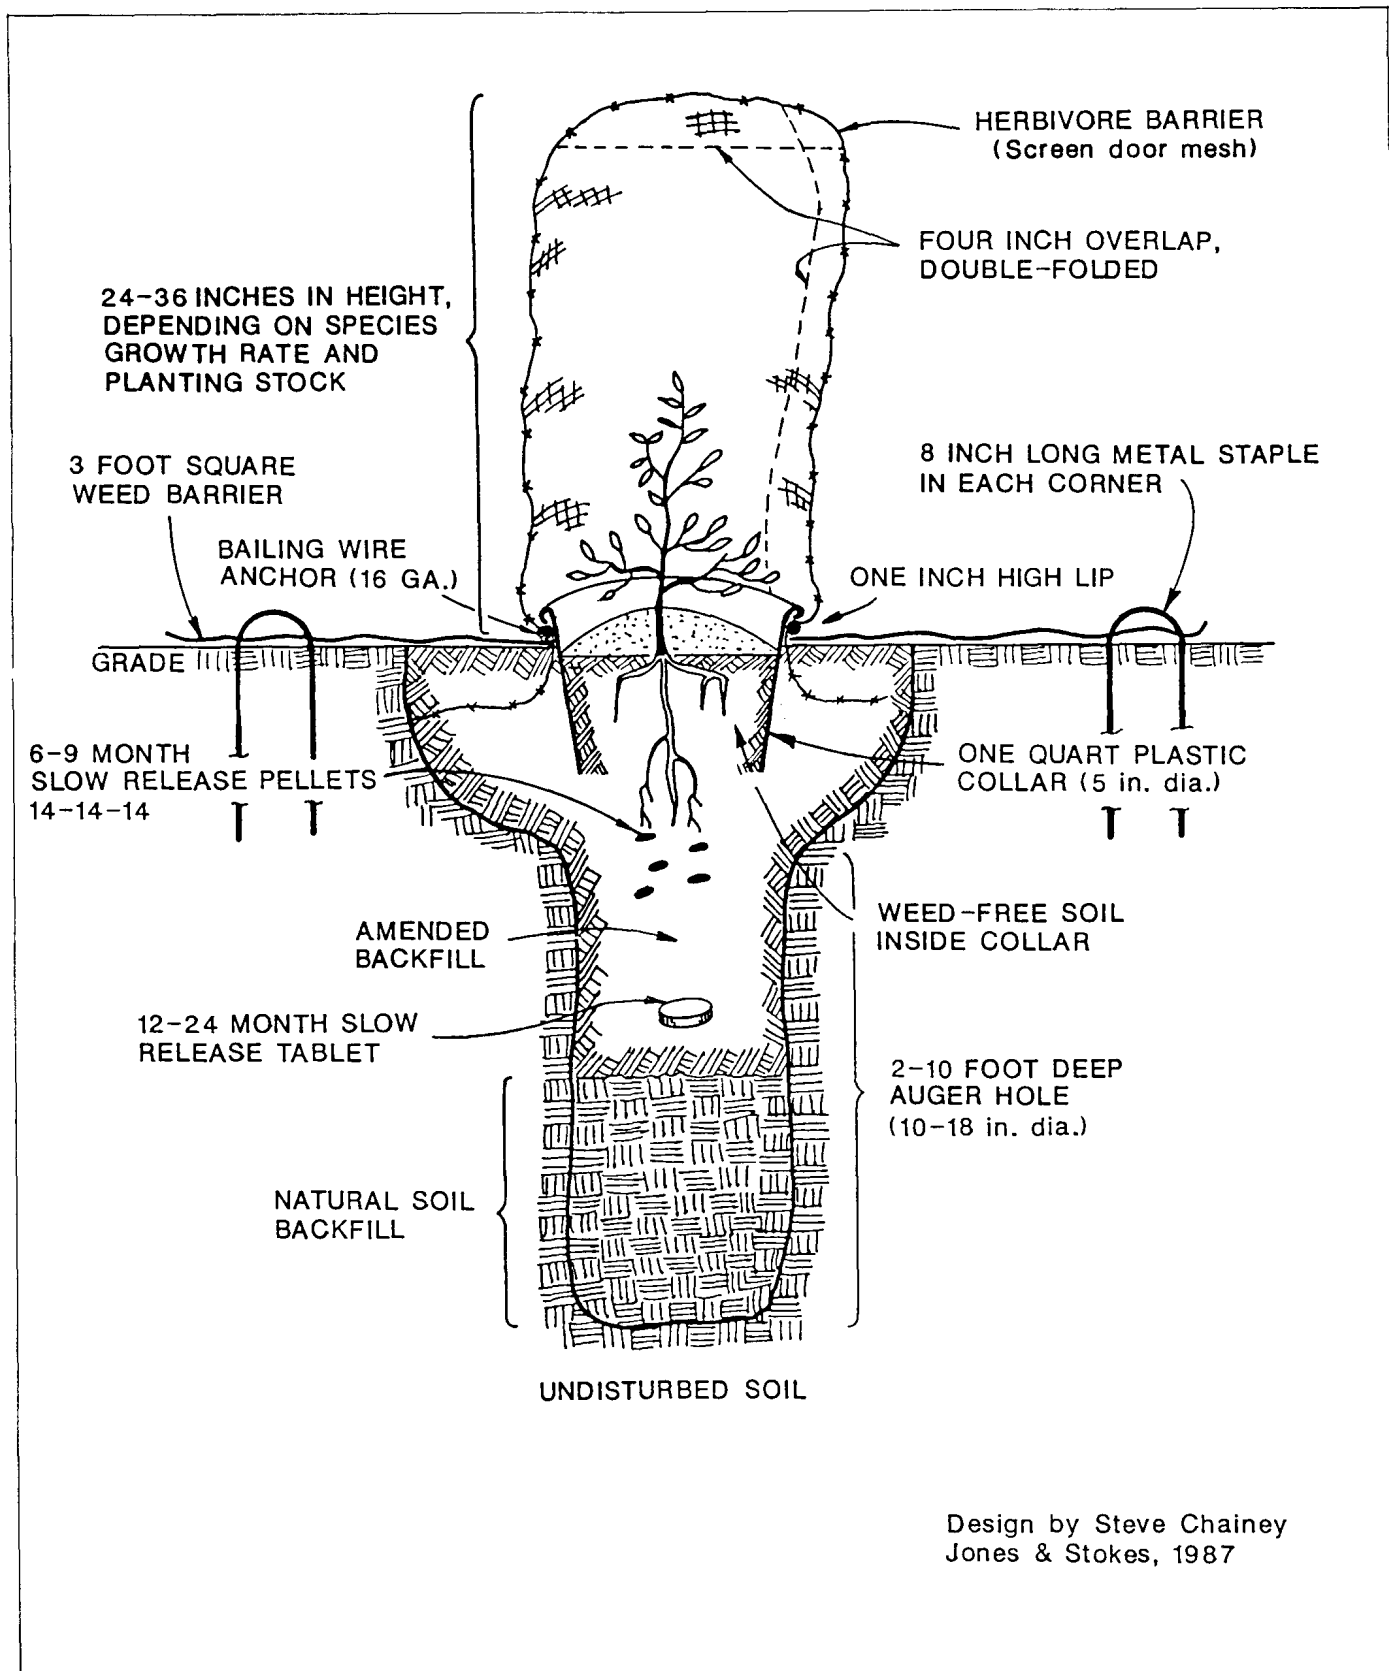
Figure 1 illustrates the plant protection kits installed around all plants except 5-gallon elderberries. The screen mesh prevents damage from deer, rabbits, rodents, and leaf-chewing insects. The screen also shades the young plant and accumulates moisture at night from dew or fog.

The plastic collar anchors the screen and serves as a barrier to horizontal extension of weed roots. It also discourages gopher damage and promotes deep vertical rooting by the seedling. The plastic will disintegrate before stem girdling an occur, but the anchor wire around the collar must be removed in 2-3 years to prevent girdling, depending on species growth rate.

The 0.9-meter- (3-foot-) square weed cloth is an effective alternative to frequent hand weeding and also conserves soil moisture. The woven plastic fabric is permeable to rainwater but prevents virtually all weed seed germination. Plastic barriers less than 0.9 meter (3 feet) in diameter are not effective because weeds next to the barrier can easily root laterally under the barrier and into the planting hole. To prevent barrier loss in the wind, the corners must be anchored with long metal staples or large rocks.

Figure 1—Conceptual sketch of plant protection kit (Section view not to scale).

As the plants grow vertically, the screen mesh is opened at the top. The mesh tube continues to shade the lower stem and prevent rodent girdling of stem tissue. Weeds inside the plastic collar are removed by hand. Maintenance visits occur every 2 weeks.

The mesh screens and the weed barriers used were highly effective at preventing herbivory and reducing weed competition. The protection kits have withstood extremely high winds and gopher burrowing activity. It appears that the screens also protected young plants from frost burn last spring. Using weed barriers also cut maintenance costs measurably and enhanced plant vigor and survival by reducing competition with weeds.
