Forest Health Protection

Pacific Southwest Region

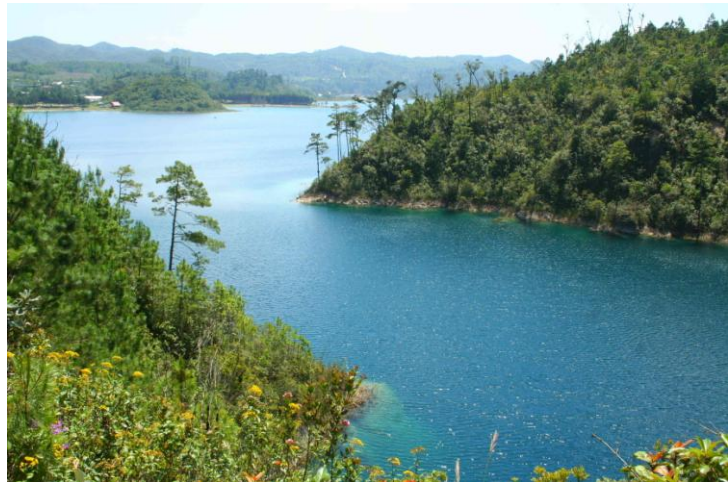
Figure 1. Laguna de Montebello National Park in southern Chiapas. Active populations of the goldspotted oak borer were found in this area.

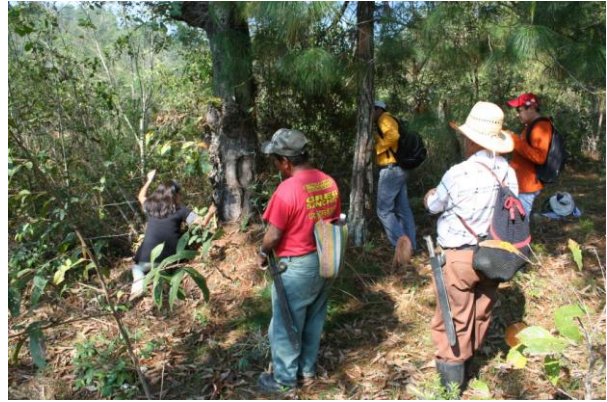
Figure 2. Oak surveys with EcoSur and CONAFOR collaborators in Ocosingo, Chiapas.

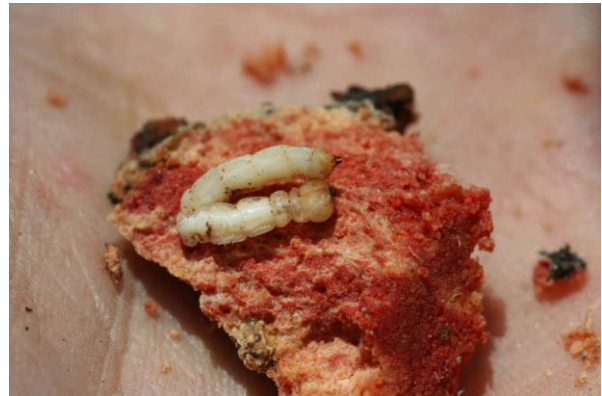
Figure 3. Mature GSOB larvae were found in Laguna de Montebello National Park in southern Chiapas.

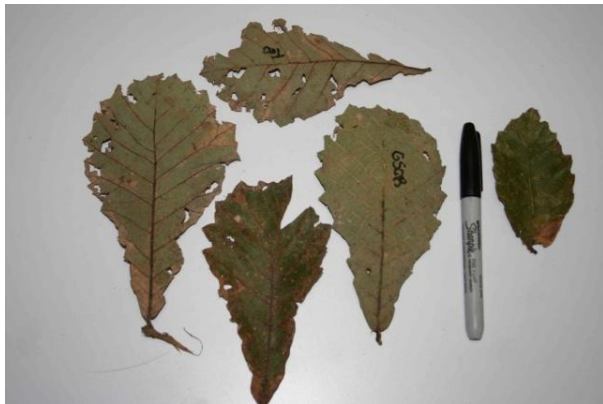
Figure 4. A common oak species found at several sites in southern Mexico that possessed GSOB populations.

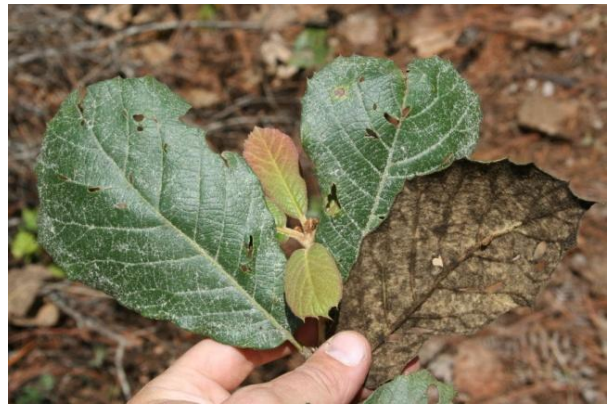
Figure 5. The goldspotted oak borer was found to injure this tree species in oak woodlands in Chiapas and Oaxaca.

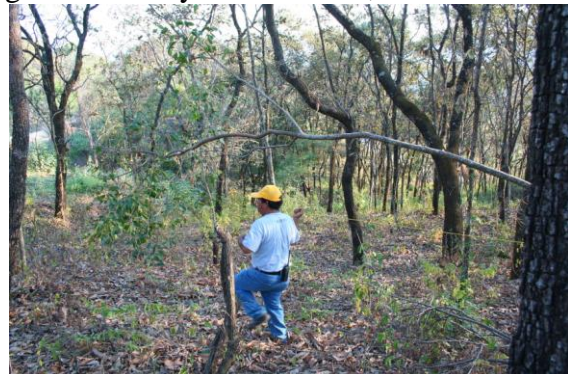
Figure 6. Plot data was taken at all sites visited. Plot data being collected at Huextepeç Reserve in San Cristóbal.

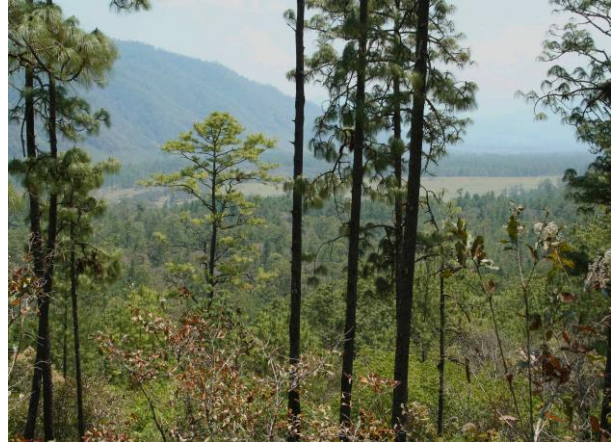
Figure 7. A pine-oak woodland north of Comitán de Domínguez, Chiapas where GSOB was found.

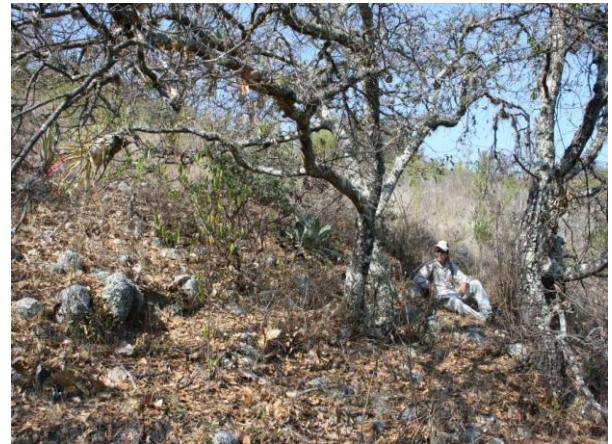
Figure 8. Oak woodland in Mitla, Oaxaca where GSOB was collected.

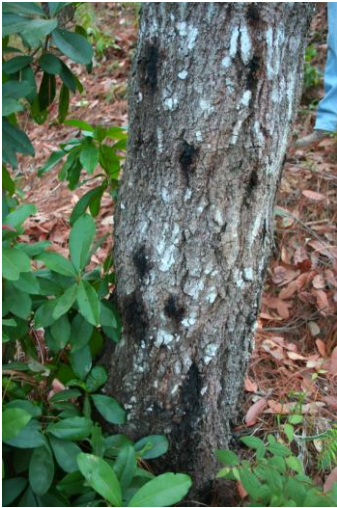
Figure 9. Staining found at Nuevo Palestine where oak mortality has been occurring at low levels for several years.

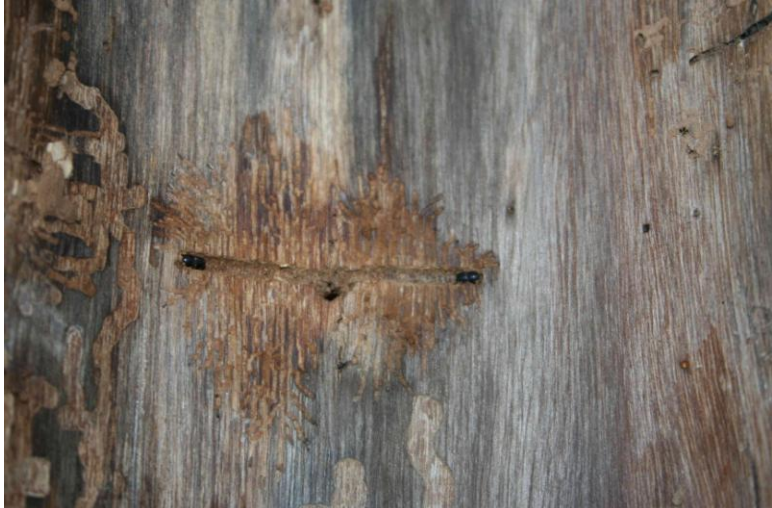
Figure 10. Ash (*Fraxinus* sp.) found with *Scolytus* sp. injury in Teopisca, Chiapas. Identification of the *Scolytus* sp. is still pending.
