Studies of Rock Characteristics and Timing of Creep at Selected Landslide Sites in Taiwan

Abstract.—A study was conducted to investigate the causes of and rock characteristics at three landslide sites in the Tesngwen Reservoir watershed of southern Taiwan. Research methods used included the petrographic microscope, X-ray diffraction (XRD), scanning electron microscope (SEM), inductively coupled plasma spectroscope (ICP), constant head permeameter in triaxial apparatus, surface extensometer, and seismic exploration by wave-refraction processes. Chemical analyses of the rock indicated a higher Na than K content at all three landslide sites; iron normally occurs as Fe³⁺. The relationships between percolation velocity (V) and gradient (I) were developed for the different sites. A prediction equation for the timing of landslide failure was also developed from surface extensometer measurements.

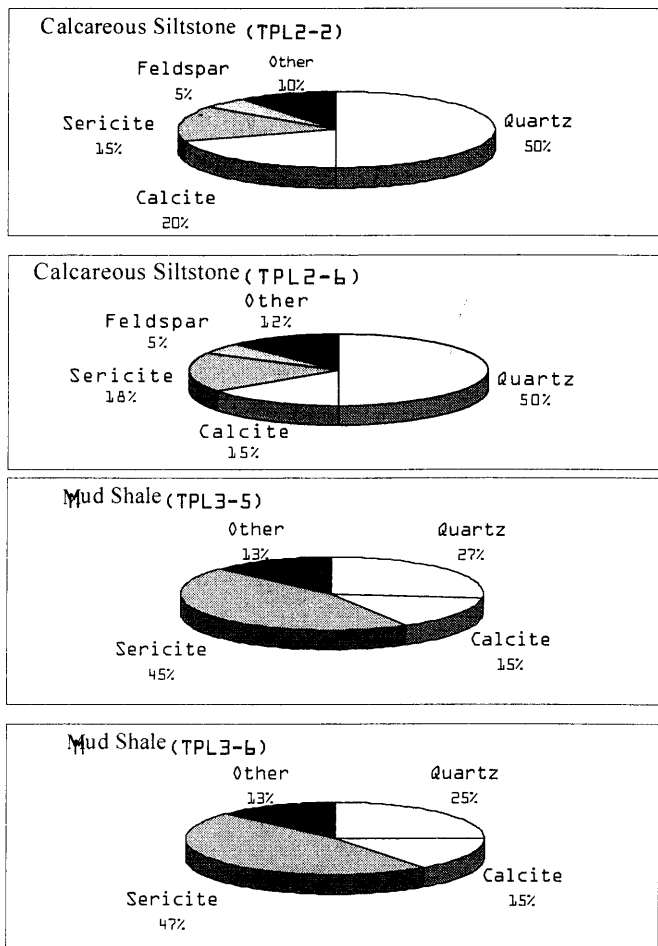
Figure 1. Relative abundance of mineral composition of rocks at Da-Pang landslide (volume %).

- The Da-pang landslide is an arc-shape creep failure type. Landslide failure was due to the steep topography, a road cut, and saturated hillslope material from heavy summer rainstorms. The rock stratigraphic unit of the site is in the Neogene Middle Miocene Da-Pang Formation composed mainly of argillaceous shale and calcareous siltstone. The mineral components of argillaceous shale include sericite, quartz and calcite; calcareous siltstone includes quartz, calcite, sericite and feldspar.
- The Ta-Tou landslide, another arc-shape type creep landslide, was caused by road excavation, concentrated runoff, poor drainage, increased pore-water pressure due to rain-storms, and gully head

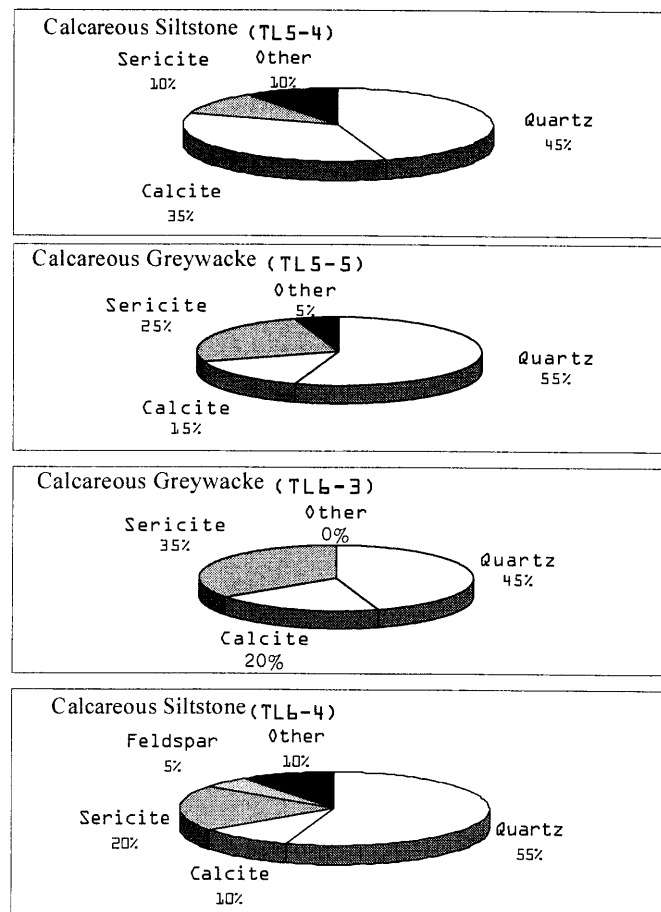
Figure 2. Relative abundance of mineral composition of rocks at Ta-Tou landslide (volume %).

erosion on a steep slope. The site is located in the Neogene Late Miocene Nanchuang Formation with calcareous sandstone and calcareous shale containing quartz, calcite, sericite and feldspar, and quartz, sericite and calcite, respectively.

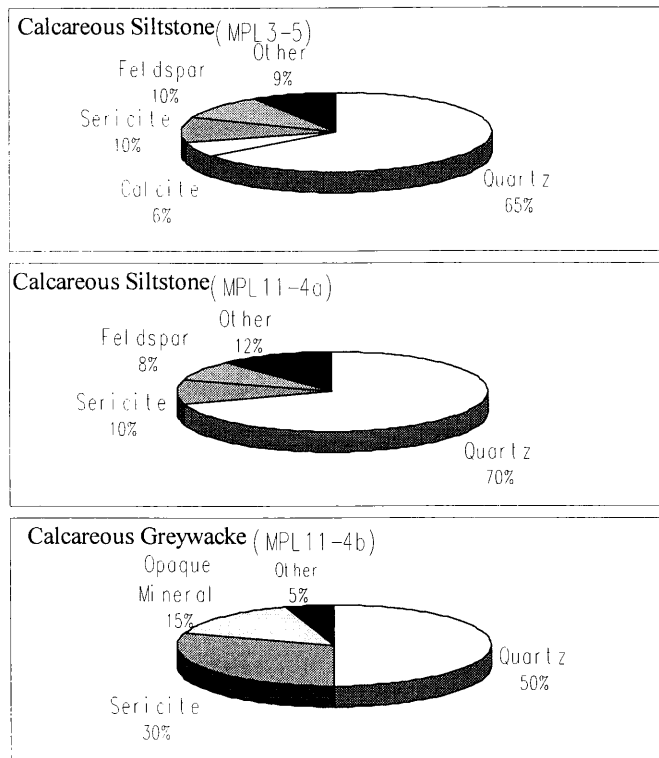
Figure 3. Relative abundance of mineral composition of rocks at Mao-Pu-Tes landslide (volume %).

- The Mao-Pu-Tse landslide is also an arc-shape type failure. This landslide was caused by the fluctuating water levels of the reservoir and the flow of the hillside after extended submersion in water undercutting of the hillslope. The Neogene Late Miocene to Early Pleistocene Kueichulin Formation at the site contains siltstone and fine greywacke with quartz, sericite and feldspar.

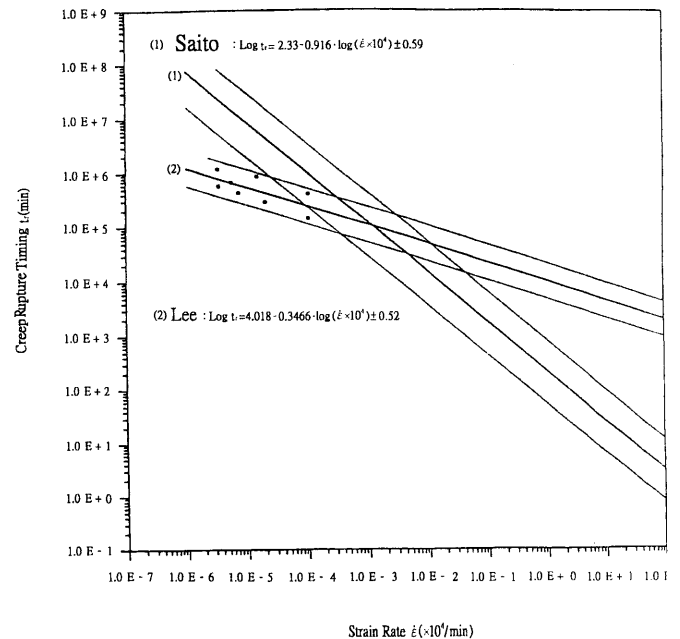
Figure 4. Comparison of rupture timing between Saito and Lee models.

Time-dependent behavior in hillslope material is referred to as creep landslide (Terzaghi, 1950; Saito, 1966; Roberts, 1977; Bates, 1987). In addition to the time factor, creep rupture is dependent on pore-water pressure, geostress, and temperature. Creep of rock detritus frequently occurs on hilly terrain. The motivating force is gravity, although lateral stress is sometimes important. The deformation mechanism is essentially one of plastic flow in which a slow downslope failure of the whole mass is combined with a vertical movement of fragments through the moving layer. Surface extensometers were used to measure displacements at different depths of a given profile at six landslide sites (figure 4).

- The prediction model for the creep failure timing developed from surface extensometer measurements at six landslide sites is:

$$\text{Log } t_r = 4.018 - 0.3466 \log (\epsilon \cdot 10^4) \pm 0.52$$
