## Comparative Durability of Untreated Wood in Use Above Ground

T. L. Highley

### ABSTRACT

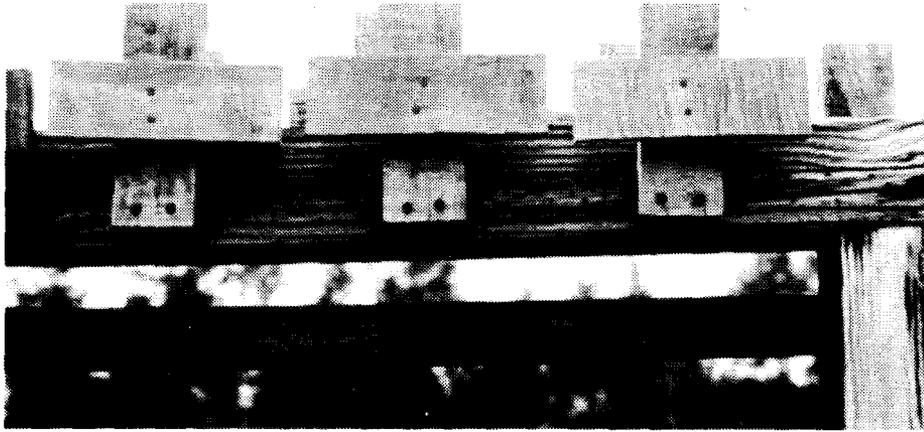
Fig. 1. Test crosses installed on fence.

Test units were constructed of 1.9 by 7.62 by 15.24 cm (3/4 by 3 by 6 in) long boards, nailed together at their centers to form a cross (Fig. 1). The intersection of the boards provided a water catchment area similar to joints where decay often originates in wood structures. Ten units were constructed of wood from each tree species. When both sapwood and heartwood were available from a given species, 10 units were constructed of each wood type. Each series of units was then installed on test fences (Fig. 1) located near Madison, Wisconsin. The Madison climate is moderately favorable for promotion of decay (Scheffer, 1971).
