## All-Terrain and Utility Terrain Vehicle Safety: Alternative Vehicles for Towing Trail Grading Equipment

By Ellen Eubanks, Landscape Architect

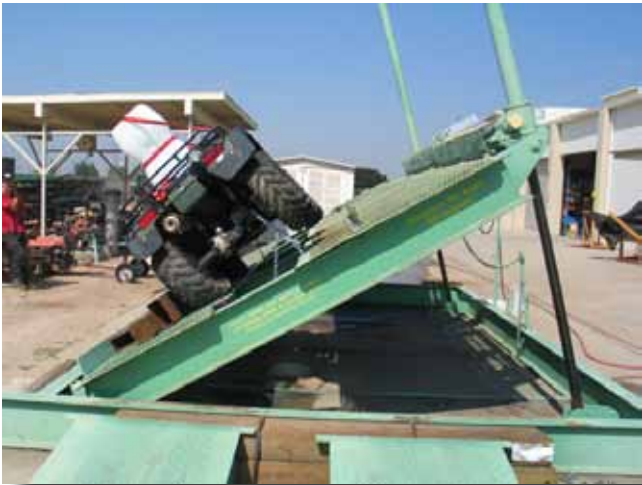
Figure 1—Tilt table shown at 40 degrees.

Each vehicle was tested on the SDTDC tilt table. We (SDTDC) conducted the tilt tests to determine the static-roll threshold of a vehicle. The angle at which the uphill tires lifted off the table's surface is the maximum angle of inclination (cross slope, hill climb) under static conditions. There is a strong relationship between the static-roll stability (determined by the tilt test) and the actual occurrence of rollovers in accidents (Winkler 2000). The SDTDC tilt table's maximum tilt is 40 degrees. See figure 1.

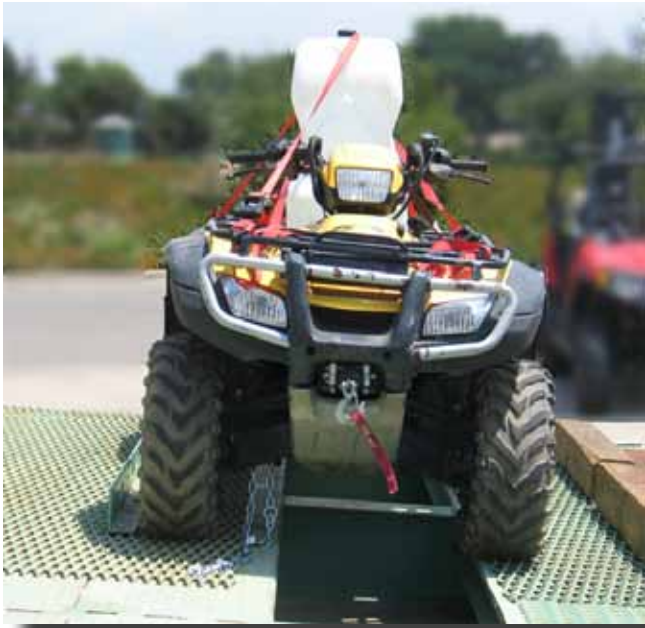
Figure A1—Foreman ES strapped and ready for the lateral test. There is a winch and a fire extinguisher on the front and a trailer hitch on the back that add weight.

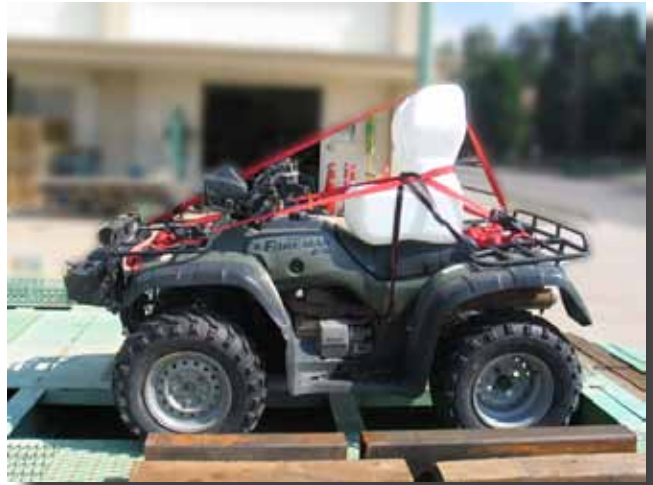
Figure A2—The Rubicon shown strapped during the lateral test. There is a winch on the front and a trailer hitch on the back that add weight.

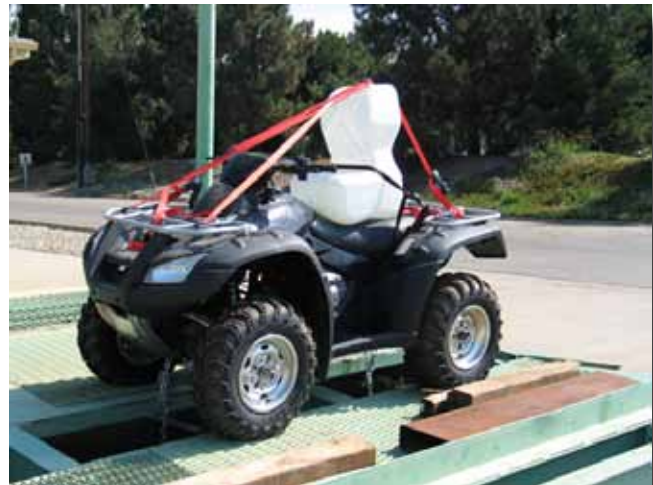
Figure A3—Rincon chained to the table for the lateral test.

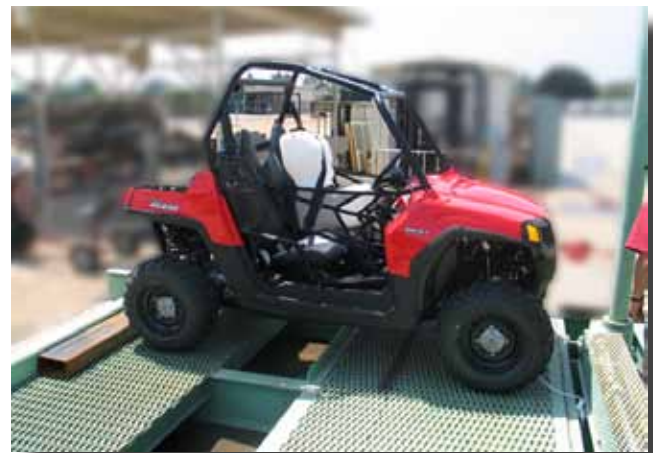
Figure A4—RZR with the dummy strapped in with a seat belt.

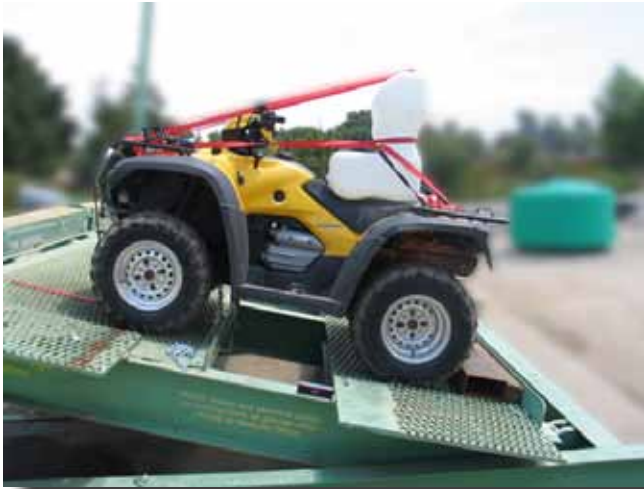
Figure A5—Dummy strapped for longitudinal test. Note the strap around the “neck” to keep the dummy from tilting backwards.

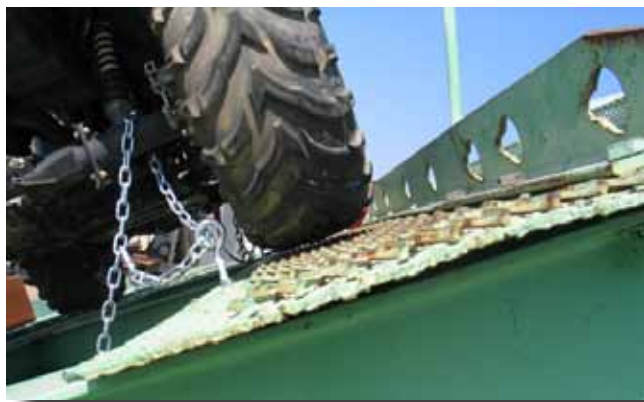
Figure A7—Foreman ES rear wheel lifted at 27.4 degrees.

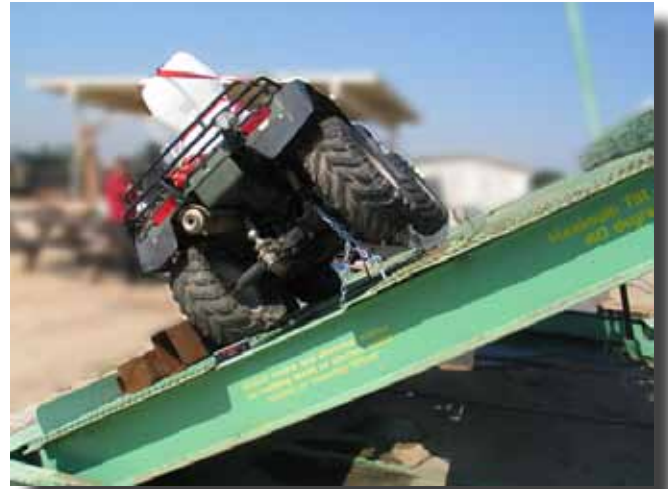
Figure A8—Foreman ES at rolling point, 30.9 degrees.

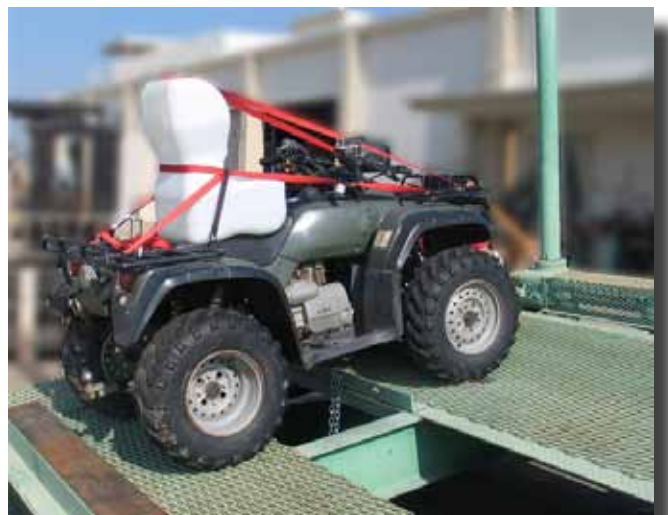
Figure A9—The Foreman ES beginning the longitudinal test. Notice that the rear tires are several inches from the blocks.

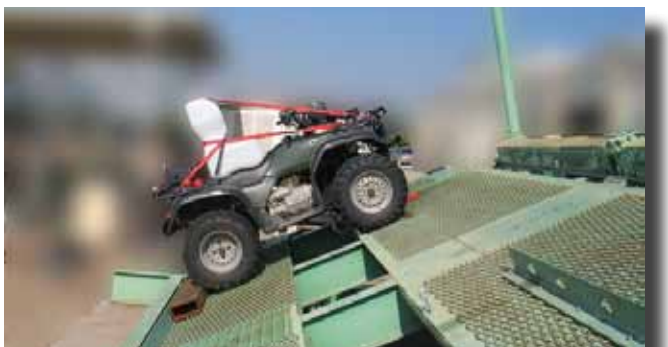
Figure A10—Because of the brakes releasing and catching, the Foreman ES's rear tires at the end of the test are on the blocks at 40 degrees.

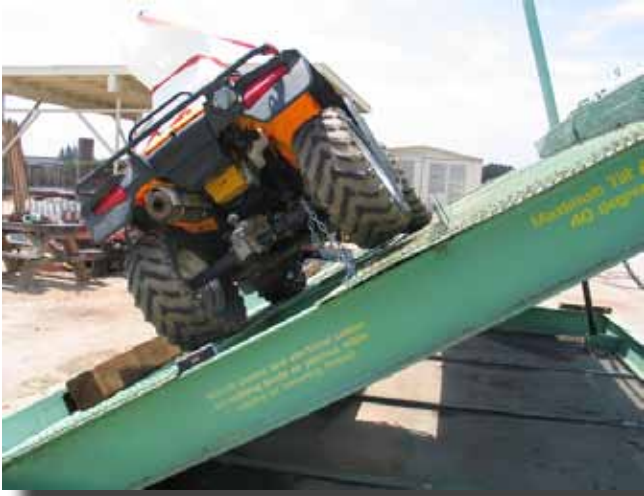
Figure A11—The Rubicon's rear wheel lifted at 27.5 degrees.

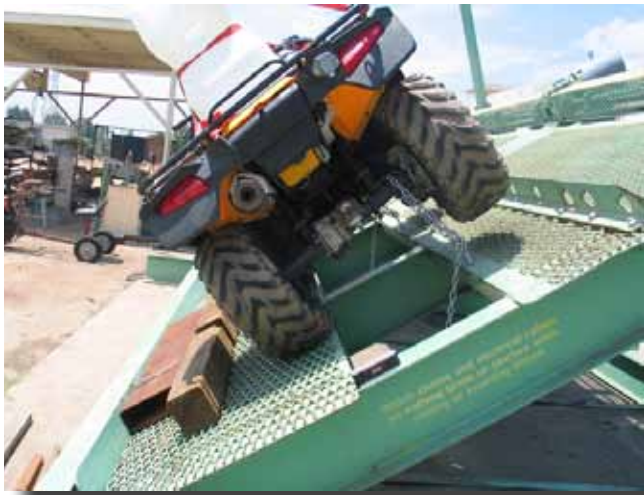
Figure A12—Rubicon ATV rolls at 34 degrees.

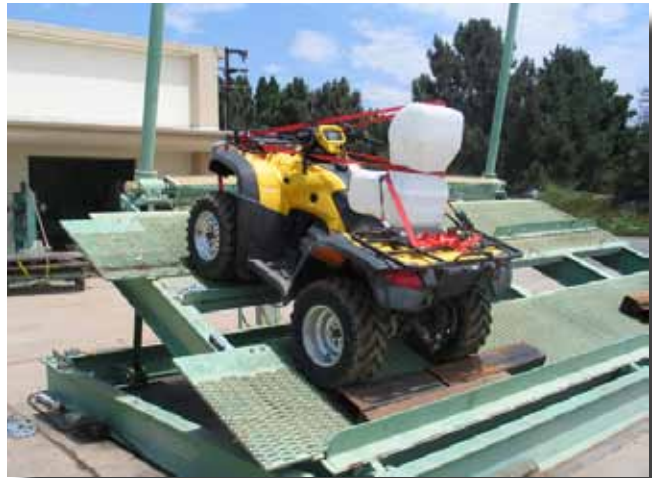
Figure A13—The Rubicon's rear tires on blocks at 19 degrees.

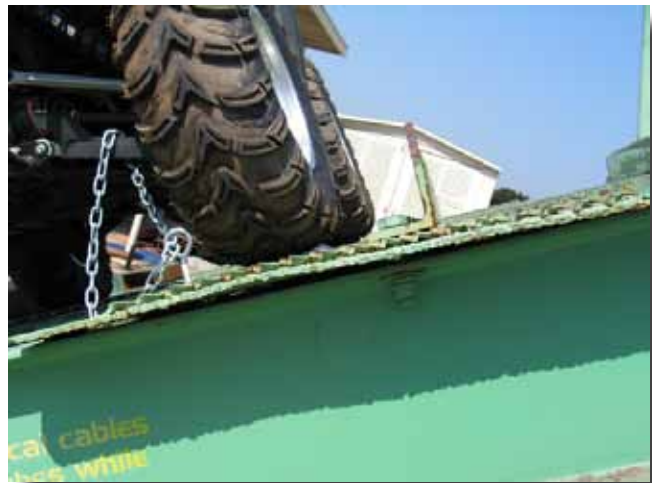
Figure A14—The Rincon front tire, in right portion of photograph, is barely off the table at 30.0 degrees.

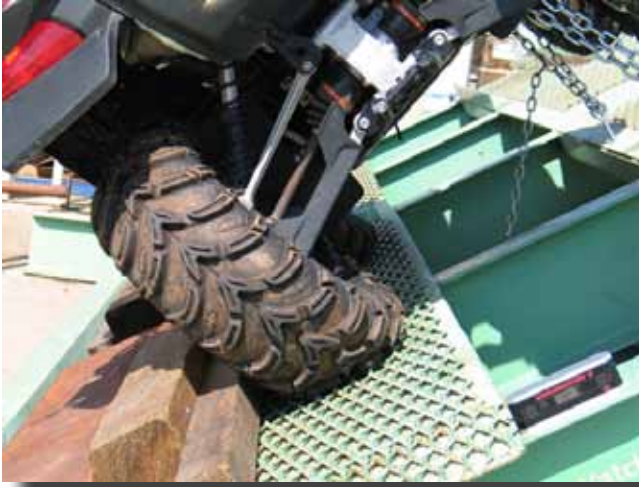
Figure A15—Notice tire distortion.

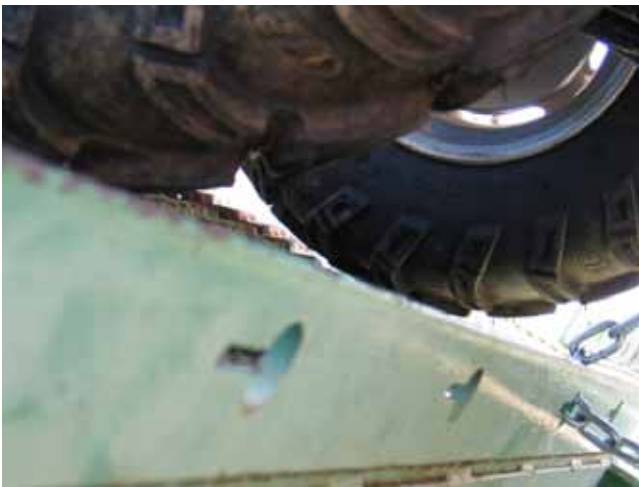
Figure A17—The right front tire lifted off at 39.5 degrees.

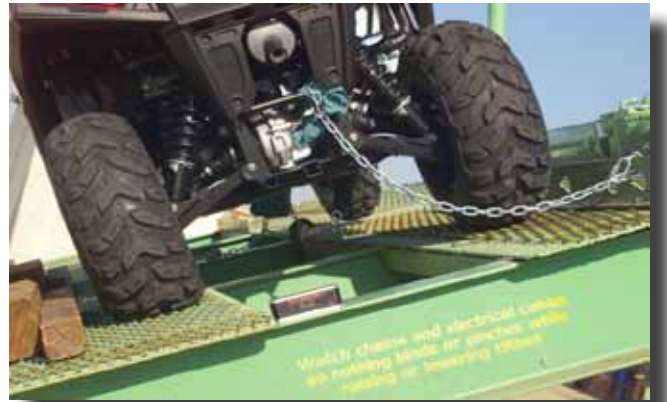
Figure A19—Front tire of the RZR is off the table at 30.8 degrees.

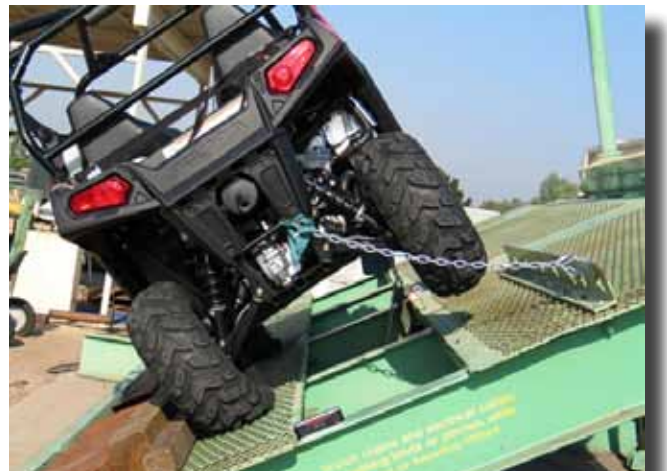
Figure A20—The RZR rolls at 32.9 degrees.

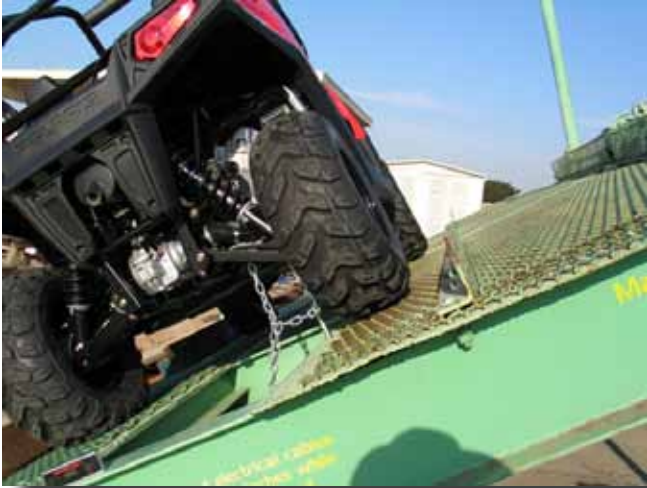
Figure A21—The right front tire lifted off at 30.8 degrees.

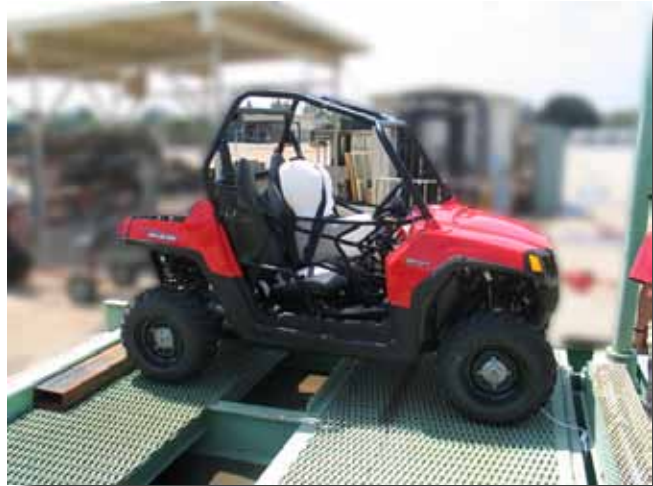
Figure A22—The RZR ready to begin the longitudinal test.

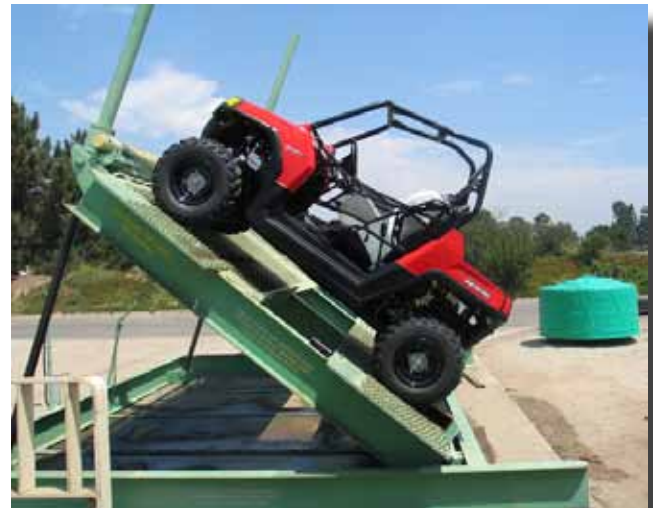
Figure A23—RZR at 40 degrees. Security ropes are still slack and RZR is on blocks.
