Forest Management Tech Tips

United States Department of Agriculture
Forest Service

**National Technology &
Development Program**

Temporary Stream Crossings to Minimize Instream Sediment

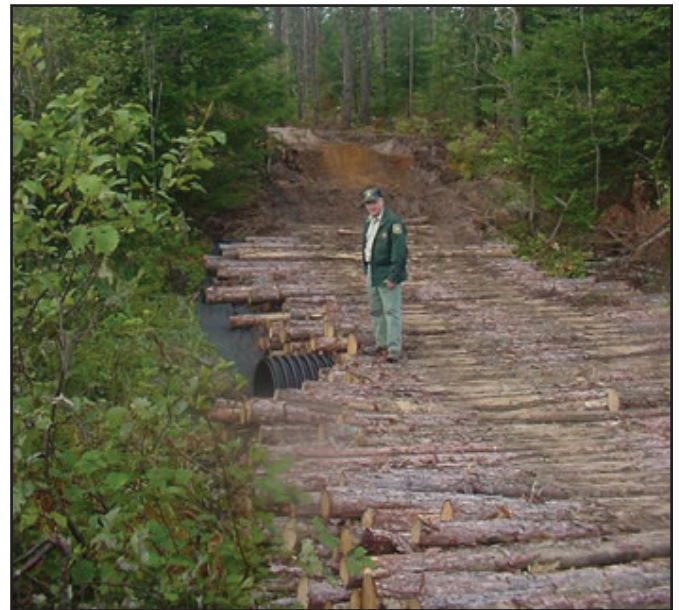
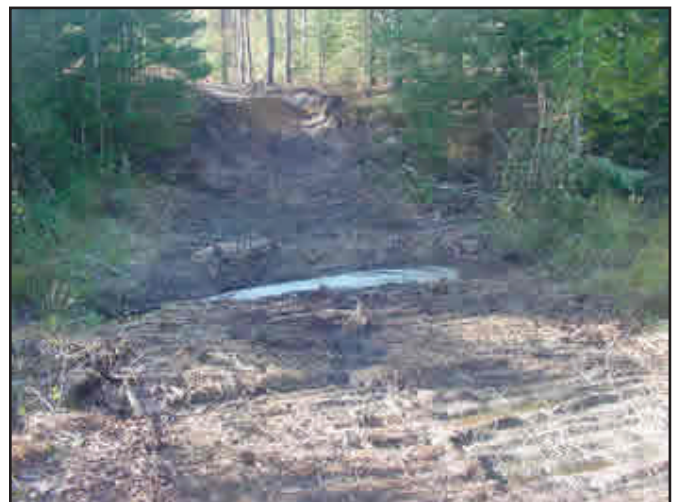
Figures 1 and 2—The temporary crossing in place and after its removal.

Information on the Forest Service Eastern Region (R-9) structure was provided by Charlotte Bofinger from the Ottawa National Forest. The situation was a summer drainage crossing for a forwarder. After installation, the crossing withstood heavy use for a month or more and then was removed. The stream course was running water to a depth of 12 inches and up to 3 feet wide. The crossing was created using separator material, corrugated plastic pipe, and pulpwood. The separator material keeps the logs from being pushed into the soil and results in cleaner logs being hauled out of the woods. A pervious, nonwoven geotextile is recommended. After the crossing was no longer needed, the pulpwood was removed and hauled. The separator material and pipe were removed for reuse.

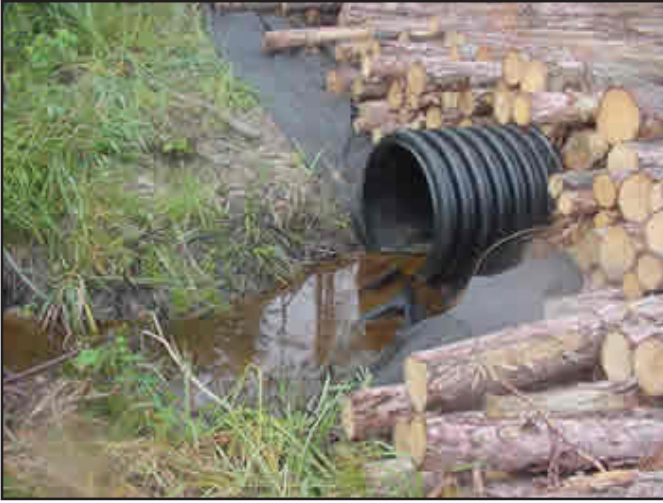
Figure 3—A closeup of the channel with separator material, pipe, and pulpwood.

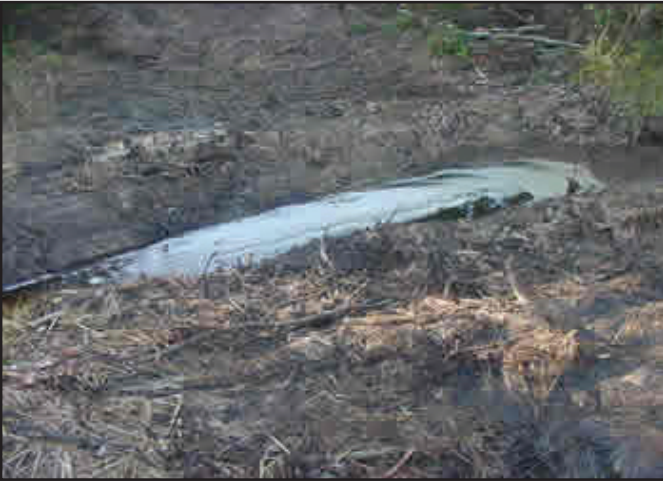
Figure 4—A closeup of the channel after removal of the temporary crossing. Note the indentations of the logs.

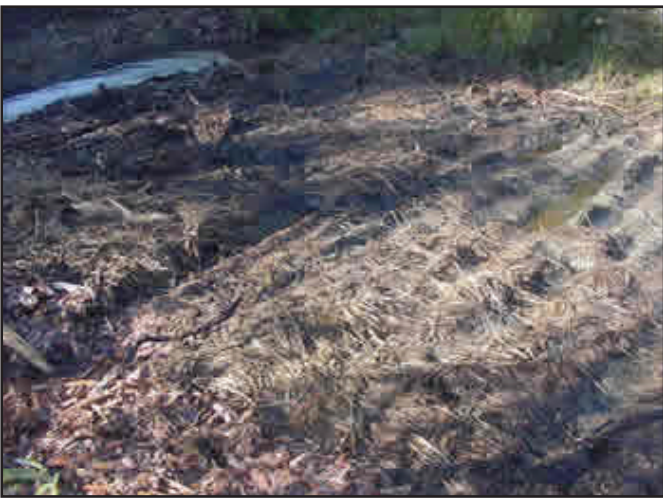
Figure 5—Ground cover of organic material is still in place after the logs are removed.

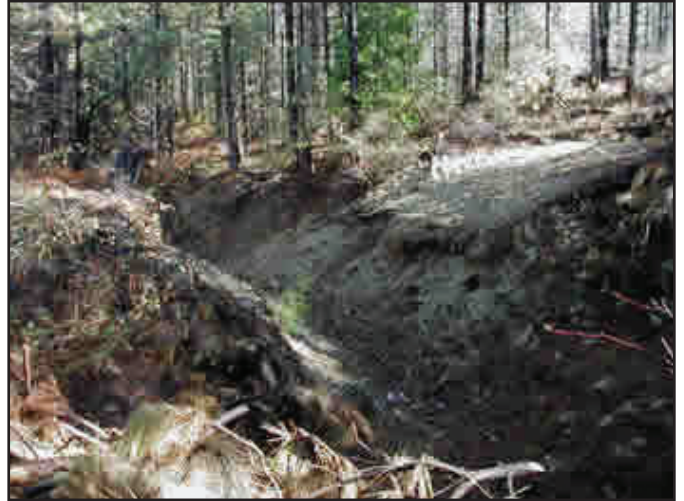
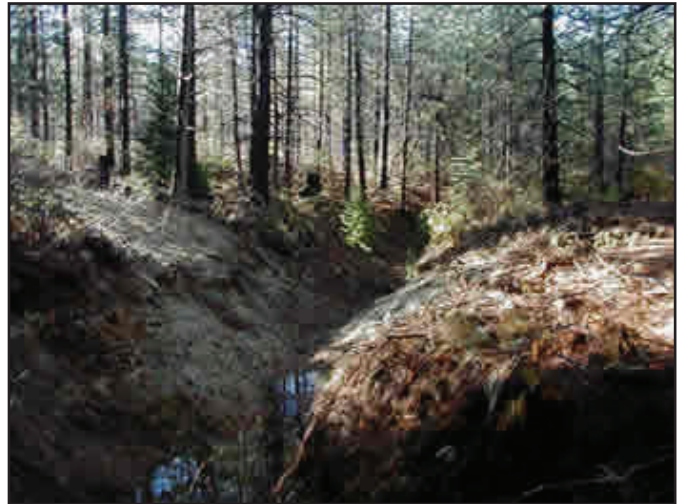
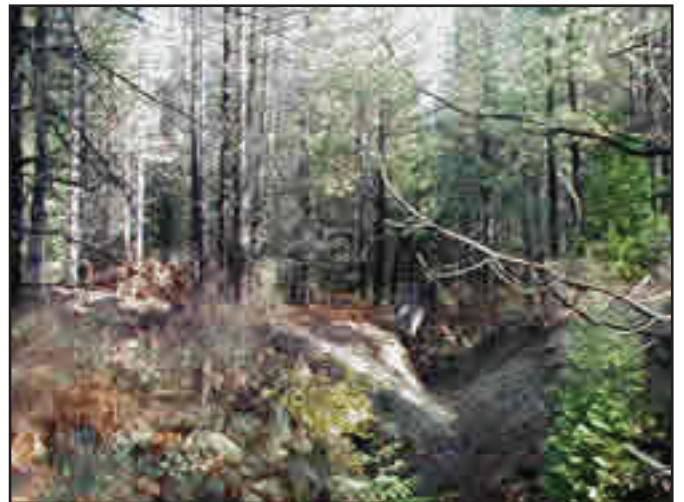
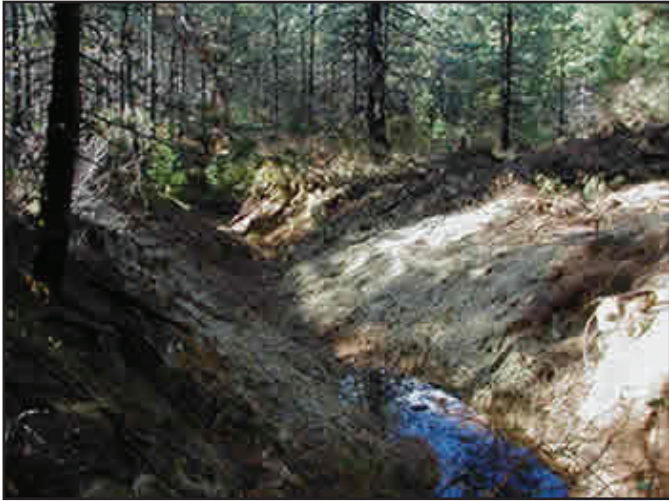
Figures 6 through 9. Crossing already removed; Tahoe National Forest.

The situation was an ephemeral drainage used during August, when the chance of measurable precipitation is minimal. The crossing was removed by September 15. The need for a temporary crossing was recognized during the National Environmental Policy Act process and was included in the analysis. There was no pipe or separator material used. The harvest was a whole-tree thinning from below. Whole trees (10- to 24-inch diameter breast height) were used in the drainage. The material used was included under the contract. After the crossing was no longer needed, the material was removed with a heel-boom loader and processed at the landing. Standard erosion control measures were required. The material was required to be removed after use and before the first rain (a date was specified). Straw was required to be placed at the crossing above the apparent high water mark on both sides of the channel. Some breakage of limbs and tops was experienced, but all slash was removed from the drainage. The end result can be seen in figures 6 through 9. The water evident in the pictures is from a November rain 2 or 3 days before the pictures were taken. The rain event was almost 3 inches.
