All-Terrain and Utility Terrain Vehicle Safety: Alternative Vehicles for Towing Trail Grading Equipment

By Ellen Eubanks, Landscape Architect

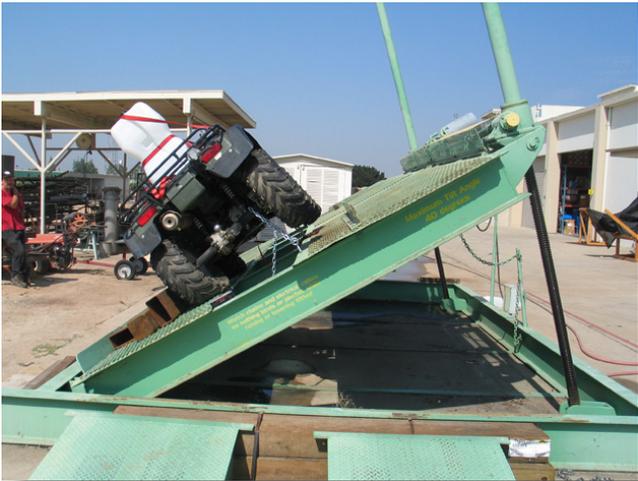
Figure 1—Tilt table shown at 40 degrees.

Each vehicle was tested on the SDTDC tilt table. We (SDTDC) conducted the tilt tests to determine the static-roll threshold of a vehicle. The angle at which the uphill tires lifted off the table's surface is the maximum angle of inclination (cross slope, hill climb) under static conditions. There is a strong relationship between the static-roll stability (determined by the tilt test) and the actual occurrence of rollovers in accidents (Winkler 2000). The SDTDC tilt table's maximum tilt is 40 degrees. See figure 1.

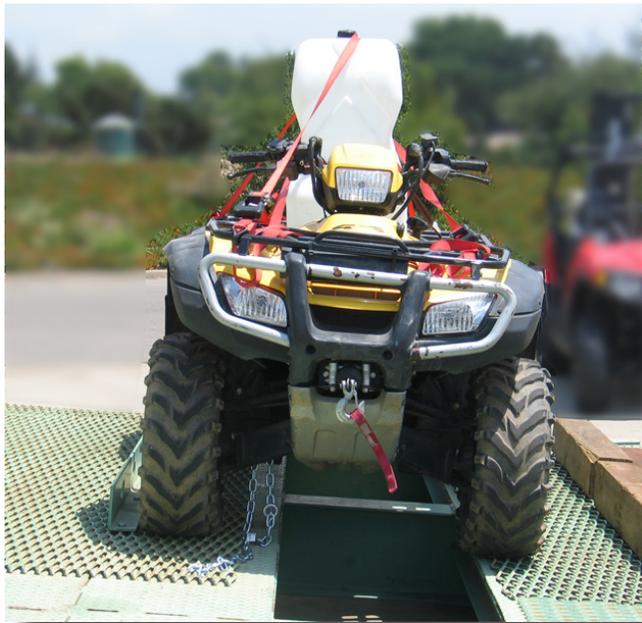
Figure A1—Foreman ES strapped and ready for the lateral test. There is a winch and a fire extinguisher on the front and a trailer hitch on the back that add weight.

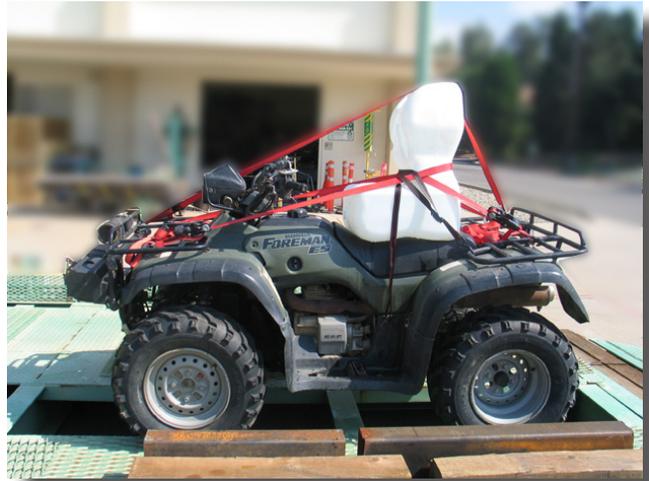
Figure A2—The Rubicon shown strapped during the lateral test. There is a winch on the front and a trailer hitch on the back that add weight.

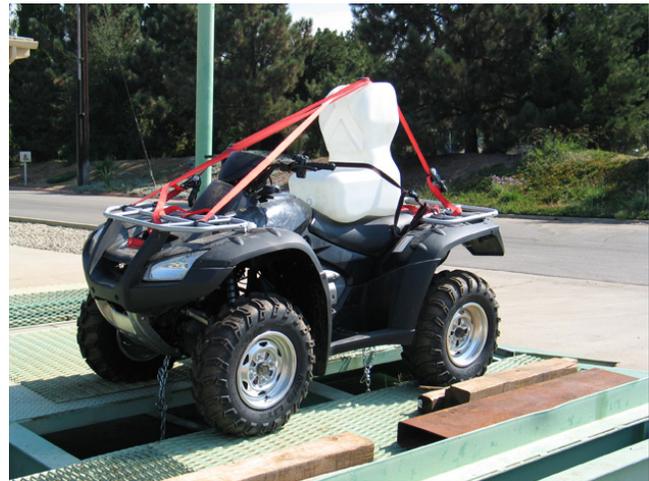
Figure A3—Rincon chained to the table for the lateral test.

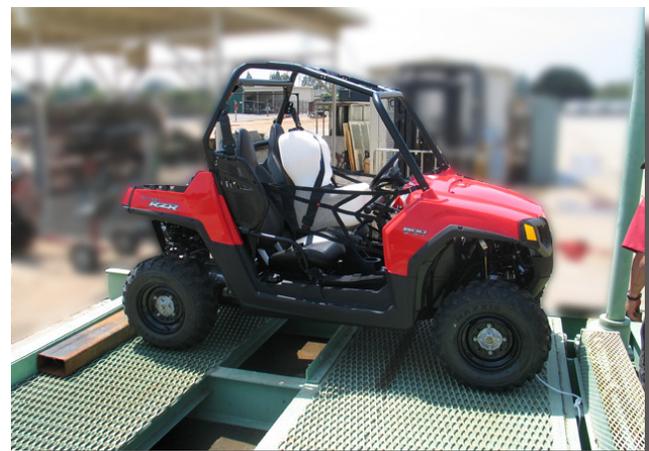
Figure A4—RZR with the dummy strapped in with a seat belt.

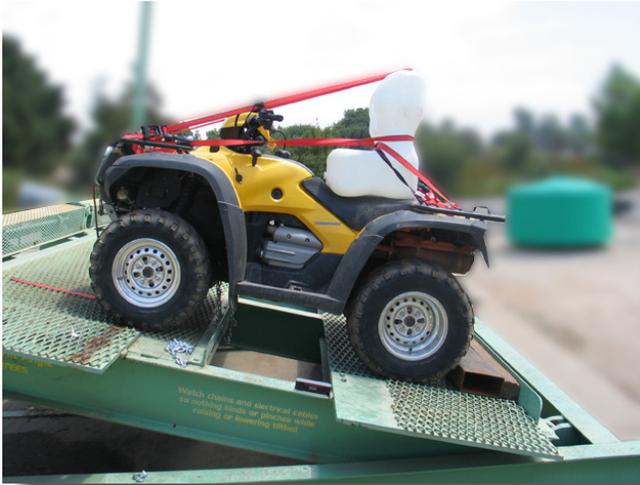
Figure A5—Dummy strapped for longitudinal test. Note the strap around the “neck” to keep the dummy from tilting backwards.

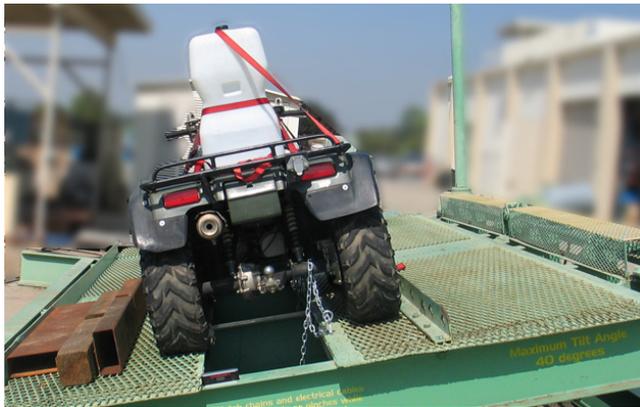
Figure A6—Some distortion in downhill tires on the Foreman ES.

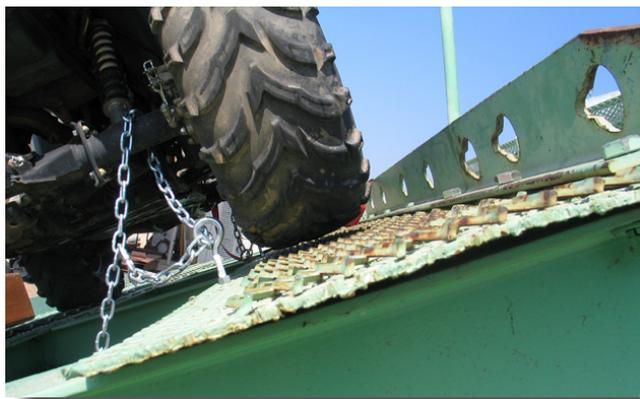
Figure A7—Foreman ES rear wheel lifted at 27.4 degrees.

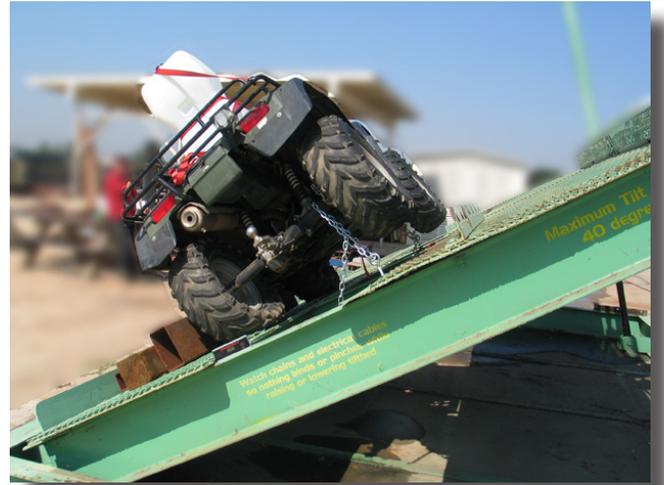
Figure A8—Foreman ES at rolling point, 30.9 degrees.

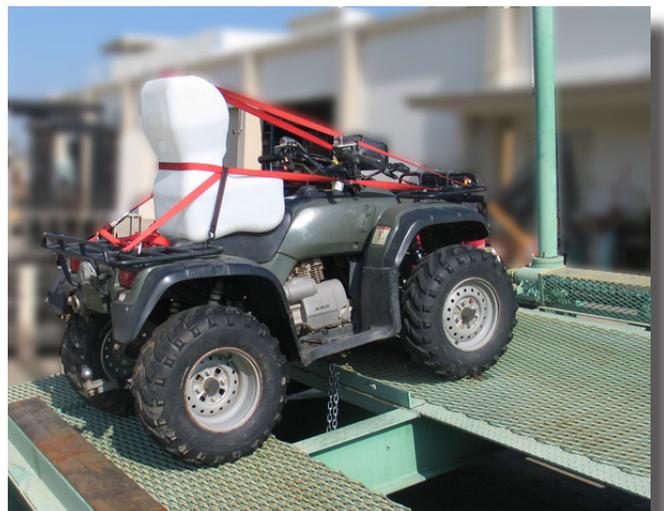
Figure A9—The Foreman ES beginning the longitudinal test. Notice that the rear tires are several inches from the blocks.

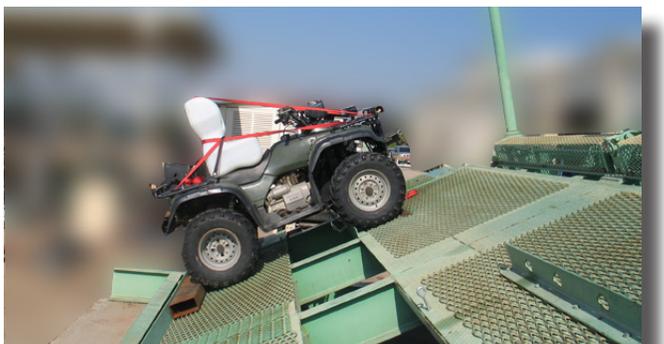
Figure A10—Because of the brakes releasing and catching, the Foreman ES’s rear tires at the end of the test are on the blocks at 40 degrees.

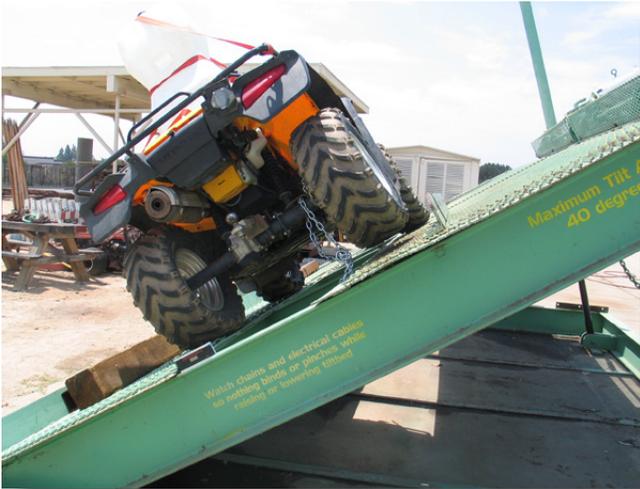
Figure A11—The Rubicon's rear wheel lifted at 27.5 degrees.

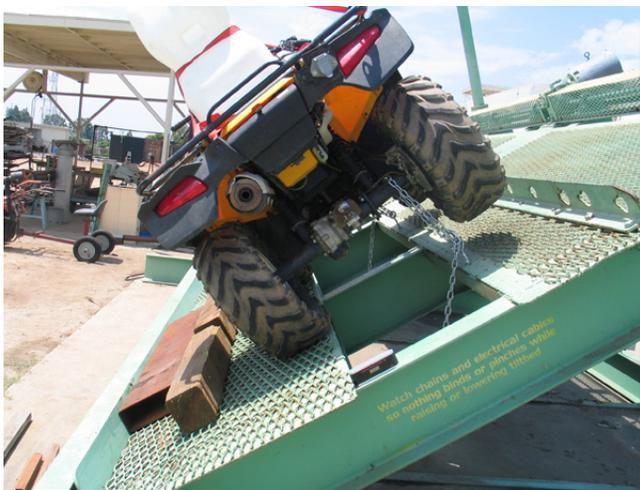
Figure A12—Rubicon ATV rolls at 34 degrees.

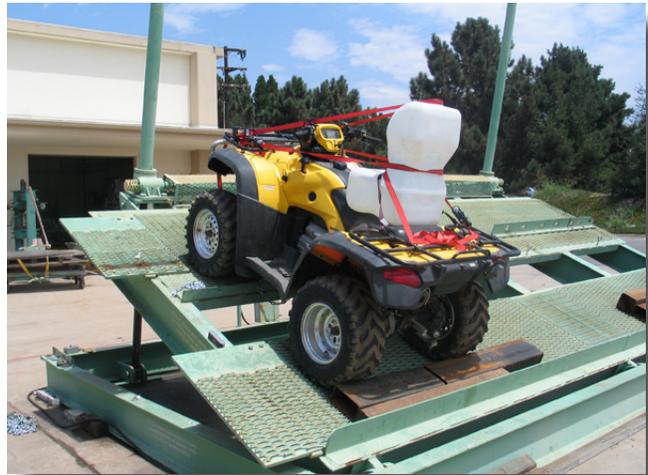
Figure A13—The Rubicon's rear tires on blocks at 19 degrees.

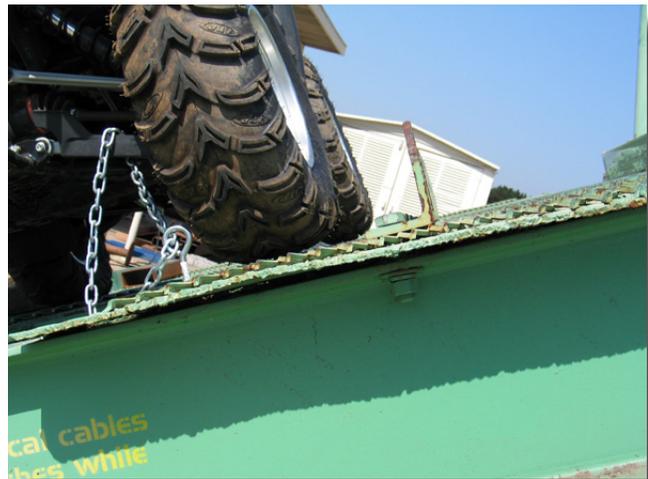
Figure A14—The Rincon front tire, in right portion of photograph, is barely off the table at 30.0 degrees.

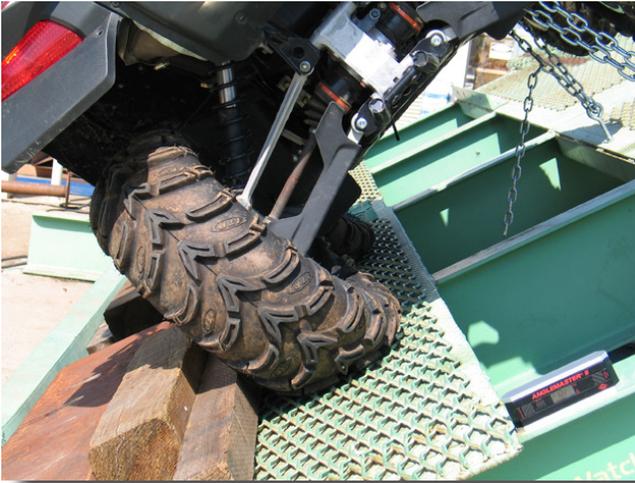
Figure A15—Notice tire distortion.

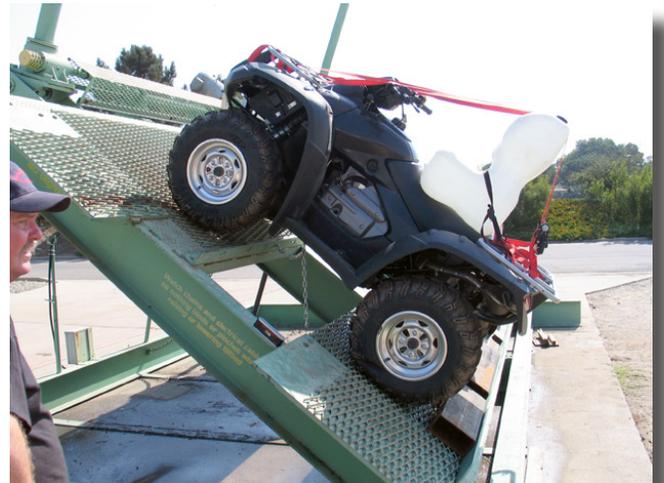
Figure A18—The Rincon tilted at 40 degrees.

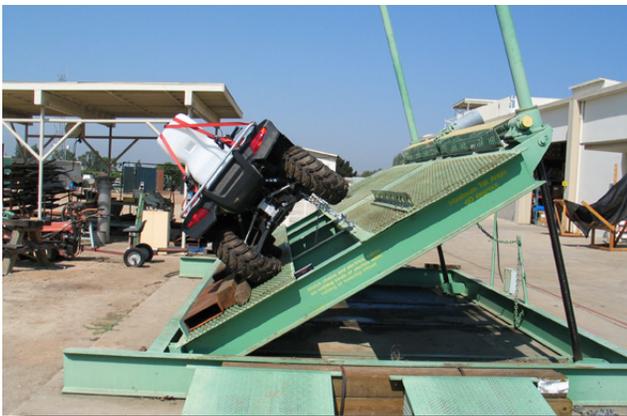
Figure A16—The Rincon rolls at 32.2 degrees.

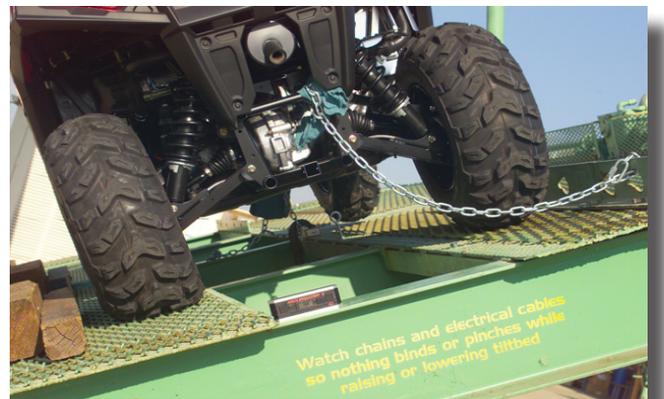
Figure A19—Front tire of the RZR is off the table at 30.8 degrees.

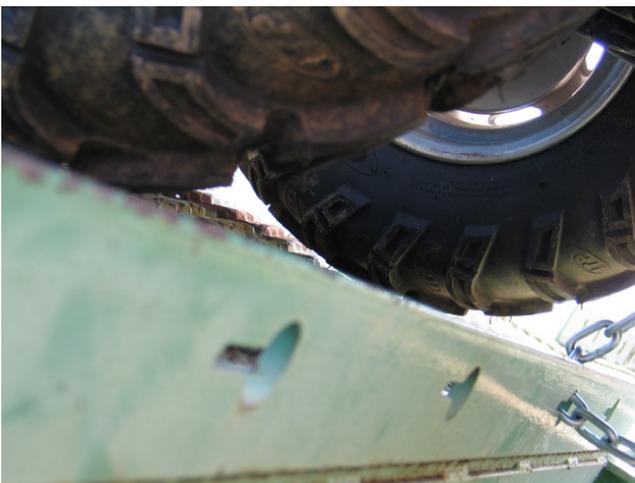
Figure A17—The right front tire lifted off at 39.5 degrees.

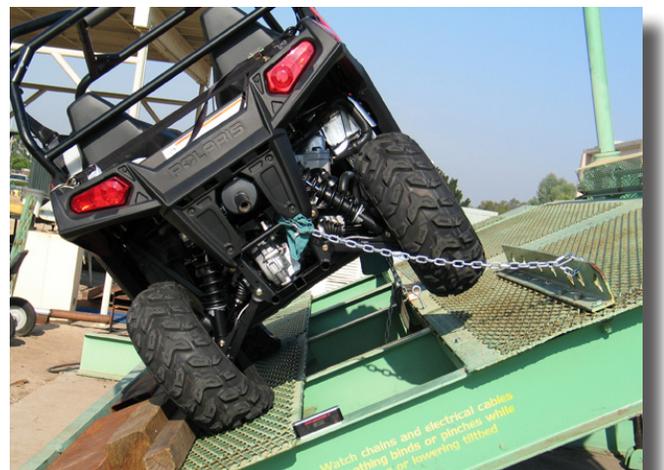
Figure A20—The RZR rolls at 32.9 degrees.

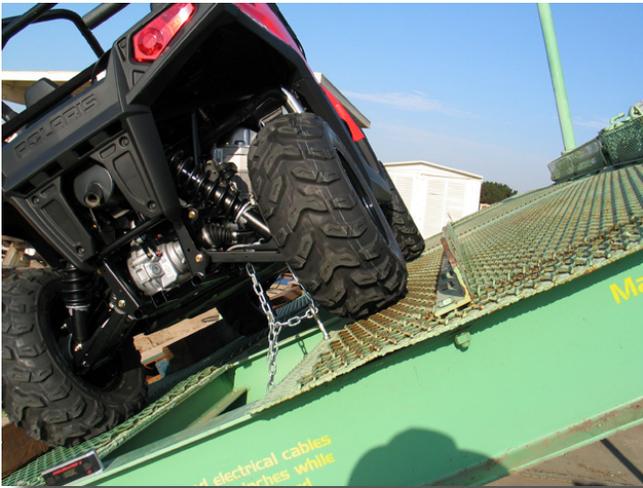
Figure A21—The right front tire lifted off at 30.8 degrees.

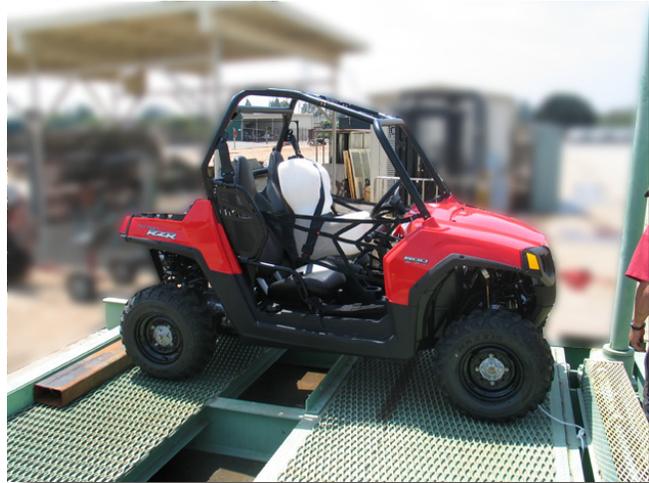
Figure A22—The RZR ready to begin the longitudinal test.

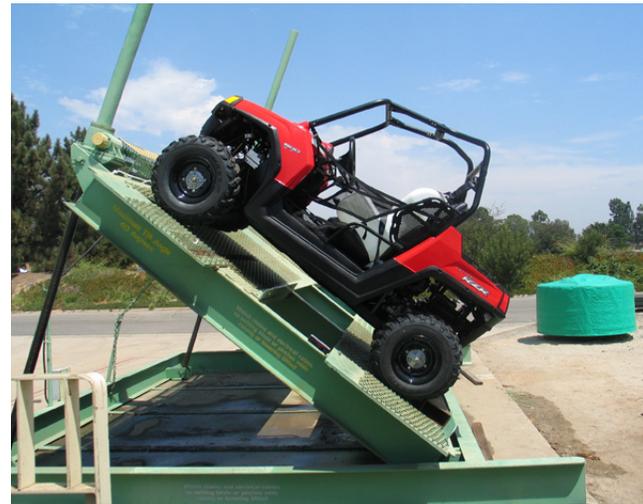
Figure A23—RZR at 40 degrees. Security ropes are still slack and RZR is on blocks.
