Trenchless Culvert Replacement Using a Horizontal Pipe-Driving System: Agness Road, Rogue-Siskiyou National Forest

—Rob Piehl, P.E., geotechnical engineer, Willamette, Suislaw, and Mt. Hood National Forests, Eugene, OR; Gary Freitas, civil engineering technician, Rogue-Siskiyou National Forest, Medford, OR; and Richard VanDyke, P.E., geotechnical engineer, retired, Eugene, OR. Photos by Gary Percy, civil engineering technician, retired, Medford, OR.

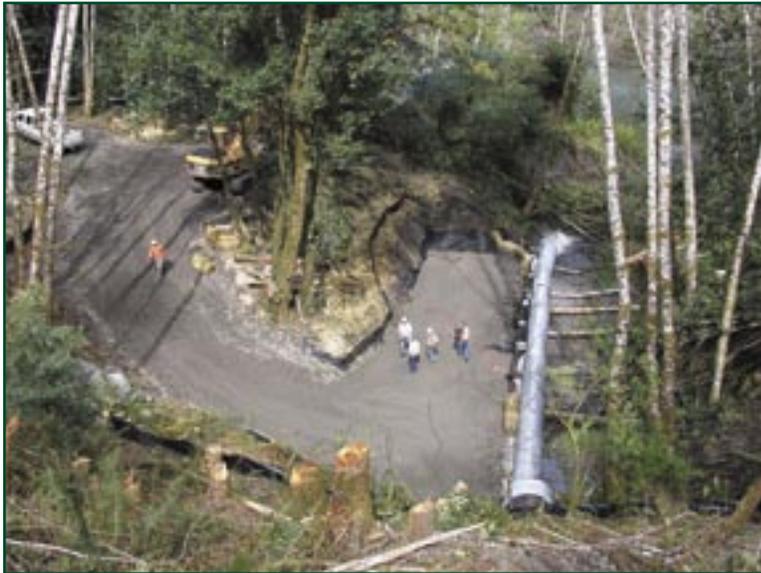
Figure 1—View from the road: the stream bypass pipe, the access road, and the launch pad.

when turbidity was noticed downstream. The crew took water samples daily and compared turbidity measurements to samples upstream. Figure 1 shows the view from the road.

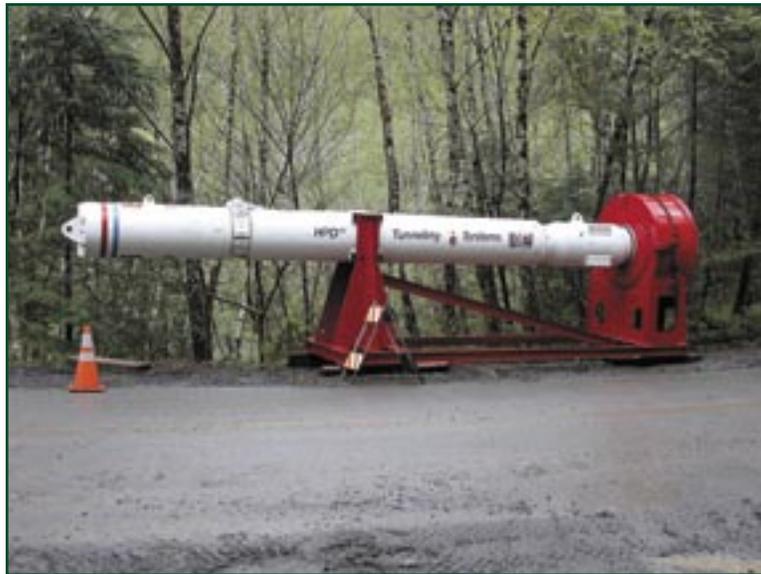
Figure 2—The hammer with red helmet attached to the end.

A modified piledriver hammer with 6 million pounds of thrust drove the casing. This piledriver is designed for high-capacity piles, such as those used in offshore drilling platforms. The contractor modified the piledriver to operate horizontally by changing some of its materials to accommodate the increased friction between the sliding portion of the hammer and the bore. The hammer is powered by compressed nitrogen gas that supplies energy to slide the hammer when it expands. The dynamic force moves through a steel helmet (figure 2) and a specially designed metal cone (the shoe) that fits the hammer to the full circumference of the casing.

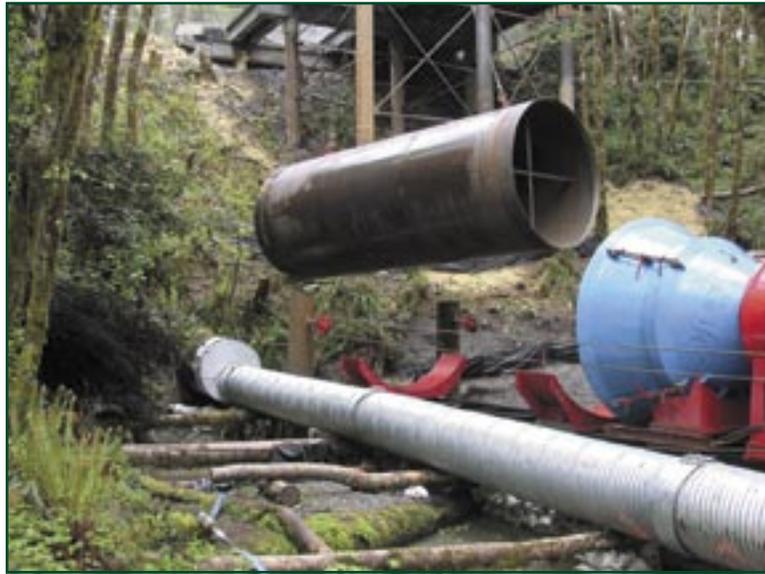
Figure 3—The first section of casing is being lowered onto the cradle with the crane. The blue cone at the right is the shoe, which transfers force from the hammer to the casing.

A steel frame supporting two H-beams formed a track to align the hammer and support the weight of the casing. The casing rested on a cradle, which slid along the upper flanges of the H-beams when it was being driven (figures 3 and 4). To keep the casing from bouncing upward, the crew attached the trailing end of the casing to the track with ten 18-inch-diameter pipe piles, designed for soil and pipe friction.

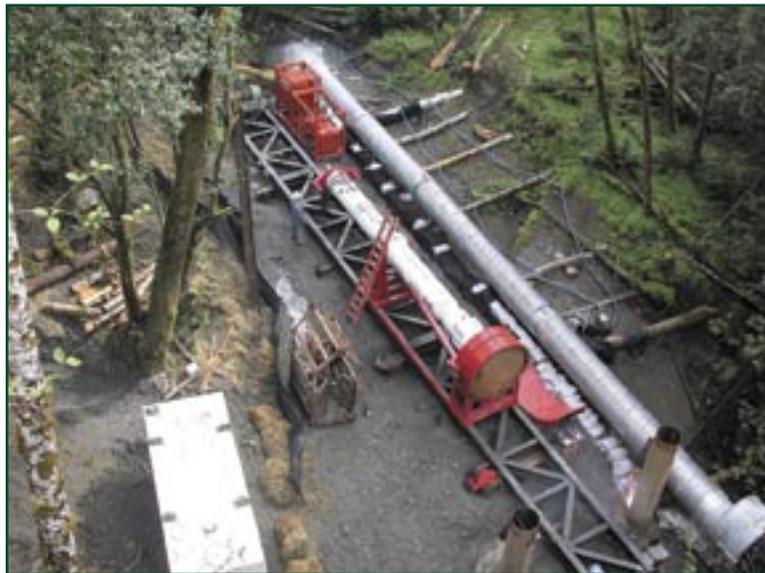
Figure 4—This view shows the operation from the other side of Quosatana Creek. The green vibratory pile hammer is suspended from the crane as it drives pipe piles.

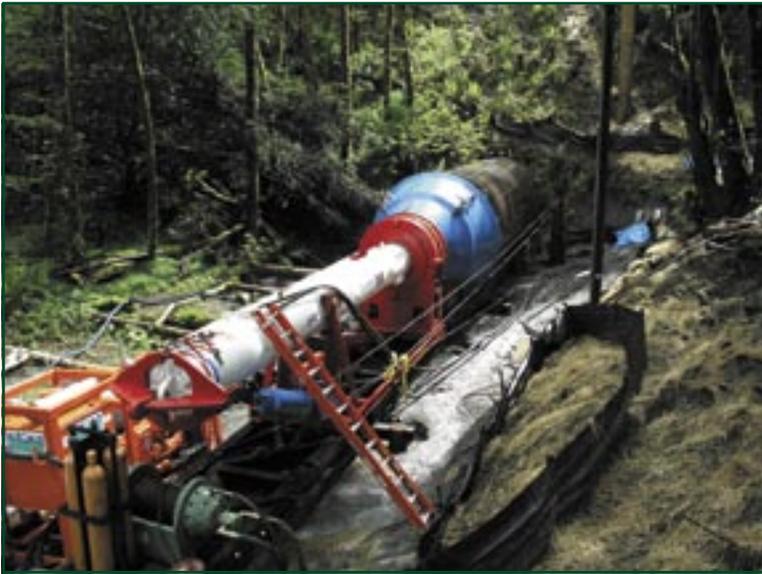
Figure 5—The hammer setup is complete. The first pipe section is in place before driving starts.

The crew used the large crane to place the hammer and the casing sections on their cradles. A winch mounted on the track slid the hammer assembly forward and pulled the hammer back to allow casing sections to be added. The crew drove two 24-inch-diameter pipe piles at the toe of the slope to support pulleys to winch the hammer forward. Because the cone that abuts the casing is merely pressed against the casing during driving, the winch must pull the hammer forward after every blow to maintain a snug fit. Figures 5 and 6 show the complete hammer set up and in operation. Figures 7 through 10 demonstrate the final phases of the project.

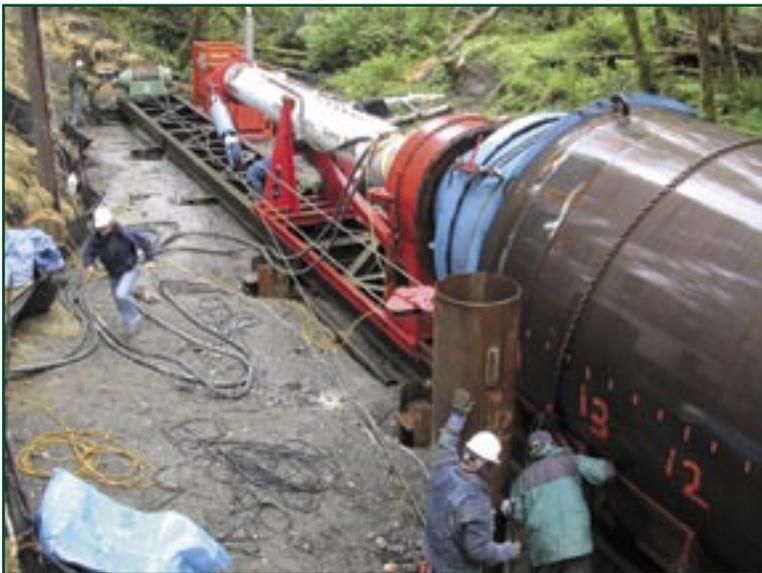
Figure 6—The hammer in action. The casing, shoe, helmet, and hammer are in place on the track. The winch is set up at the end of the track and takes up the slack in the system between hammer blows.

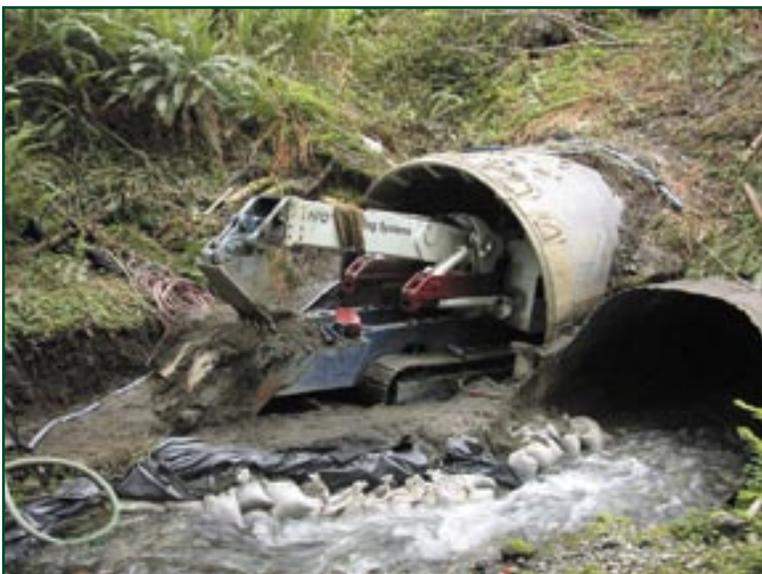
Figure 7—A tunnel excavator completes the job of cleaning out the new casting. It scoops up soil onto a belt between its tracks and transports the soil to the other end of the casing where the soil is loaded onto a truck.

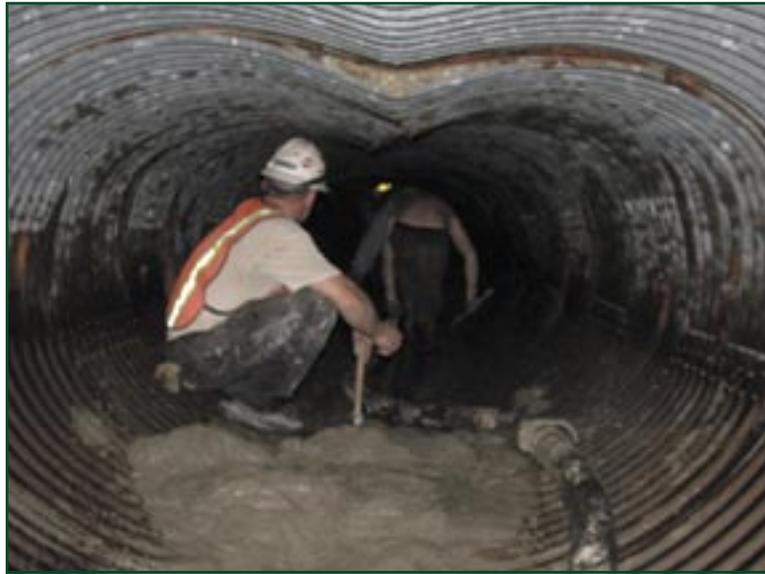
Figure 8—Grouting the old pipe. Note its condition.

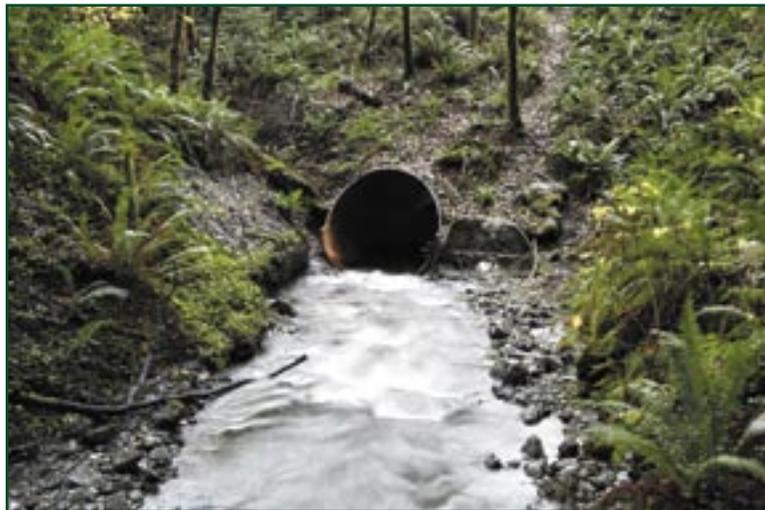
Figure 9—The new pipe's inlet. The grouted old pipe is just to the right.

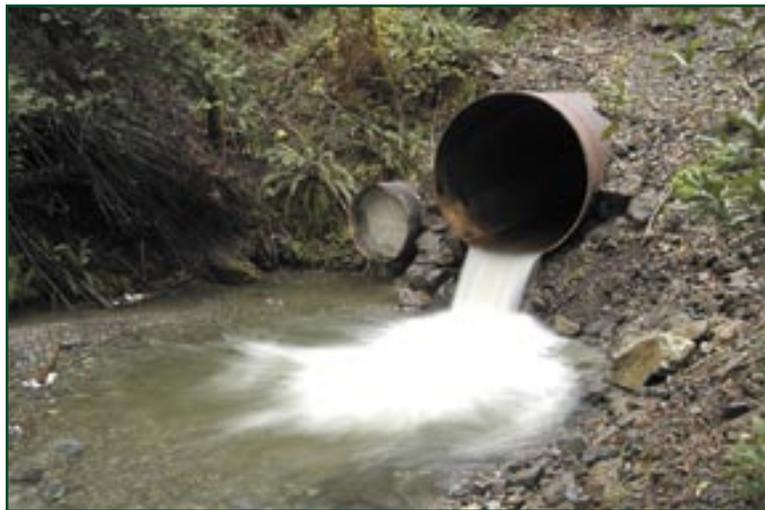
Figure 10—The new pipe's outlet. The grouted old pipe is to the left.
