## Appendix A—Vehicle Entrapments Study Plan

### MTDC Project #6287 Vehicle Entrapments

## Appendix B—Characterizing Gases Generated in Vehicles and Fire Shelters

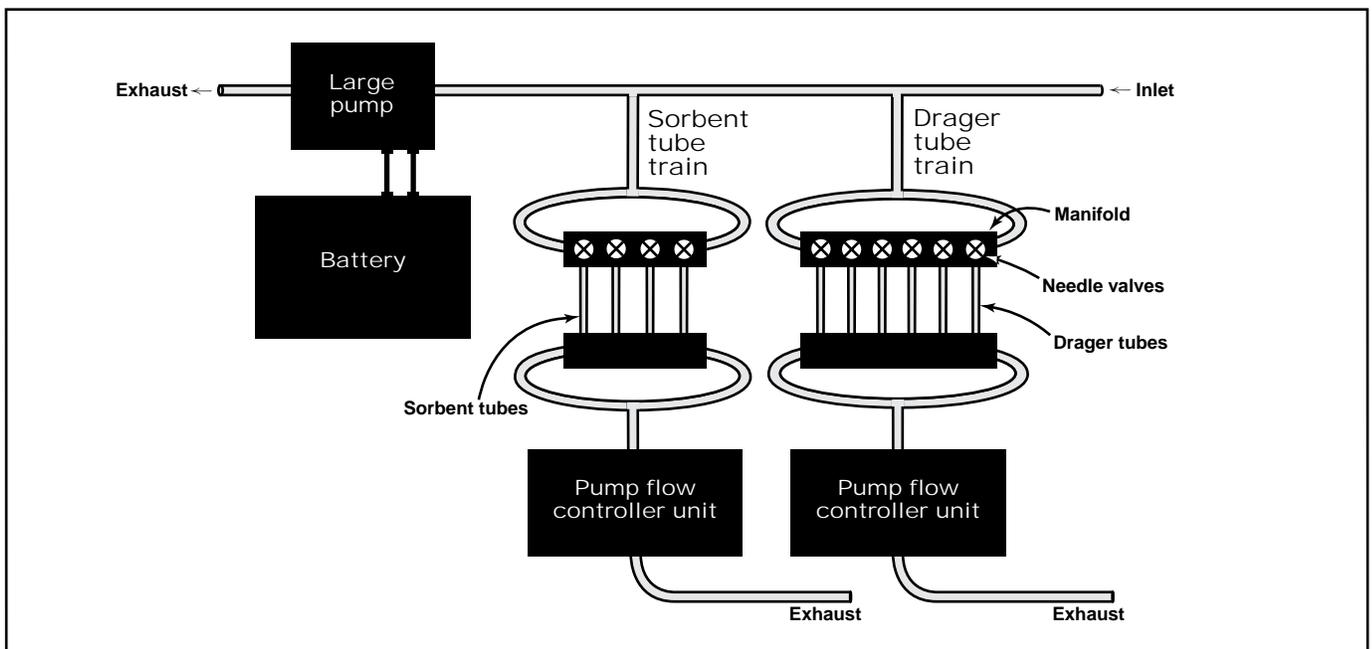
Figure 1—Schematic of the new gas sampling system used during the entrapment tests in California.

Both the Drager and sorbent tubes in this package require a constant gas flow to be delivered through the tubes, unlike the passive Drager tubes used in the first test. A system of pumps, flow controllers, tubing, and a valved manifold system supplied the air flow. Three pumps were required for each gas sampling package (Figure 1). A 12-volt pump pulls a steady gas stream of 2 liters per minute into the system through 1/4-inch ID Tygon tubing. This pump was powered by a 12-volt Power Sonic

rechargeable gel battery that had a lifetime of 8 hours under continuous usage. Excess gas flow is channeled to an exhaust port. From this main gas flow, two smaller pumps pull the required air flows through 1/8-inch Tygon tubing to either the sorbent tube sampling train or the Drager tube sampling train. The tubes in each sampling train were arranged in parallel. Each tube has specific flow requirements that are controlled by a valved manifold. The flow across each tube is set by its associated needle valve on the manifold. The pumps pulling flow across each sampling train also can be programmed to adjust flow

control. This guarantees delivery of a constant preset flow rate if the inline Teflon filter collects a great quantity of particulate or if there is a minor blockage (such as pinched tubing) in the system. Once gas has passed through the sampling trains, the gas is channeled to the exhaust ports.

Outer packaging and a long-distance flow delivery system (umbilical) were needed to help the instrumentation survive the hazardous fire environment. The components of the system were mounted on an aluminum sheet that slid inside an old steel military surplus ammunition box. The system was oriented such that the box sits on its side in the field or when working with the interior components. A Swagelok bulkhead fitting provided the connection for interior and exterior tubing. The exterior PTFE Teflon tubing was 24 feet long. A soft ceramic sheath protected it from high temperatures. The sheathing must withstand temperatures as high as 1400 °C where it is exposed in the vehicle cab and shelter. The umbilical was supported by an aluminum pipe that extended from the cab, through the floor to the ground. A piece of aluminum over the end of the pipe protected the umbilical and interior tubing while allowing gases to freely enter the tubing.

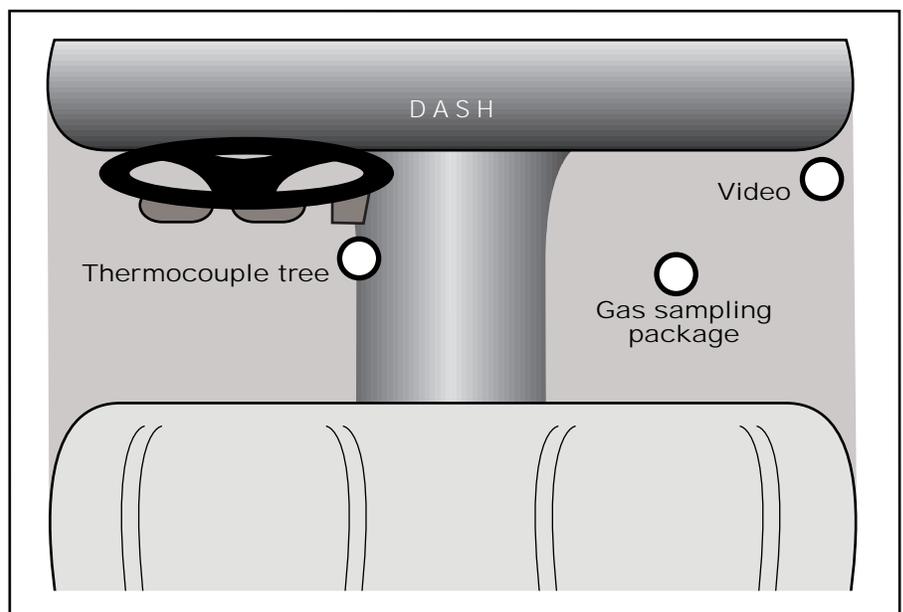
Figure 2—Overhead view of the instrumentation positions in the cab of the vehicle. The aluminum conduit with wiring or tubing inside was fitted through these holes and served as support and protection.

The gas detection system was deployed in a standard aluminum fire shelter and in the Ford Patrol. The umbilical was supported by aluminum pipes inside the vehicle cab (Figures 2 and 3). The remainder of the umbilical stretched across the road to the gas sampling

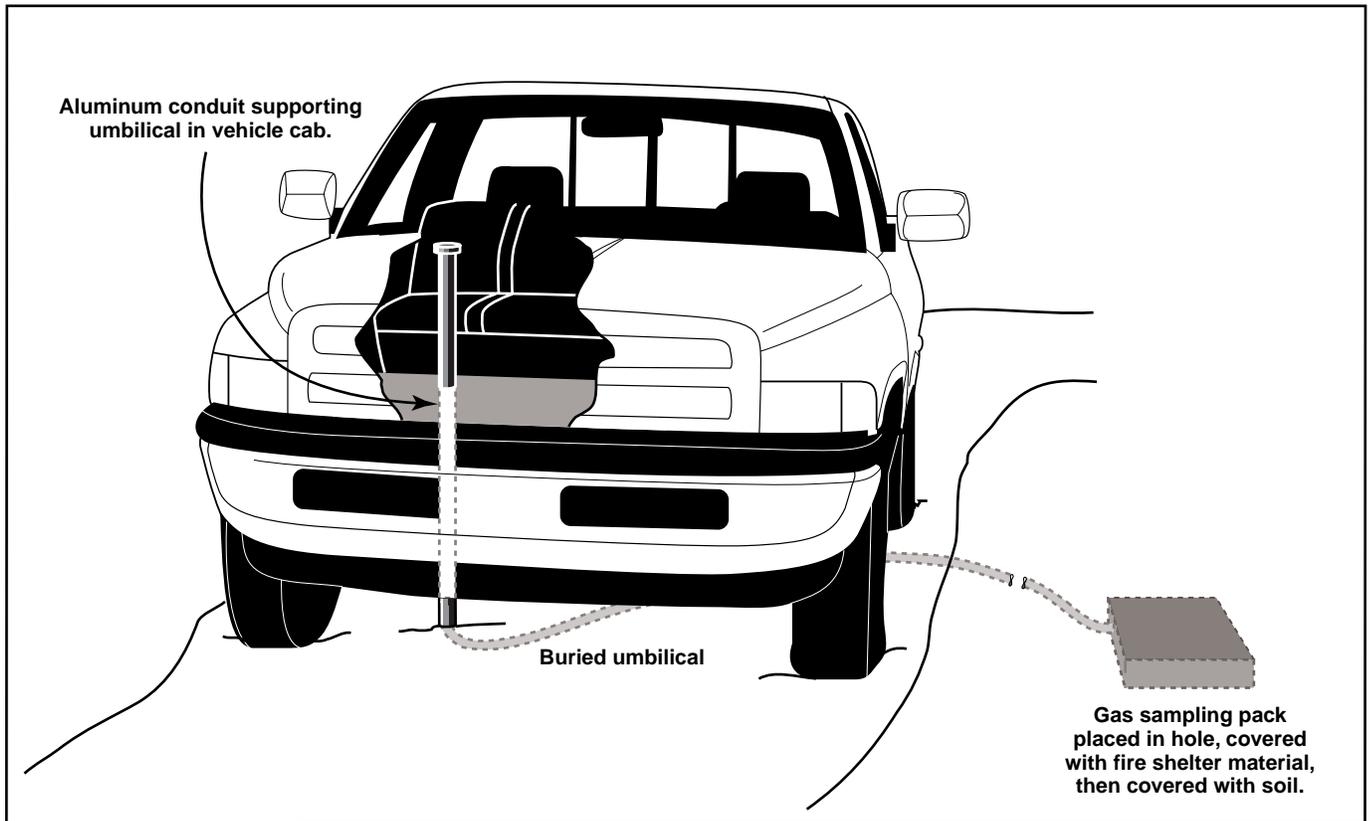
Figure 3—Cutaway view of the gas sampling assembly inside the aluminum conduit in the cab of the vehicle, and underground.

package, which was on the cut bank side of the road. The instrumentation was on the lee side of the vehicle and shelters with respect to the direction of the fire's expected approach. Before the fire, gas flow across each tube and across the whole train was calibrated. A BIOS dry calibration, piston-type flow meter was used for the calibrations. As close to ignition time as possible, the flow controller was programmed, the pumps were started, and the umbilical and gas box were buried.
