Buffering the Buffer¹

Leslie M. Reid² and Sue Hilton³

Abstract: Riparian buffer strips are a widely accepted tool for helping to sustain aquatic ecosystems and to protect downstream resources and values in forested areas, but controversy persists over how wide a buffer strip is necessary. The physical integrity of stream channels is expected to be sustained if the characteristics and rates of tree fall along buffered reaches are similar to those in undisturbed forests. Although most tree-fall-related sediment and woody debris inputs to Caspar Creek are generated by trees falling from within a tree's height of the channel, about 30 percent of those tree falls are triggered by trees falling from upslope of the contributing tree, suggesting that the core zone over which natural rates of tree fall would need to be sustained is wider than the one-tree-height's-width previously assumed. Furthermore, an additional width of "fringe" buffer is necessary to sustain appropriate tree-fall rates within the core buffer. Analysis of the distribution of tree falls in buffer strips and un-reentered stream-side forests along the North Fork of Caspar Creek suggests that rates of tree fall are abnor

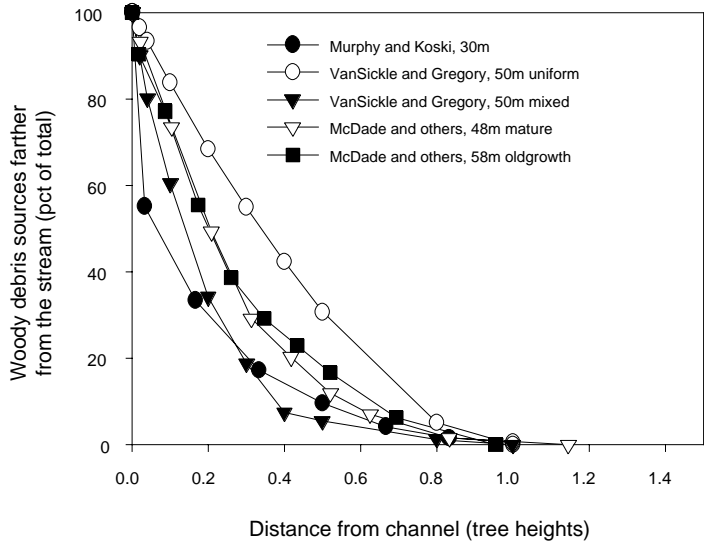
Figure 1—Location of woody debris sources with respect to channel edges. Measurements by Murphy and Koski (1989) were reported by Spence and others (1996) to have been from a forest with a 30-m canopy height; results from VanSickle and Gregory (1990) are modeled; results from McDade and others (1990) are from field measurements.

Studies in Oregon (McDade and others 1990, VanSickle and Gregory 1990) and Alaska (Murphy and Koski 1989) demonstrate the relative importance of in-falling trees as a function of distance from a channel: trees near the stream have a much greater likelihood of introducing woody debris than do those farther away (*fig. 1*). Because introduction of woody debris disturbs banks and diverts channel flows, in-channel erosion is likely to be modified by in-fall, and the sediment input triggered by this source is likely to vary with distance from the channel in the same way as input of woody debris. The first objective of this study was to define variations in wood and sediment input to channels as a function of the distance of the source tree from the channel.

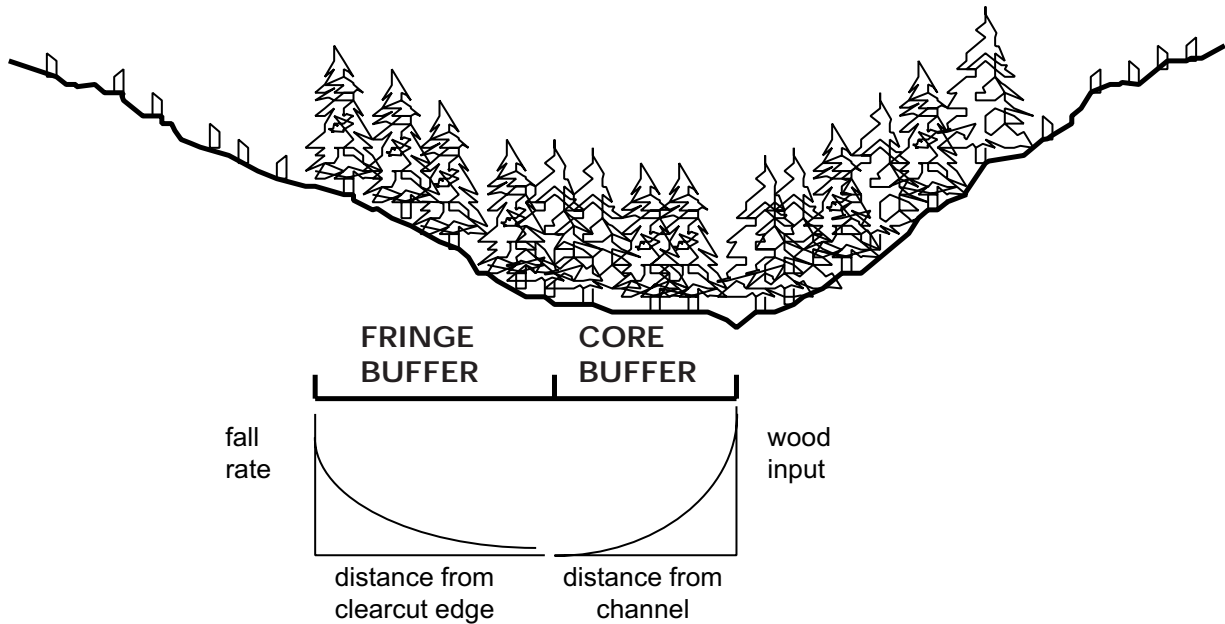
Figure 2—Hypothetical example of “core” and “fringe” buffer zones intended to sustain the physical integrity of the channel system. The core zone extends from the channel to the maximum distance of sediment or wood input from falling trees, and the fringe zone extends beyond the core far enough to maintain appropriate tree-fall rates within the core zone.

Buffer widths appropriate for sustaining the physical characteristics of the stream channel then could be designed using these two kinds of information. The minimum width of the core buffer could be selected as the maximum distance from which tree-fall sediment and debris enter the stream (*fig. 2*), and the minimum width of the fringe buffer would be the distance over which edge effects influence rates of tree fall inside a stand (*fig. 2*). The final objective of the study was to use the results of the first two objectives to estimate core and fringe buffer widths that would be capable of sustaining an appropriately functioning riparian buffer that is itself capable of maintaining an appropriately functioning physical stream environment.

species and sizes, as required to sustain the physical integrity of the stream channel. Although 96 percent of the in-falling wood is derived from within one tree-height's distance of the channel, about 30 percent of these falls resulted from trees being hit by another falling tree. Because the triggering trees could have been located at even greater distances from the channel, this pattern indicates that an additional increment of width is required to sustain the appropriate fall rate of potential trigger trees. If this additional width is not considered during the design of a fringe buffer, accelerated fall rates of marginal trigger trees would increase rates of secondary tree fall within the core zone.

How wide a buffer is wide enough? In this case, preliminary results suggest that a one-tree-height width of uncut forest that is allowed to sustain appropriate fall rates would include 96 percent of the potential woody debris sources for the channel system. Combining the pattern of source trees with the distribution of triggering tree-fall distances indicates that an additional 0.1-tree-height's width would be needed to preserve the fall rate of trigger-trees that is needed to sustain the 96 percent input rate (*fig. 4*). Beyond this, an uncut fringe-zone of 3 to 4 tree-height's width would be necessary to ensure that the fall rate within the core zone is within a factor of 2 of background rates (*fig. 6*). Thus, a total no-cut zone of at least 4 to 5 tree-heights' width would appear to be necessary if woody debris inputs are to be maintained at rates similar to those for undisturbed forested channels. Such provisions might be necessary also along property boundaries if neighboring landowners are to be protected from excessive wind damage.

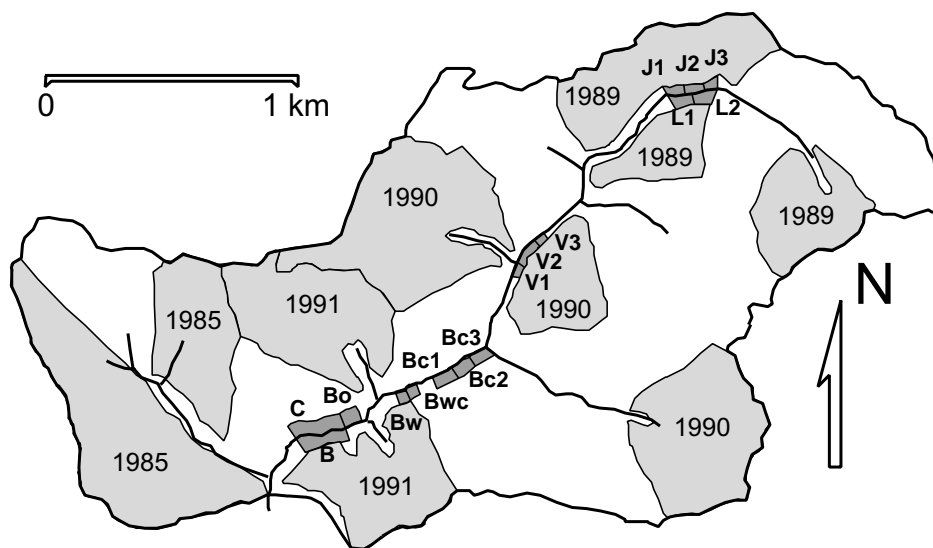
Figure 3—Location of the North Fork Caspar Creek tree-fall study plots, showing clearcut unit boundaries, year cut, study plots, and plot names. See table 1 for plot descriptions. Plot JL is located on the floodplain between the J plots and the L plots.

Demonstration State Forest, Mendocino County, California (fig. 3). The watershed is underlain by Cretaceous to Oligocene sandstones and shales of the Franciscan assemblage, on which are developed loam soils which typically have depths of 50 to 200 cm. Drainage density is about 4 km/km², and portions of the streams are inset into locally developed inner gorges. Valley-bottom width along the mainstem channel generally ranges between 5 and 15 m, and, where developed, inner gorge slopes have slope-lengths of about 40 to 100 m and gradients of 30° to 40°. Hillslopes beyond the inner gorge range in gradient between 15° and 30° with a maximum slope length of about 350 m.

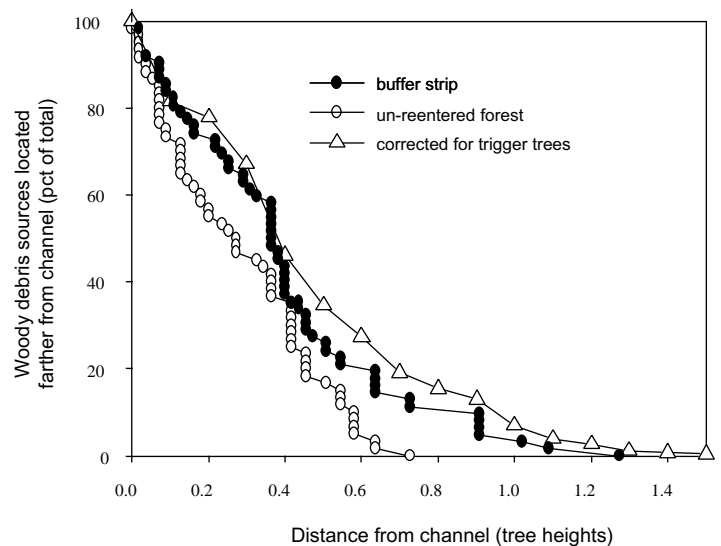
Figure 4—The distribution with respect to the channel edge of sources for woody debris inputs to North Fork Caspar Creek from buffer strips and un-reentered forest. The recalculated curve accounts for inputs from tree falls triggered by trees falling from farther upslope. An average canopy height of 55 m is assumed.

Measurements from the long-channel survey indicate that fallen trees influenced the stream channel by introducing woody debris from as far as 40 m from the channel in un-reentered forests and 70 m along buffer strips (fig. 4). About 90 percent of the instances of debris input occurred from falls within 35 m of the channel in un-reentered forests and within 50 m of the channel in buffer strips. The pattern for un-reentered forests approximately follows the distributions measured by McDade and others (1990) for mature and old-growth forests (fig. 1). However, the distribution predicted by VanSickle and Gregory (1990) for a mixed-age conifer forest (fig. 1) underrepresents the observed importance of trees falling from greater distances. This discrepancy is probably due to the observed tendency of Caspar Creek trees to fall downslope, whereas the modeling exercise assumed a random distribution of tree-fall directions (VanSickle and Gregory 1990). The distribution of source distances observed for buffer strips at Caspar Creek demonstrates higher rates of input at greater distances than measured or modeled previously, possibly reflecting the combined effects of high tree-fall rates in the selectively logged portion of the buffers and the predominantly downslope orientation of falls.

Tree falls were triggered by another falling tree in about 30 percent of the surveyed cases. Thus, even though the width of the zone of direct influence to the channel is a distance approximately equal to a tree's height, the importance of secondary tree falls expands the width of buffer strip required to maintain the physical integrity of the channel. The distribution of input sources was thus recalculated to account for the influence of trigger-trees (fig. 4).

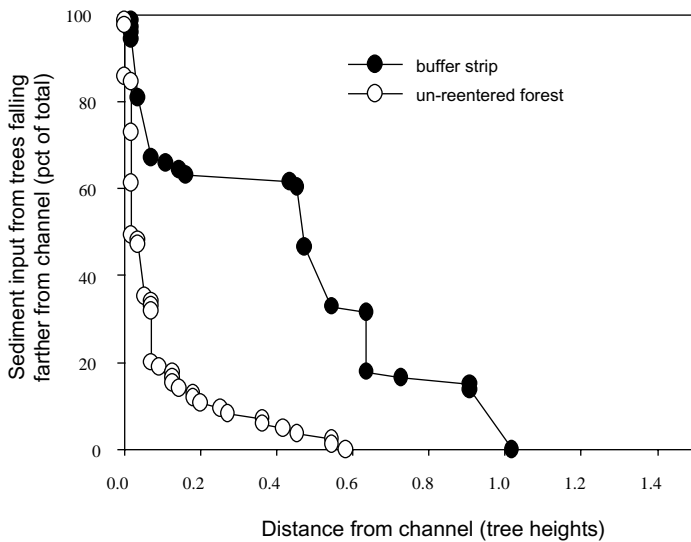
Figure 5—The distribution with respect to the channel edge of tree falls associated with sediment production to North Fork Caspar Creek from buffer strips and un-reentered forest. Sources are weighted by the approximate volume of sediment contributed. An average canopy height of 55 m is assumed.

in the channel. At low to moderate rates of debris loading, sediment input from the latter source is expected to be proportional to the amount of woody debris introduced to the channel. Sediment input from root-throw depends strongly on the proximity of the tree-throw mound to the channel. In general, only those uprooted trees originally located within a few meters of the channel contributed sediment from rootwads. Observations after the 1995 storm suggest that 90 percent of the sediment introduced directly by tree fall in the un-reentered forested reaches originated from within 15 m of the channel, while in buffer strips, sediment was introduced by trees falling from considerably farther away (fig. 5). Rates of direct sediment input by tree fall during the storm were on the order of 0.1 to 1 m³ of sediment per kilometer of main-stem channel bank.

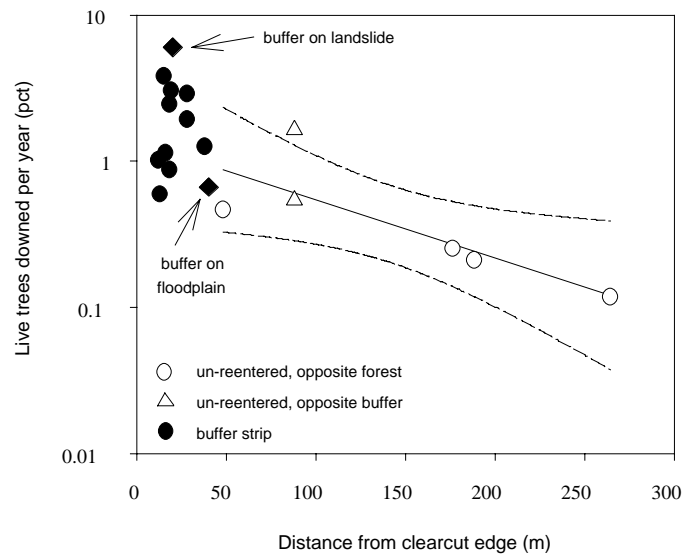
Figure 6—Probability of failure of live trees as a function of the distance between the center of each study plot and the edge of the nearest clearcut. The regression line and 95 percent confidence band are calculated for un-reentered plots (open symbols); data from buffer-strip plots are not included in the regression.

The distribution of fall rates within un-reentered stands was then examined to determine whether the influence of the clearcut boundary persisted even farther into the stands. In un-reentered stands (fig. 6, open symbols), average fall rates (R , percent downed per year) are correlated with the distance between the plot center and the nearest clearcut edge (x , meters):

$$R = 1.36e^{-0.00915x} \quad r^2 = 0.66 \quad (1)$$

However, the trend of the relation shown in figure 6 suggests that the background rate has not been fully achieved by 264 m into the stand, the distance represented by the most isolated of the study plots. The potential minimum background rate can be estimated using the assumption that the influence of a clearcut edge would not be felt beyond a ridge. Extrapolation of the relation

At this point, results of the study are preliminary, and they reflect conditions in a single watershed. Relationships such as that shown in *figure 6* will need to be tested in other areas. Sites will also need to be monitored over a longer period. Because the partially cut buffers and nearby uncut stands now have significantly fewer standing trees than the more remote un-reentered stands, it is likely that the disturbed stands will eventually start producing less woody debris. Additional information concerning debris mobility, decay rates, stand development, and stand-age-dependent mortality could be used to model future changes in debris input, allowing assessment of future influences on channel processes.

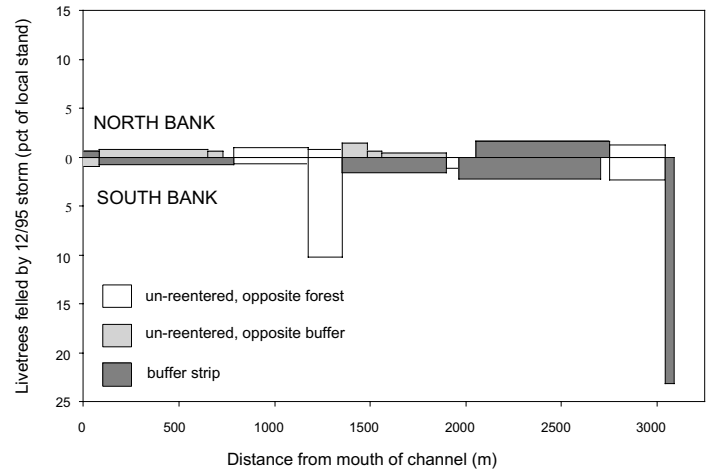
Figure 7—Distribution of tree falls along North Fork Caspar Creek during the storm of December 1995 in terms of probability of failure for a live tree. High rates at 1300 m and 3050 m represent localized concentrations of very intense blowdown, possibly reflecting the influence of localized wind eddies.

Data from the post-storm survey also indicate that in-fall frequencies from the north bank were generally lower than those from the south bank. The pronounced tendency of trees on both north- and south-facing slopes to fall downslope suggests that the larger angle between buttressing roots and bole may provide less resistance to failure in a downslope direction. Failure may thus be most likely when strong winds blow downslope. In addition, any

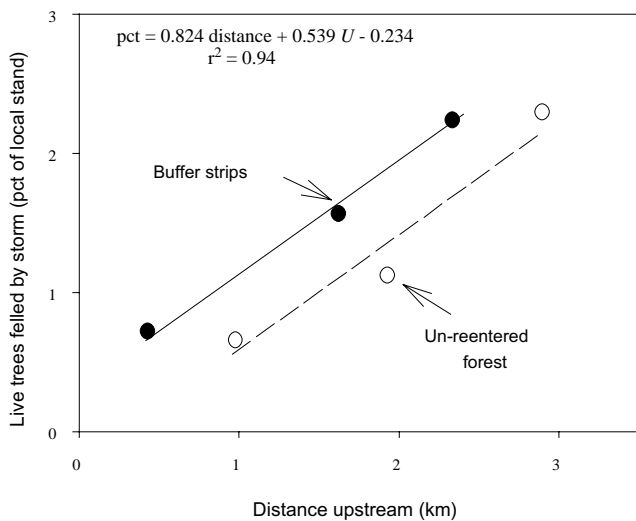
Figure 8—Tree-fall rates from the December 1995 storm in buffer strips and un-reentered forest stands along the south bank of North Fork Caspar Creek. Data from localized areas of extreme blowdown and from uncut forests opposite buffer strips are not included. The dummy variable, U, takes on a value of 0 for un-reentered forest and 1 for buffer strips.
