Street Trees of Los Angeles

E. Gregory McPherson, George Gonzalez, Greg Monfette, Ron Lorenzen

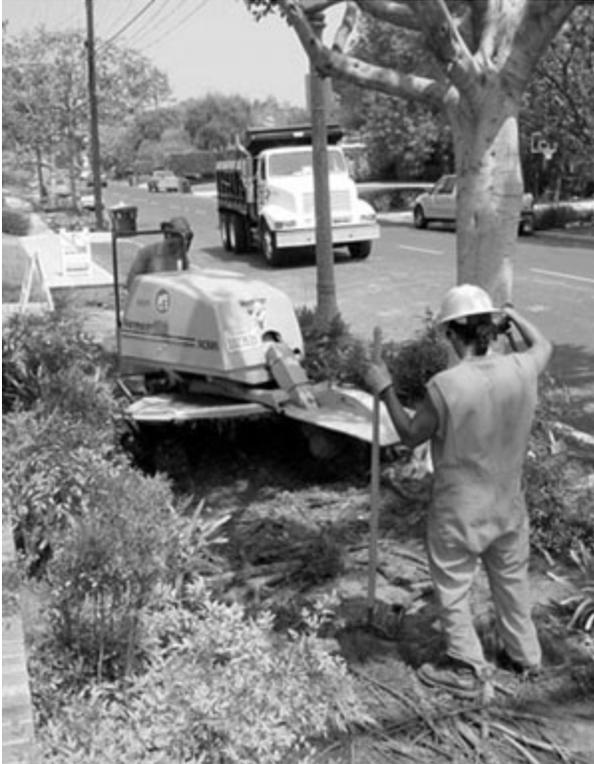
Figure 1. Straight line root pruning is done initially with a machine through one quadrant of the root zone. The cut is made adjacent to the edge of the sidewalk and only as deep as needed for the sidewalk repour.

Most root pruning occurs in a straight line through one quadrant of the root zone, usually adjacent to the sidewalk. The depth of cut varies with different tree root patterns but is limited to the depth required to replace the sidewalk. Initial root pruning is performed by a Vermeer 50TX root pruning machine (Figure 1). Clean final cuts are then made utilizing chain saws with carbide blades (Figure 2). Selective pruning of individual roots with chain saws is frequently performed prior to ramping sidewalks.

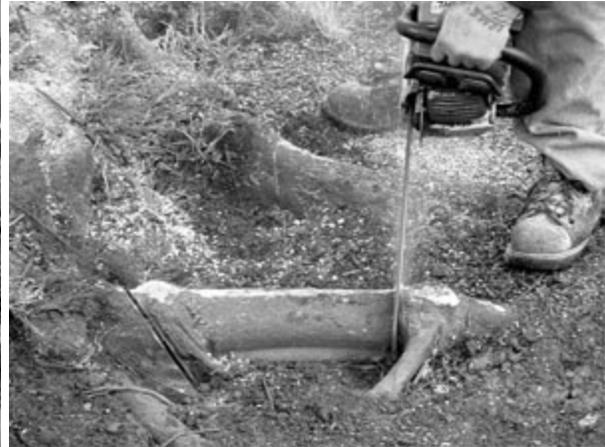
Figure 2. Hand saws or chain saws with carbide blades are used for cleaner final cuts than obtained with the root pruning machine. Selective pruning of individual roots by hand is frequently performed prior to repouring sidewalks.

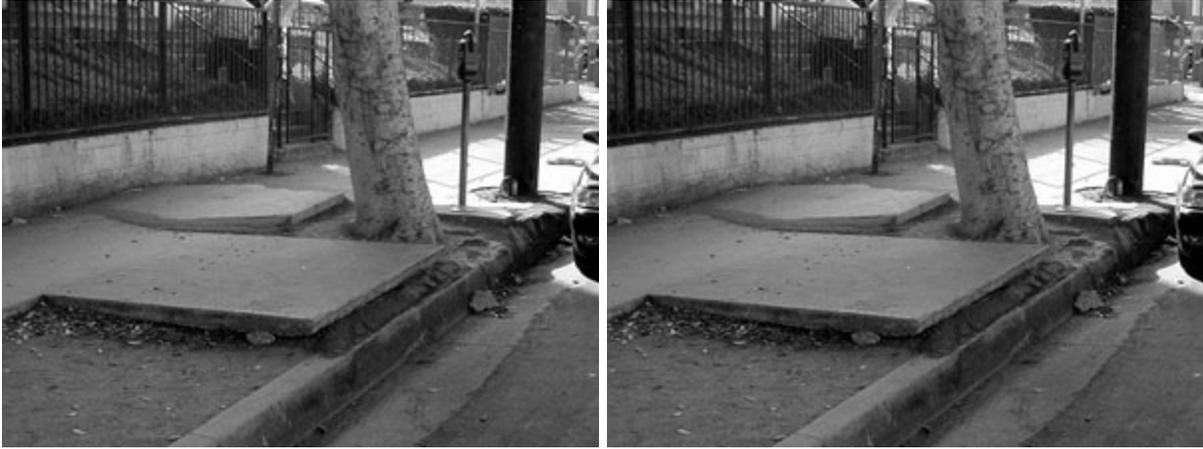
Figure 3. Wherever possible, cut-outs are enlarged during the sidewalk repair process. In this case, the cut-out was enlarged parallel to the street so access for pedestrians was not impeded. Although not possible here, meandering the sidewalk around the tree increases the cut-out size, but requires permission from the adjacent property owner.

“Borrowing” space from the adjacent sidewalk creates larger sidewalk cut-outs (Figure 3). This alternative reduces sidewalk width for a limited distance adjacent to the tree. The cut-out provides trees with a larger growing space, while reducing the size of pruned roots and their proximity to the root flare. ADA regulations on minimum sidewalk width can limit the use and size of cut-outs.

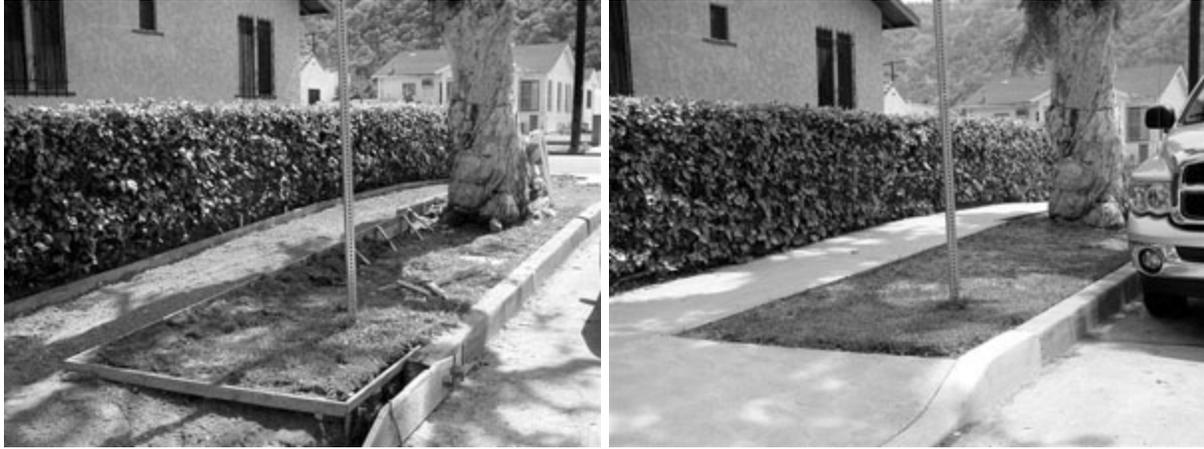
Figure 4. Ramping the sidewalk reduces the amount of root pruning and is used to preserve highly valued trees. Ramping delays damage but does not provide a long-term solution to sidewalk heaving.

Sidewalk ramping allows for existing roots to remain intact by re-pouring concrete over the roots to create a gradually sloped ramp (Figure 4). It is used when removal of roots would compromise the stability of a grade ‘A’ tree. Research in the City of Santa Monica suggests that sidewalk ramping does not prevent future damage but can delay it by five years or more (Warriner, 2001).
