# **STREAM INVENTORY REPORT**

## **CASPAR CREEK (NORTH FORK)**

A stream inventory was conducted during the summer of 1995 on the upper reach of Caspar Creek beginning at the confluence with the unnamed tributary locally known as South Fork Caspar Creek. This section of Caspar Creek is locally known and hereafter referred to as North Fork Caspar Creek. The inventory was conducted in two parts: habitat inventory and biological inventory. The objective of the habitat inventory was to document the habitat available to anadromous salmonids in North Fork Caspar Creek. The objective of the biological inventory was to document presence and distribution of juvenile salmonid species. Adult spawning surveys have been conducted on North Fork Caspar Creek. Spawning survey results are available from the California Department of Fish and Game, Region 3 Office in Yountville, California. The United States Forest Service, Redwood Sciences Laboratory, in Arcata also has fisheries and large woody debris data available.

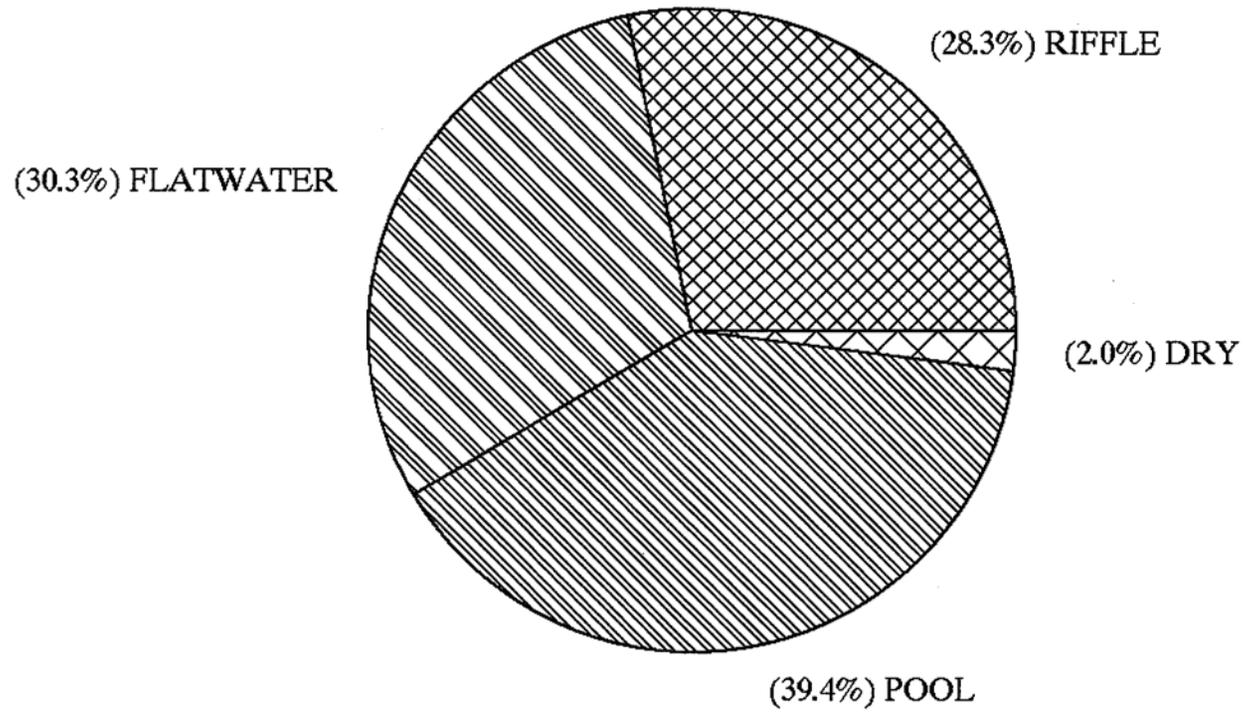
GRAPH 1

Table 1 summarizes the Level II riffle, flatwater, and pool habitat types. Based on frequency of **occurrence** there was 39% pool units, 30% flatwater units, and 28% riffle units (Graph 1). Based on total **length** of Level II habitat types there were 39% pool units, 38% flatwater units, and 21 % riffle units (Graph 2).

## HABITAT TYPES BY PERCENT OCCURRENCE

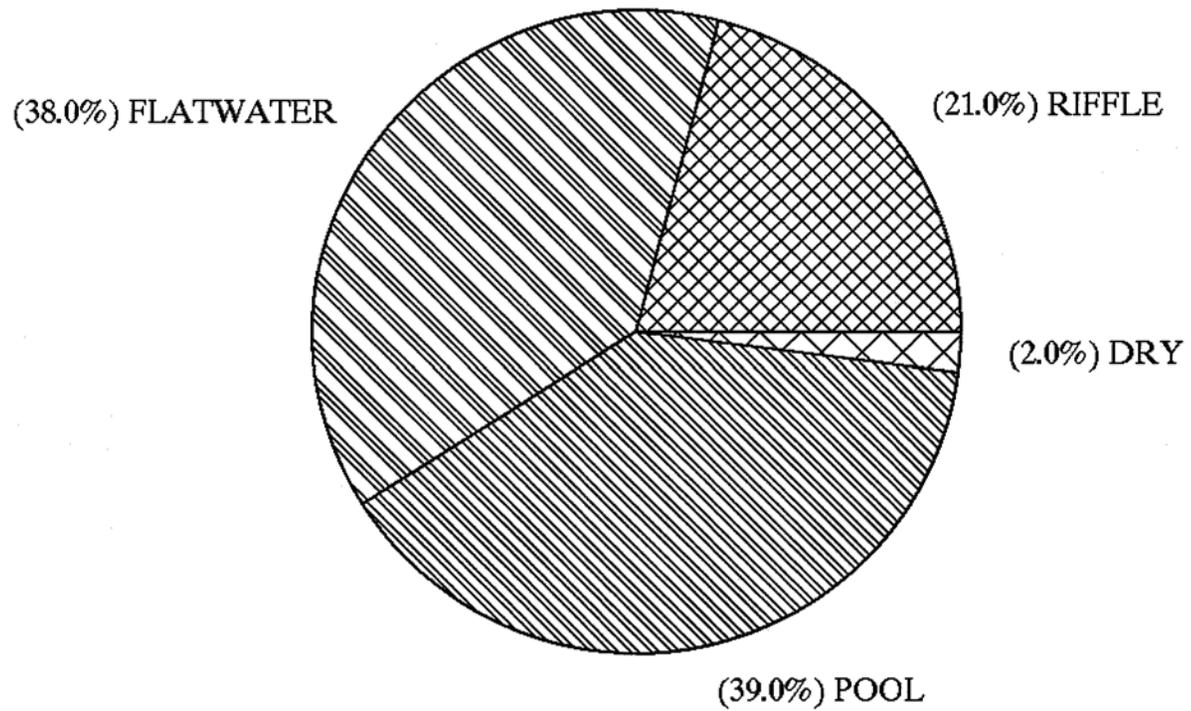
GRAPH 2

## HABITAT TYPES BY PERCENT TOTAL LENGTH

Flatwater habitat types comprised 38% of the total **length** of this survey, riffles 21%, and pools 39%. The pools are relatively shallow, with only 64 of the 346 (18.5%) pools having a maximum depth greater than 2 feet. In general, pool enhancement projects are considered when primary pools comprise less than 40% of the length of total stream habitat. In first and second order streams, a primary pool is defined to have a maximum depth of at least two feet, occupy at least half the width of the low flow channel, and be as long as the low flow channel width. Installing structures that will deepen pool habitat is recommended for locations where their installation will not be threatened by high stream energy.

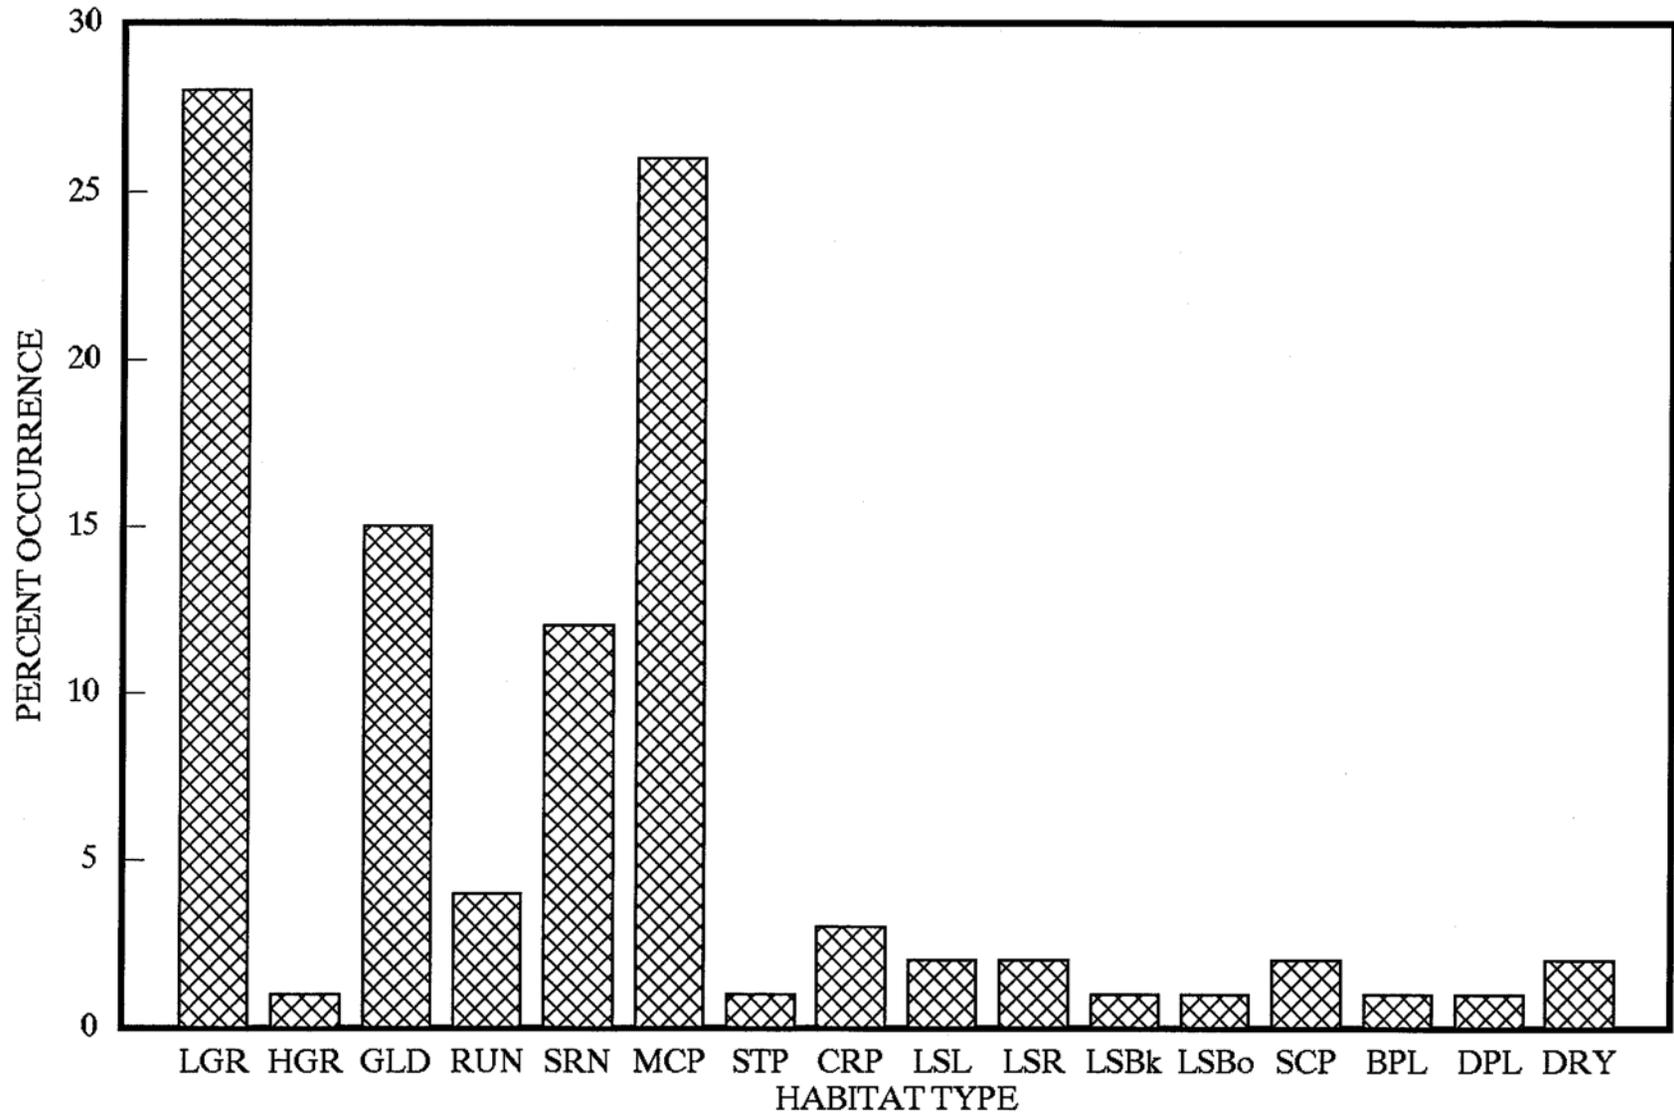
GRAPH 3

Eighteen Level IV habitat types were identified (Table 2). The most frequent habitat types by percent **occurrence** were low-gradient riffles, 28%; mid-channel pools, 26%; and glides, 15% (Graph 3). Based on percent total **length**, mid-channel pools made up 25%, low gradient riffles 20%, and step runs 20%.

## HABITAT TYPES BY PERCENT OCCURRENCE

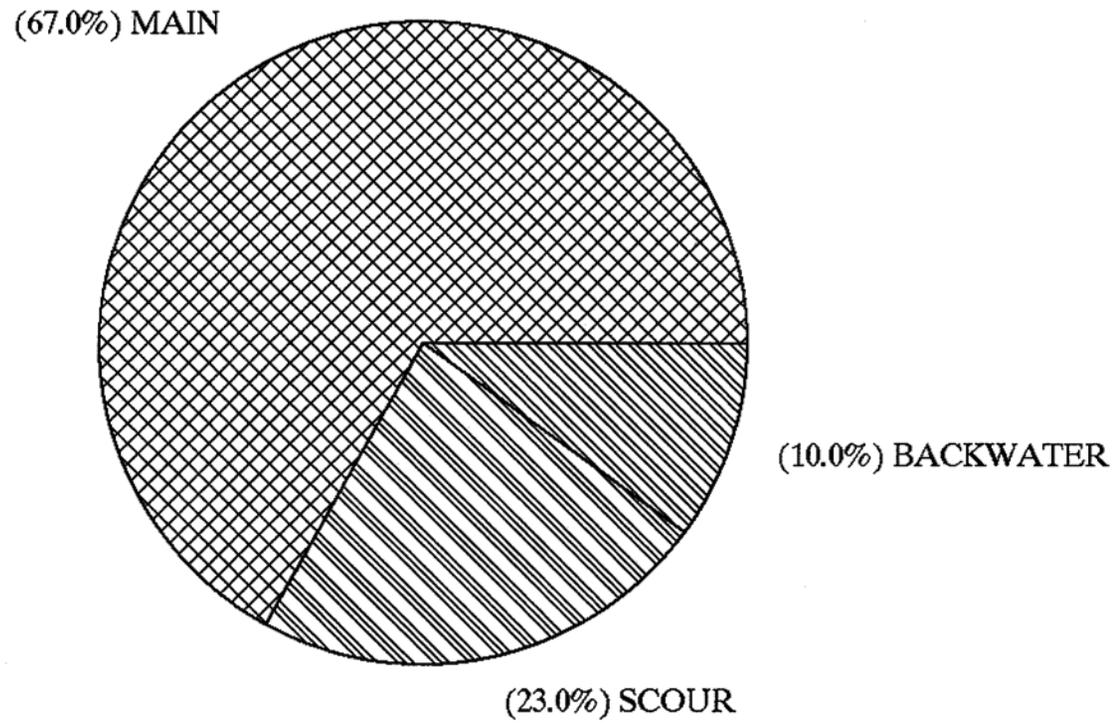
GRAPH 4

A total of 346 pools were identified (Table 3). Main channel pools were most frequently encountered at 67% and comprised 66% of the total length of all pools (Graph 4).

POOL HABITAT TYPES BY PERCENT OCCURRENCE

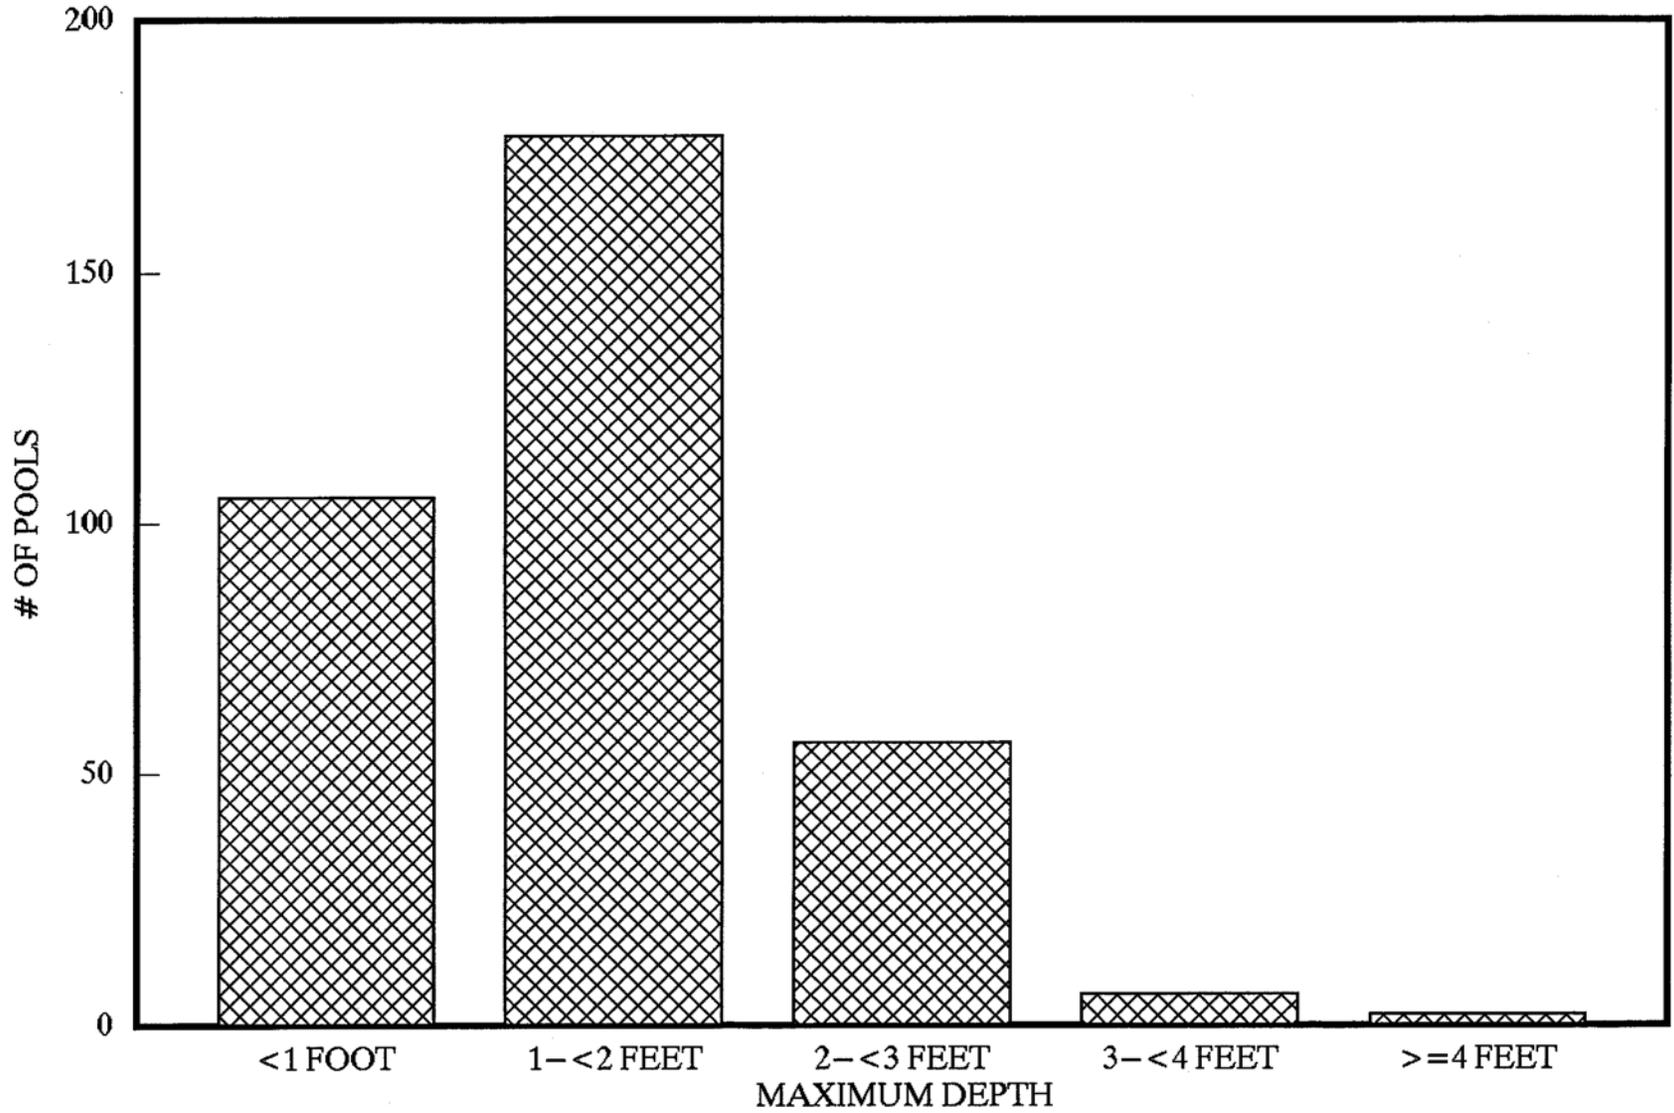
GRAPH 5

Table 4 is a summary of maximum pool depths by pool habitat types. Depth is an indicator of pool quality. Sixty-four of the 346 pools (18%) had a depth of two feet or greater (Graph 5).

MAXIMUM DEPTH IN POOLS

- 4) Where feasible, design and engineer pool enhancement structures to increase the depth of the pools. This must be done where the banks are stable or in conjunction with stream bank armor to prevent erosion.

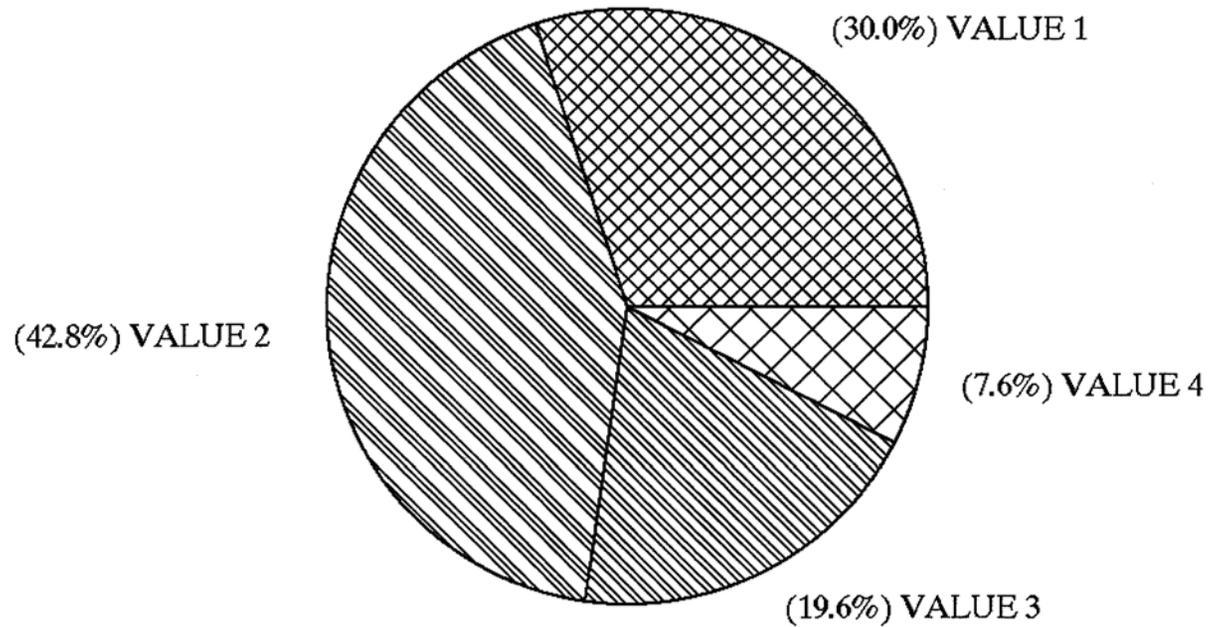
GRAPH 6

The depth of cobble embeddedness was estimated at pool tail-outs. Of the 290 pool tail-outs measured, 87 had a value of 1 (30.0%); 124 had a value of 2 (42.8%); 57 had a value of 3 (19.6%); and 22 had a value of 4 (7.6%) (Graph 6). On this scale, a value of 1 indicates the highest quality of spawning substrate.

## PERCENT EMBEDDEDNESS

Seventy-nine of the 290 pool tail-outs measured had embeddedness ratings of 3 or 4. Only 87 had a 1 rating. Cobble embeddedness measured to be 25% or less, a rating of 1, is considered to indicate good quality spawning substrate for salmon and steelhead. In North Fork Caspar Creek, sediment sources should be mapped and rated according to their potential sediment yields, and control measures should be taken.

- 5) Inventory and map sources of stream bank erosion and prioritize them according to present and potential sediment yield. Identified sites should then be treated to reduce the amount of fine sediments entering the stream.

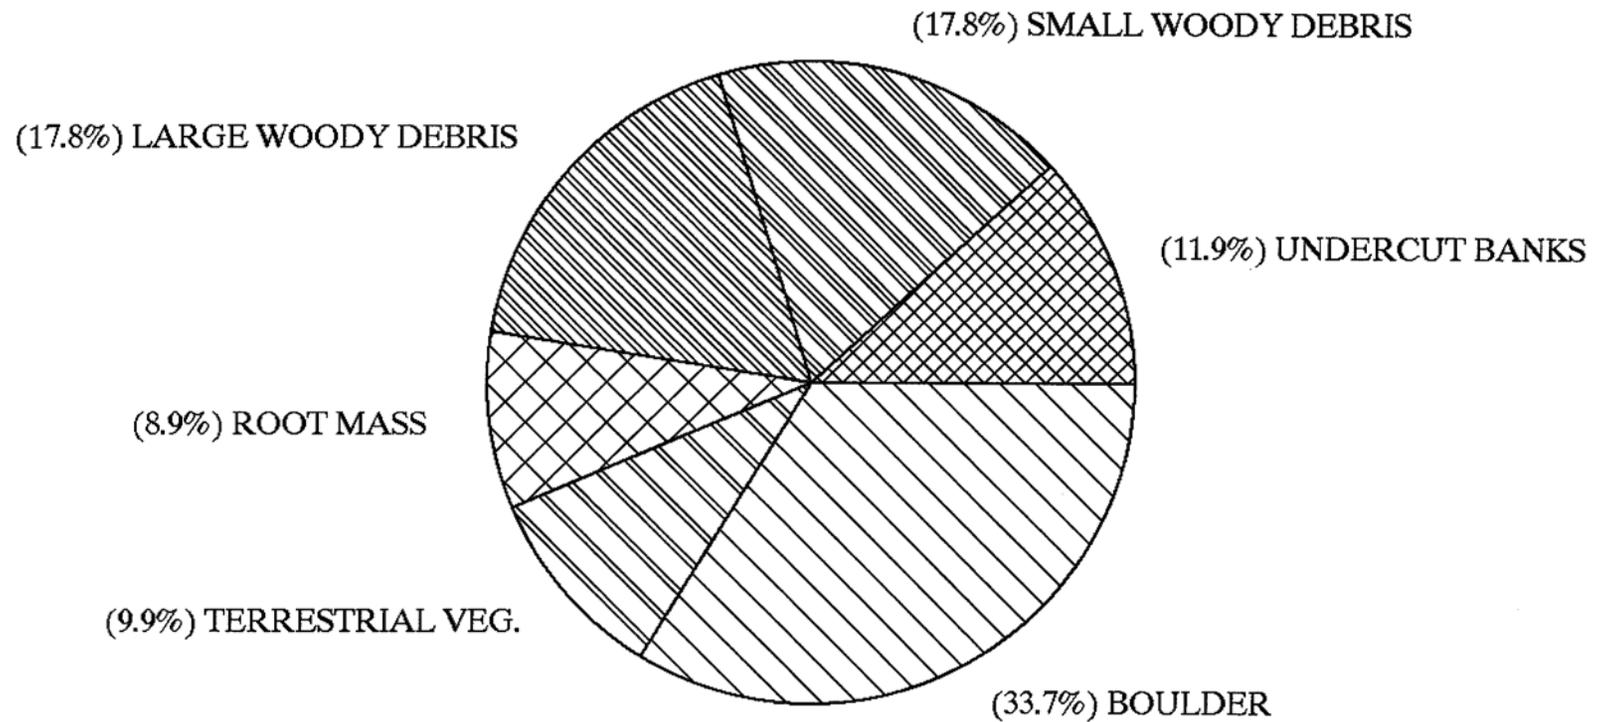
GRAPH 7

Table 5 summarizes mean percent cover by habitat type. Boulders are the dominant cover type in North Fork Caspar Creek. Large and small woody debris are lacking in nearly all habitat types. Graph 7 describes the pool cover in North Fork Caspar Creek.

MEAN PERCENT COVER TYPES IN POOLS

The mean shelter rating for pools was low with a rating of 37. The shelter rating in the flatwater habitats was much lower at 9. A pool shelter rating of approximately 100 is desirable. The relatively small amount of cover that now exists is being provided primarily by boulders in all habitat types. Log and root wad cover structures in the pool and flatwater habitats are needed to improve both summer and winter salmonid habitat. Log cover structure provides rearing fry with protection from predation, rest from water velocity, and also divides territorial units to reduce density related competition.

- 1) North Fork Caspar Creek should be managed as an anadromous, natural production stream.
- 2) Increase woody cover in the pools and flatwater habitat units. Most of the existing cover is from boulders. Adding high quality complexity with woody cover is desirable and in some areas the material is locally available. In particular, large wood should be placed in a manner to increase backwater areas to produce winter holdover habitat.

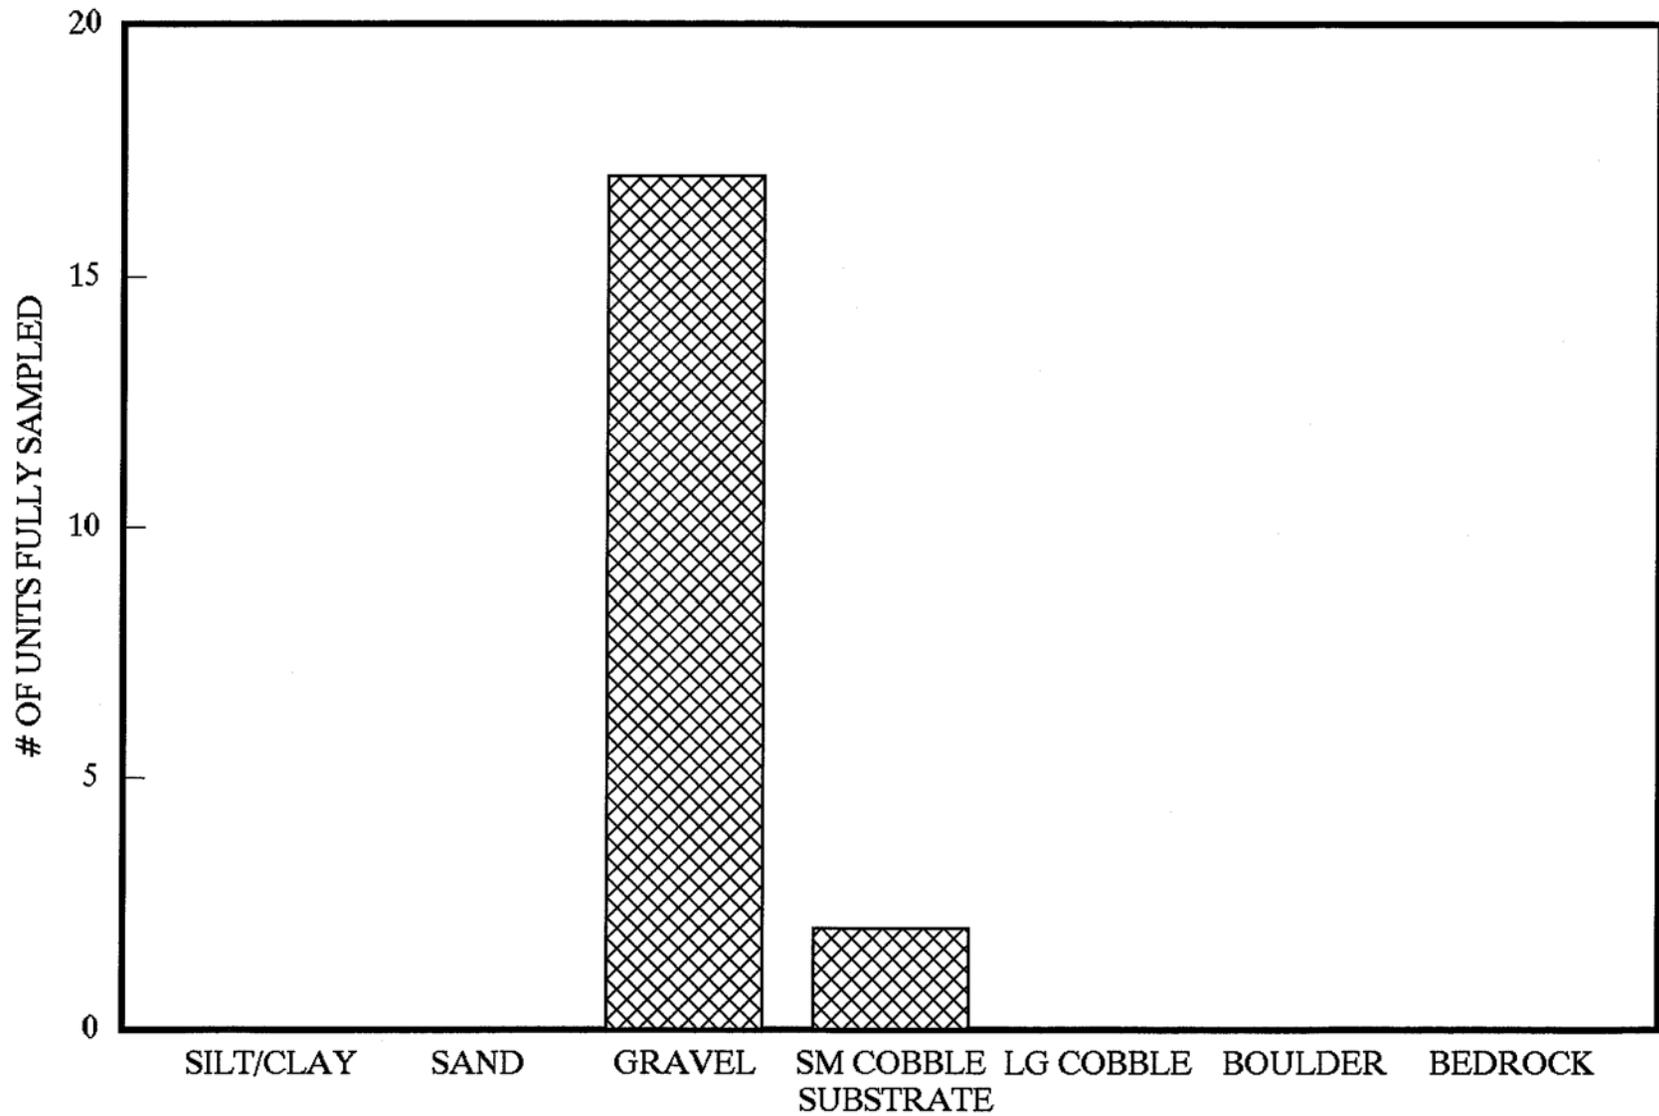
GRAPH 8

Table 6 summarizes the dominant substrate by habitat type. Gravel was the dominant substrate observed in 17 of the 19 low gradient riffles measured (89%). Small cobble was the next most frequently observed dominant substrate type and occurred in 11% of the low gradient riffles (Graph 8).

SUBSTRATE COMPOSITION IN LOW GRADIENT RIFFLES

All of the nineteen low gradient riffles measured had gravel or small cobble as the dominant substrate. This is generally considered good for spawning salmonids.

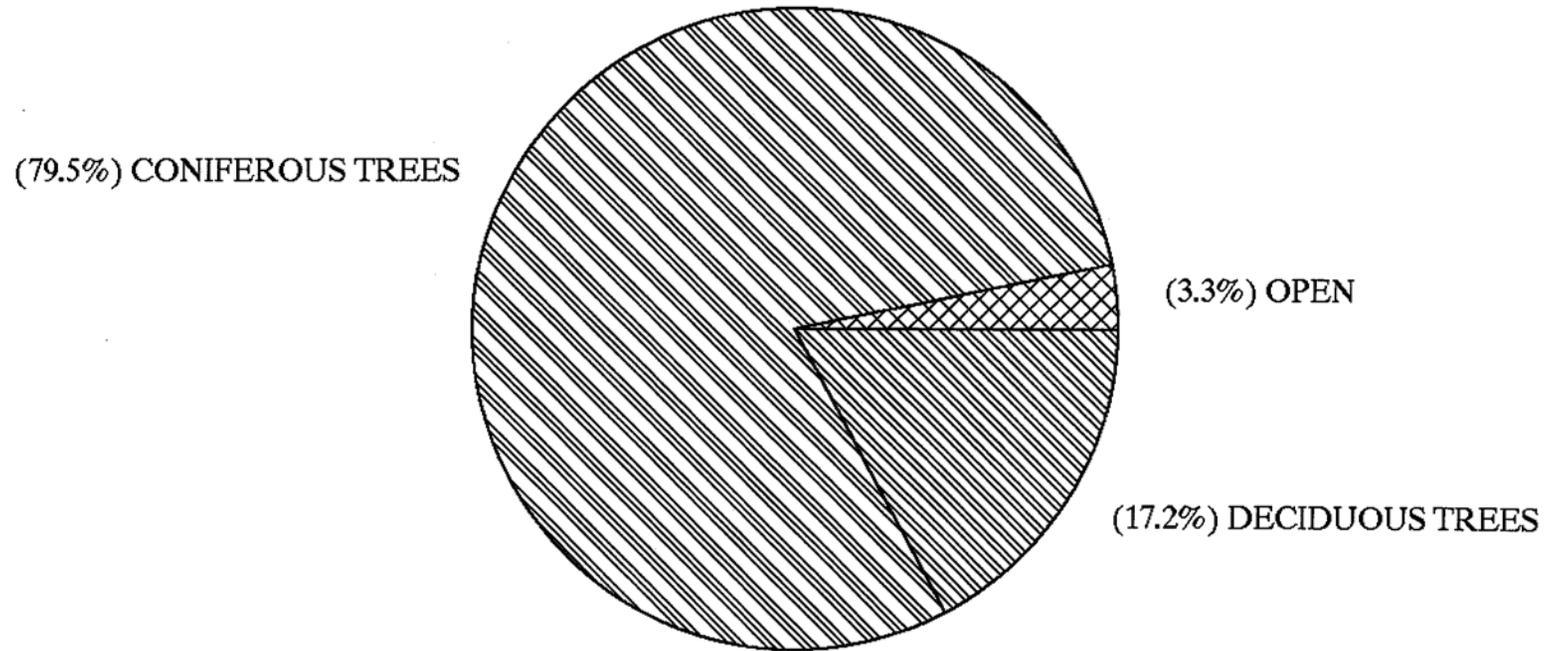
GRAPH 9

The mean percent canopy density for the stream reach surveyed was 97%. The mean percentages of deciduous and coniferous trees were 18% and 82%, respectively. Graph 9 describes the canopy in North Fork Caspar Creek.

PERCENT CANOPY

The mean percent canopy density for the stream was 97%. This is a relatively high percentage of canopy. In general, revegetation projects are considered when canopy density is less than 80%.

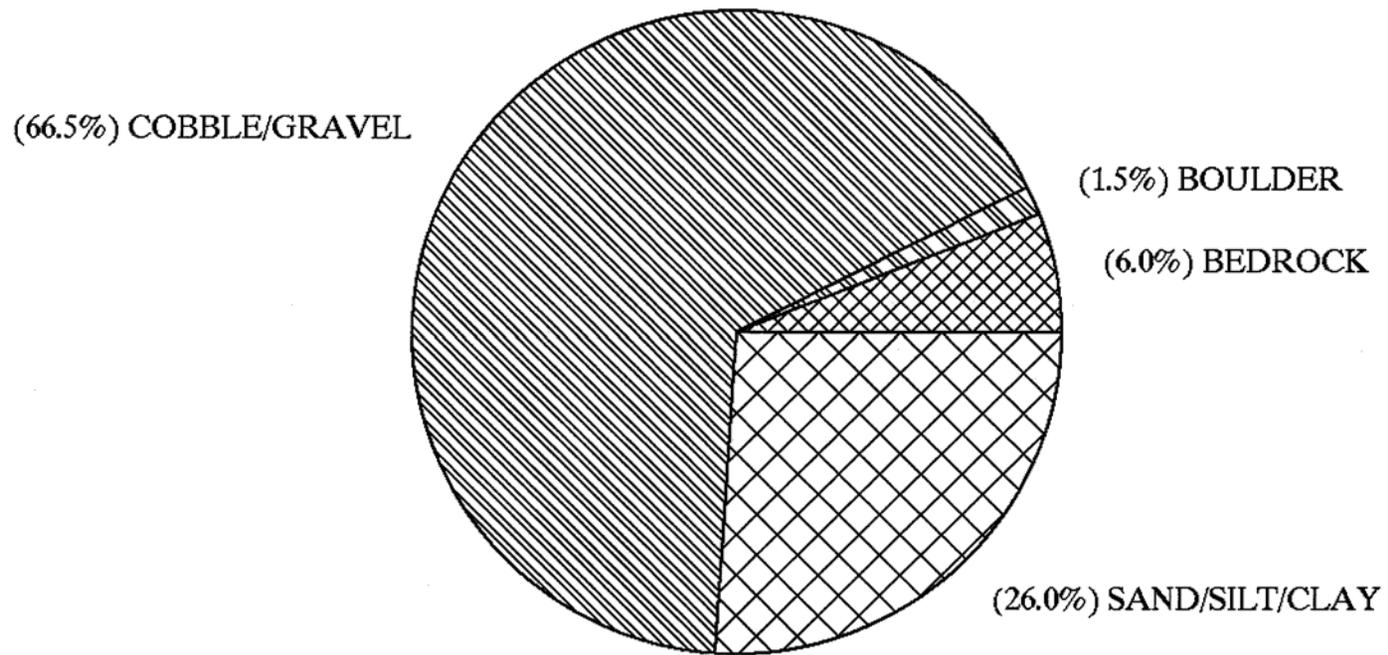
GRAPH 10

For the stream reach surveyed, the mean percent right bank vegetated was 85%. The mean percent left bank vegetated was 82%. The dominant elements composing the structure of the stream banks consisted of 6.0% bedrock, 1.5% boulder, 66.5% cobble/gravel, and 26.0% sand/silt/clay (Graph 10). Grass was the dominant vegetation type observed in 58% of the units surveyed. Additionally, 4% of the units surveyed had deciduous trees as the dominant vegetation type, and 23% had coniferous trees as the dominant vegetation, including down trees, logs, and root wads (Graph 11).

DOMINATE BANK COMPOSITION IN SURVEY REACH

The percentage of right and left bank covered with vegetation was high at 85% and 82%, respectively. In areas of stream bank erosion or where bank vegetation is not at acceptable levels, planting endemic species of coniferous and deciduous trees, in conjunction with bank stabilization, is recommended.

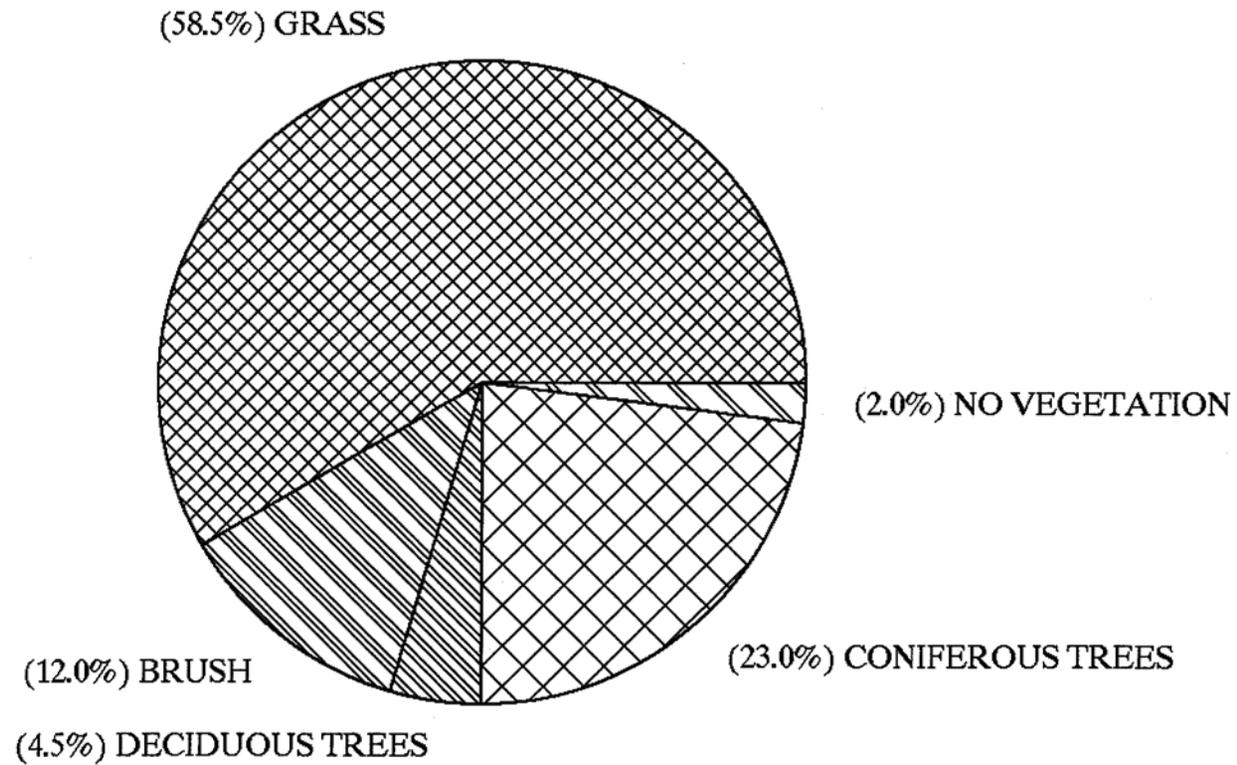
GRAPH 11

DOMINATE BANK VEGETATION IN SURVEY REACH
