## B R I E F I N G

February 26, 2014

## REDUCING POST-FIRE RUNOFF AND SEDIMENT YIELDS

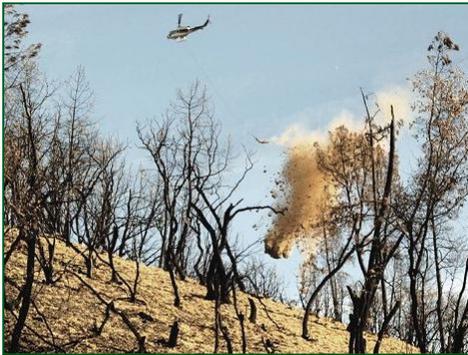
*Aerial application of post-fire straw mulch treatment*

Immediately after application, the straw mulch at the Hayman Fire increased the total ground cover to 80%. Total ground cover stayed high as the vegetation and litter (including invasive cheatgrass that was inadvertently introduced as seed in the straw mulch) increased and replaced the decreasing straw mulch cover. The wheat straw mulch treatment significantly reduced peak flow rates and sediment yields as compared to the control catchment from the initial and continuous increase in ground cover.

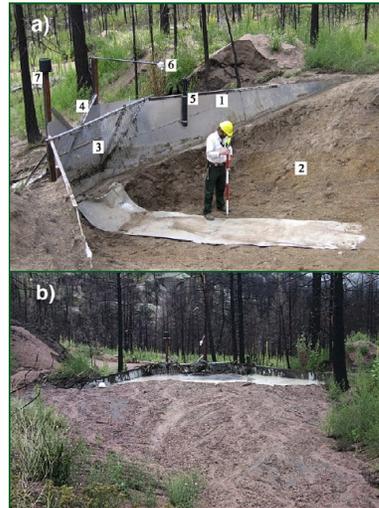
*A instrumented sediment trap and weir in the Hayman control catchment. a) The empty catchment after sediment removal. b) The catchment filled with sediment after a high intensity thunderstorm.*
