Maintenance Issues and Repair Guidelines for Precast Concrete Toilets and Utility Buildings

Gary Kees, Project Leader

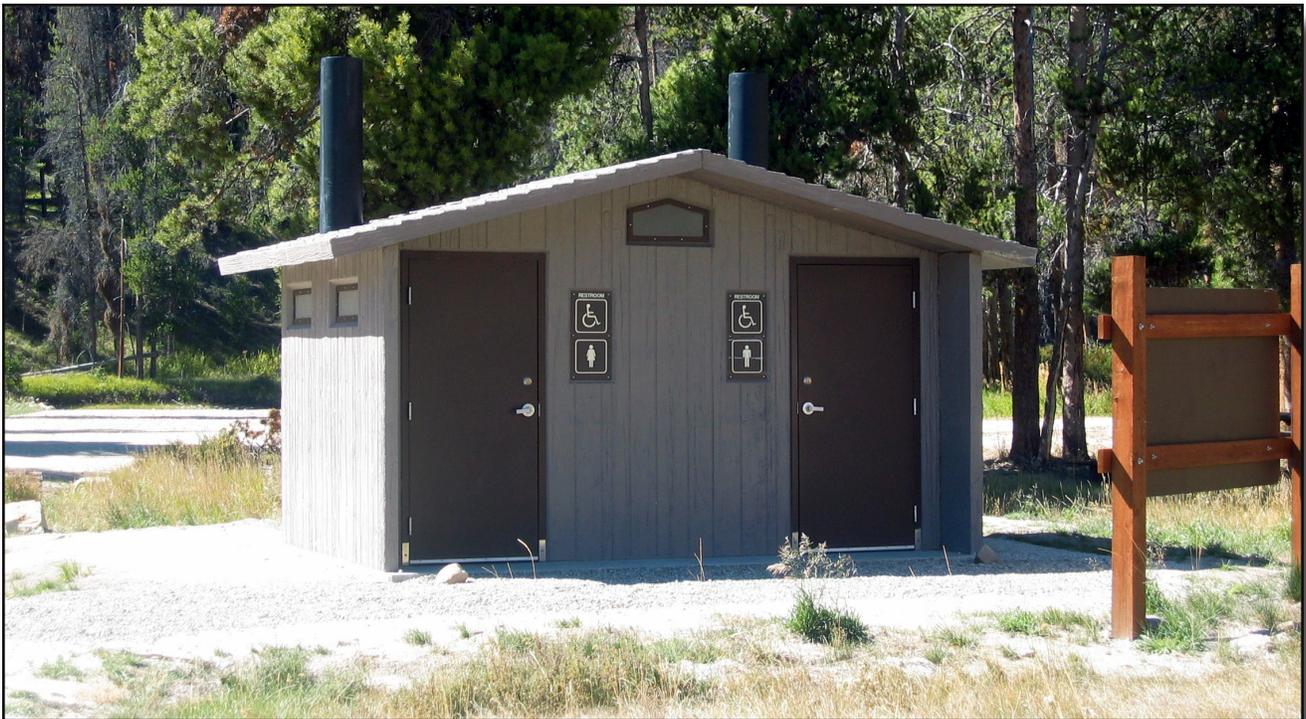
Figure 1—Precast concrete toilets are tough, but still require some periodic maintenance. This Tioga special double-vault toilet is made by CXT, Inc., of Spokane, WA.
