The Effects of Fire

On Cultural Resources

THE HAMMOND FIRE

THE HAMMOND FIRE BAER PROJECT

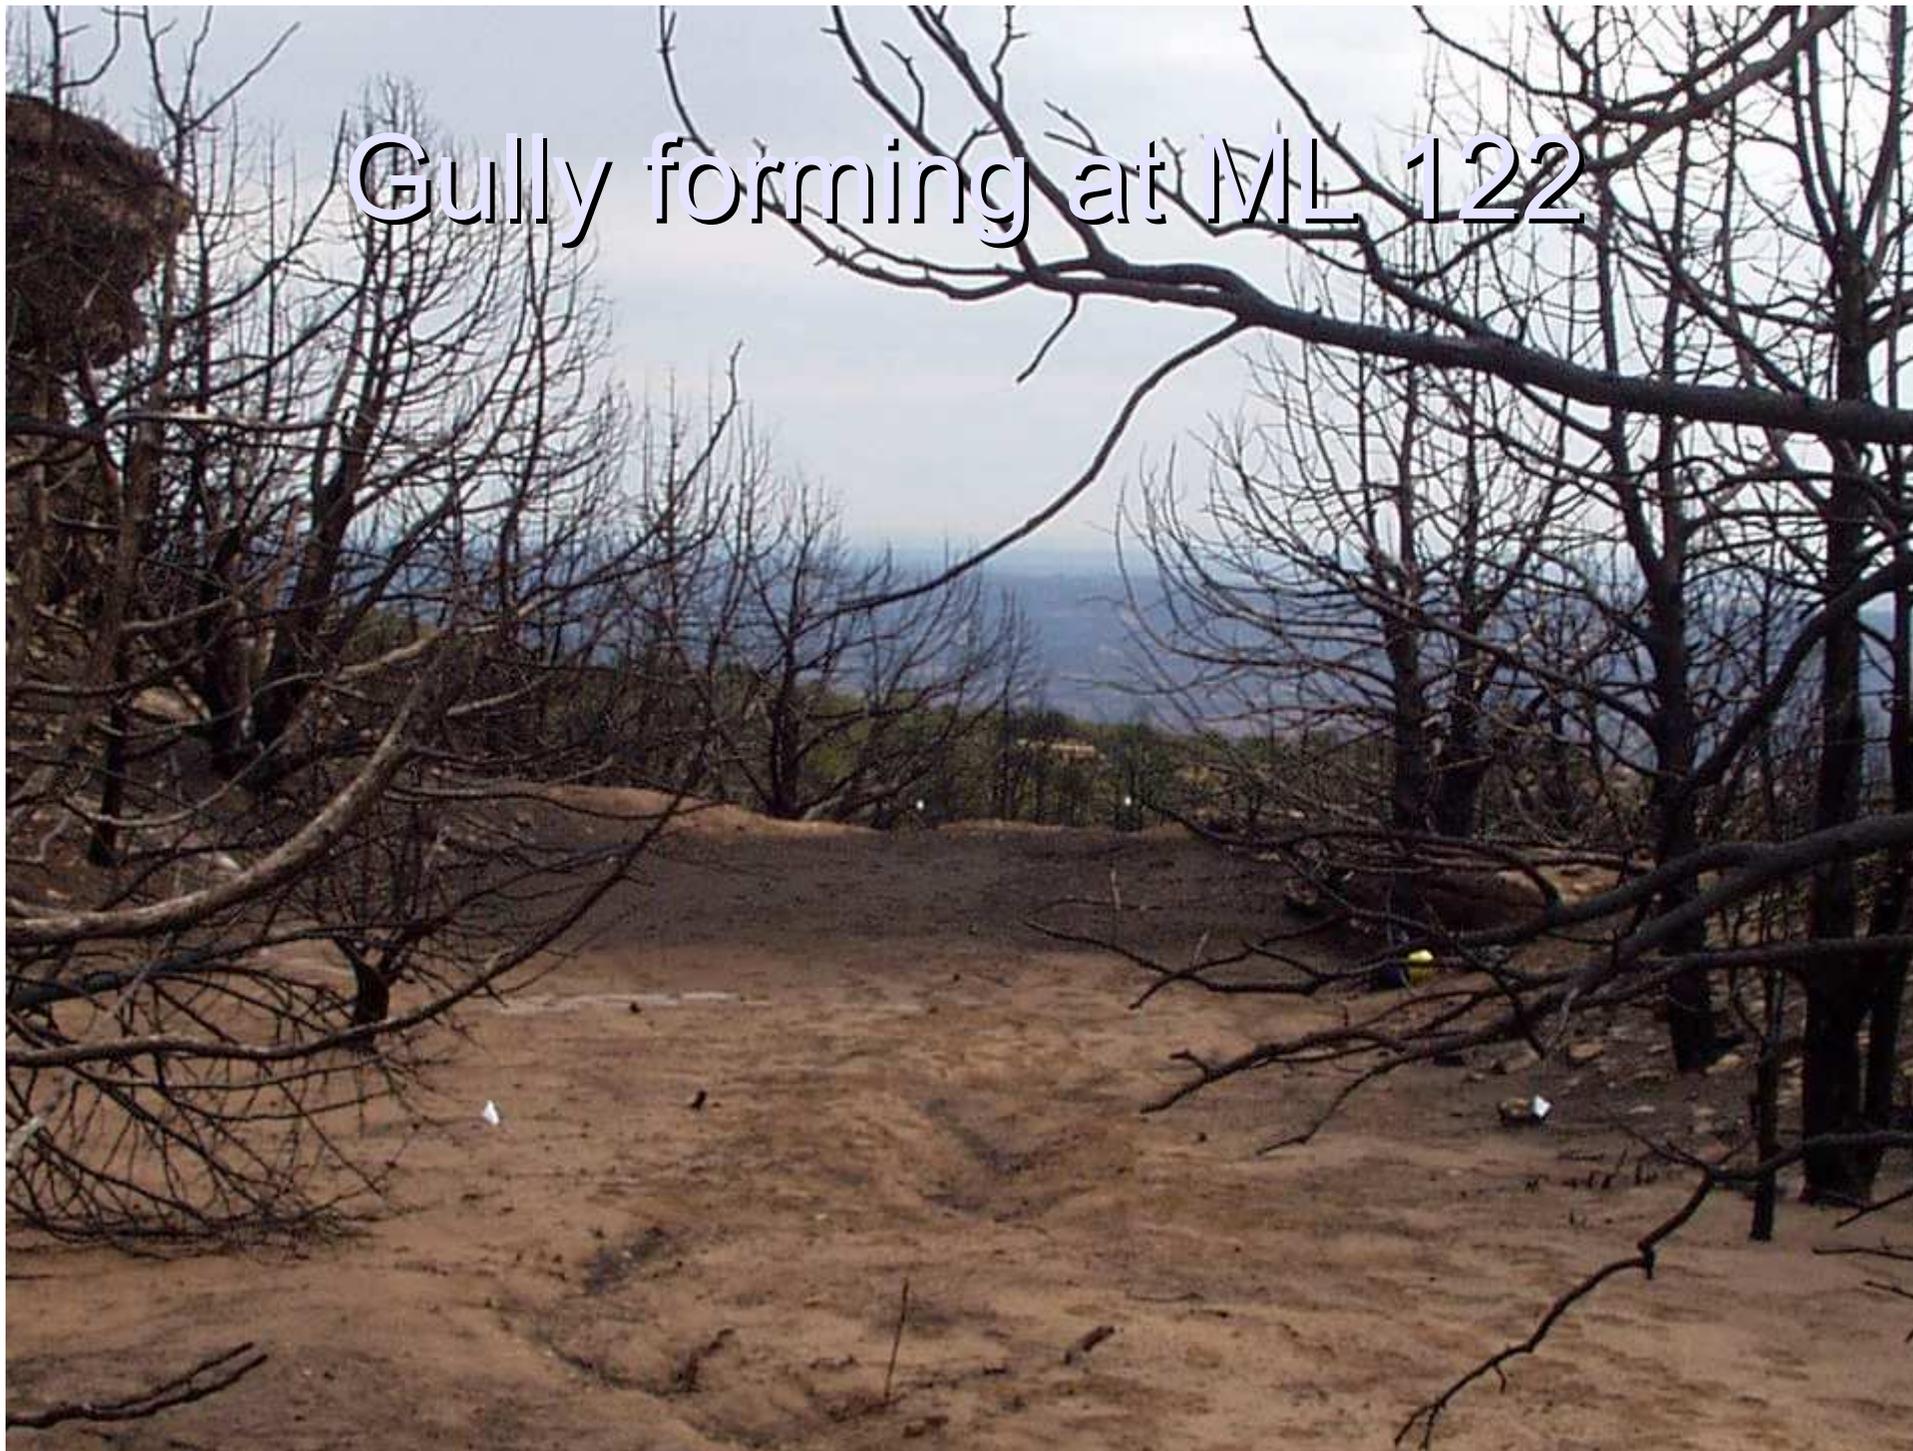
Gullying at ML 122

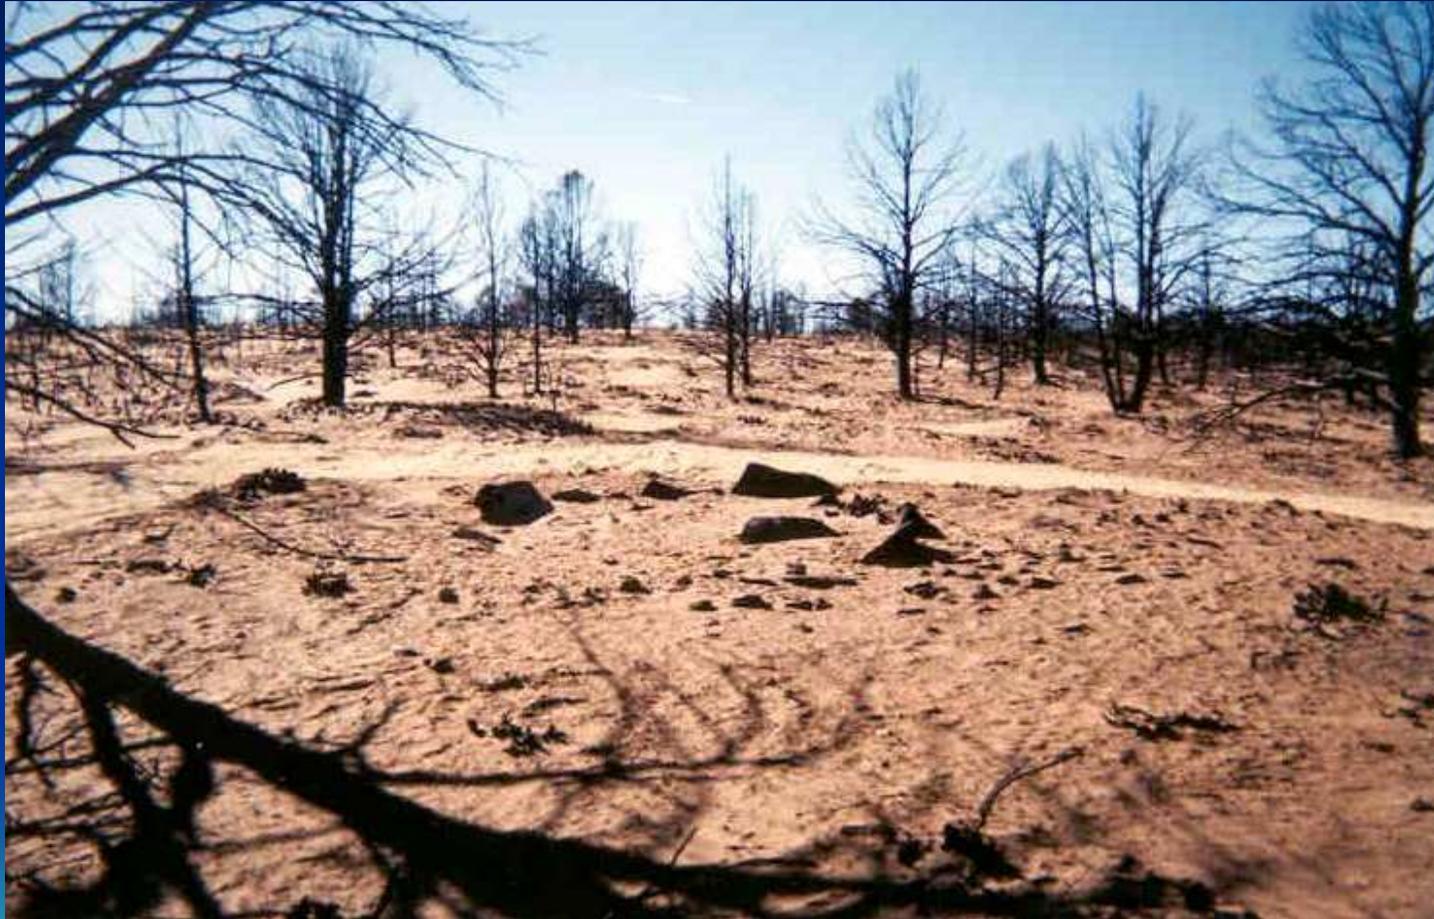
ML 33

Matting with aeolian deposition

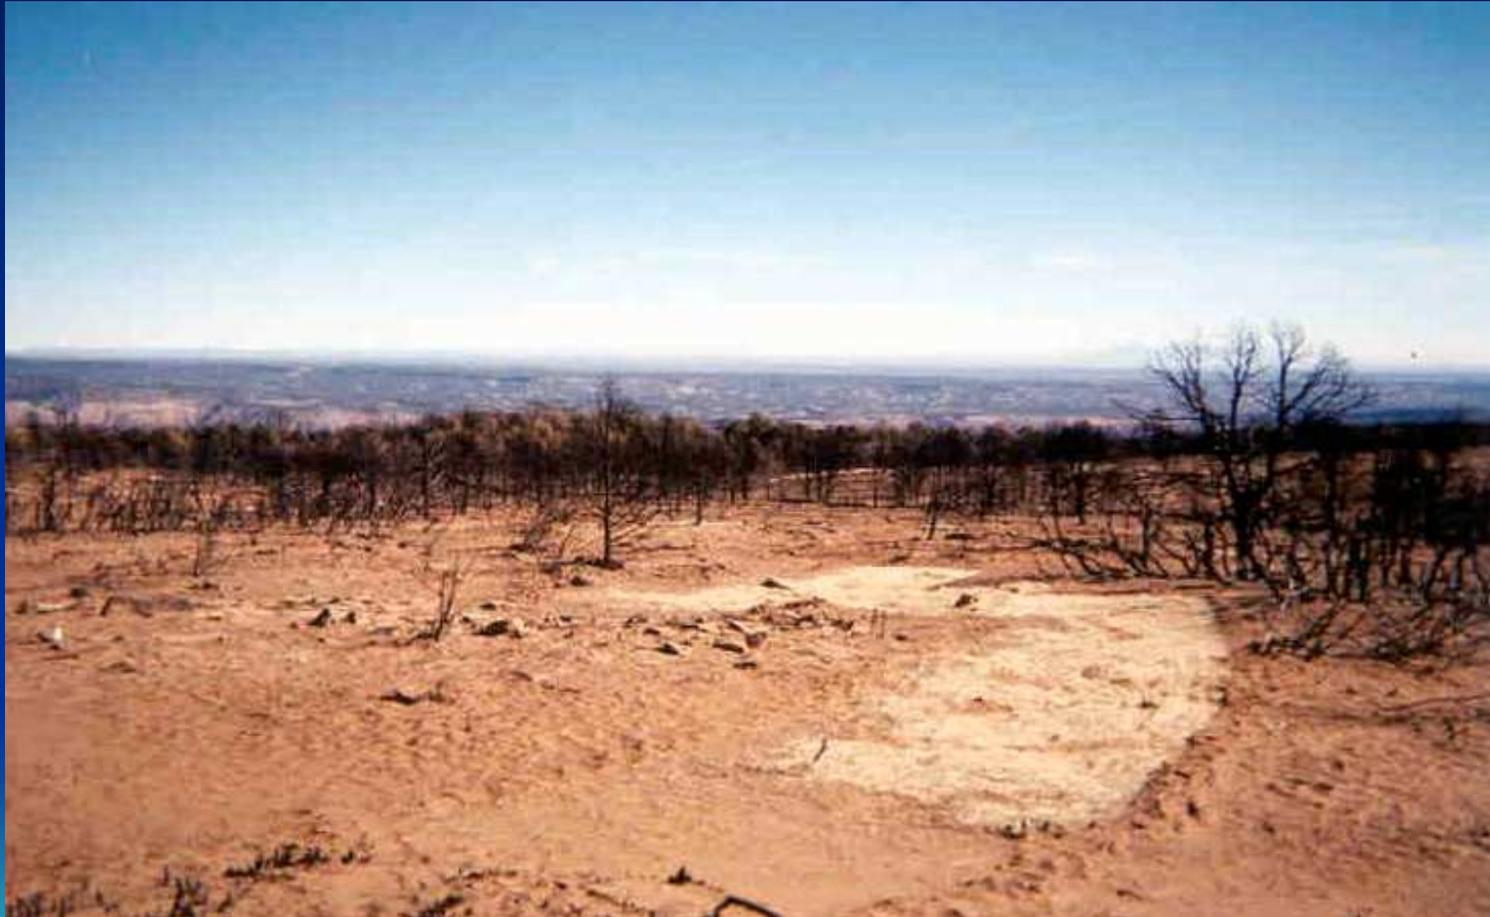
ML 20-Extensive use of matting

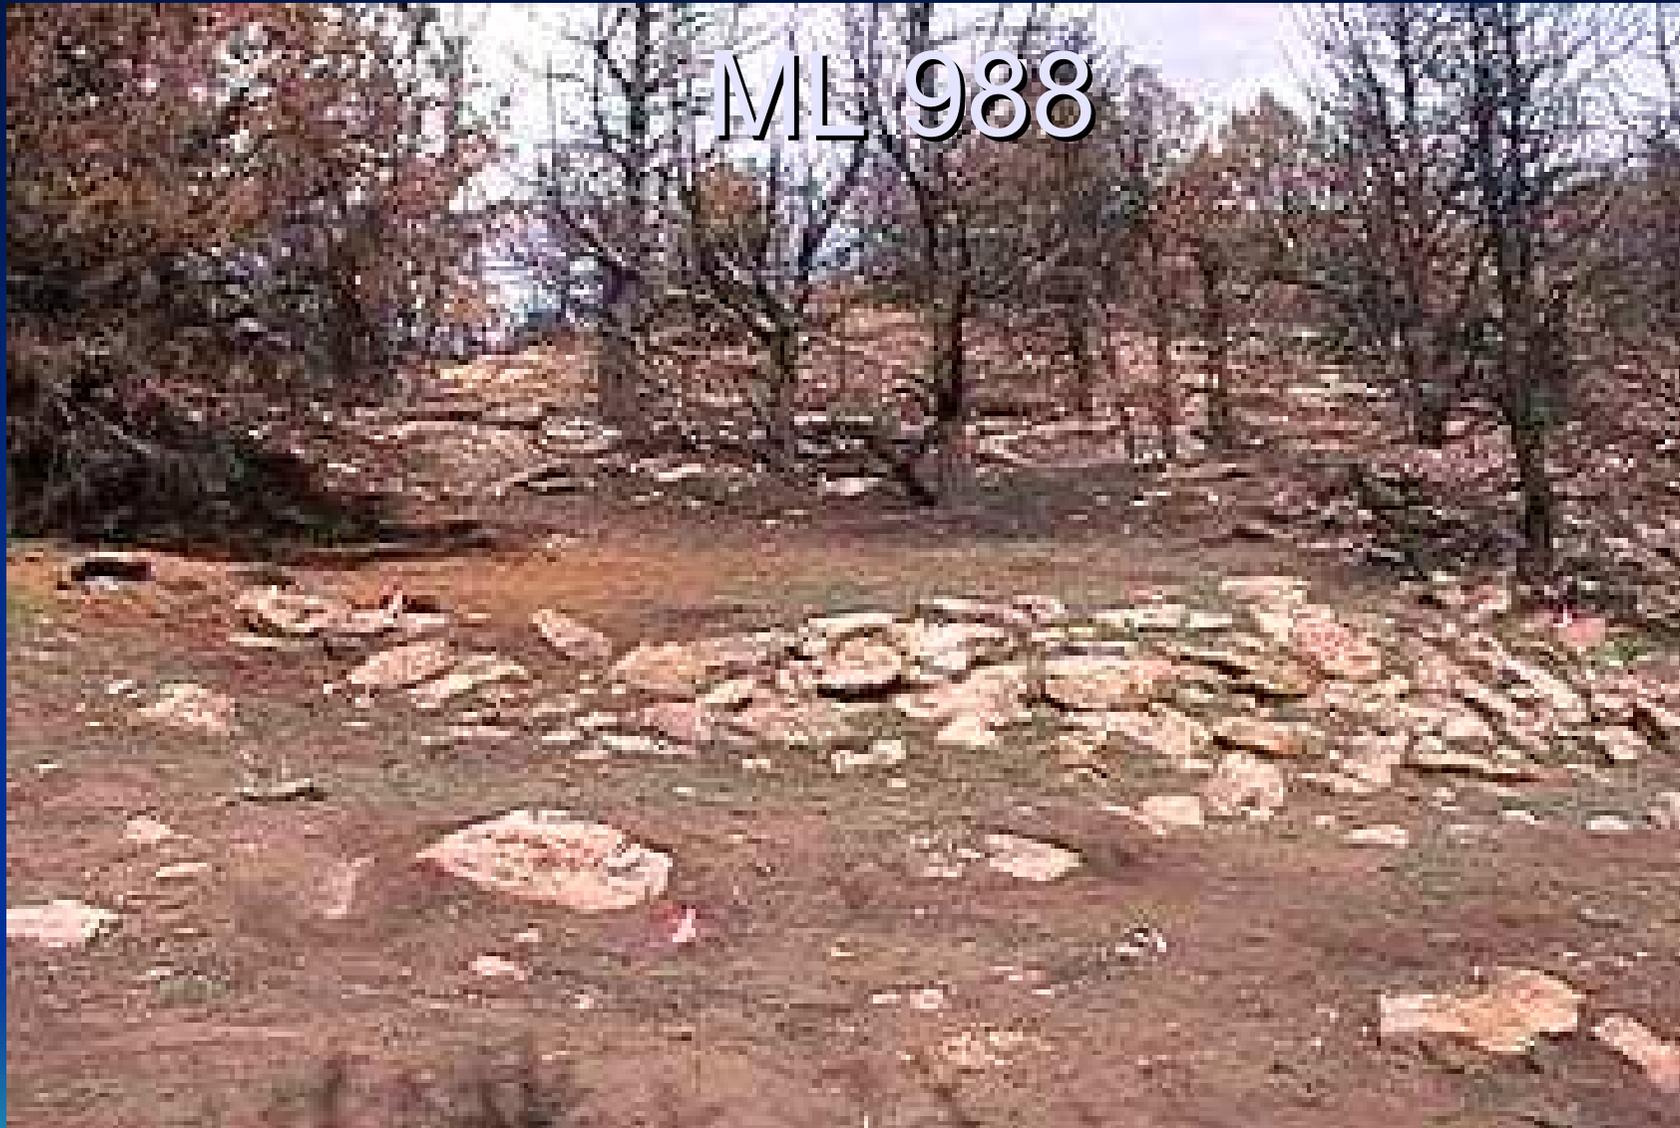
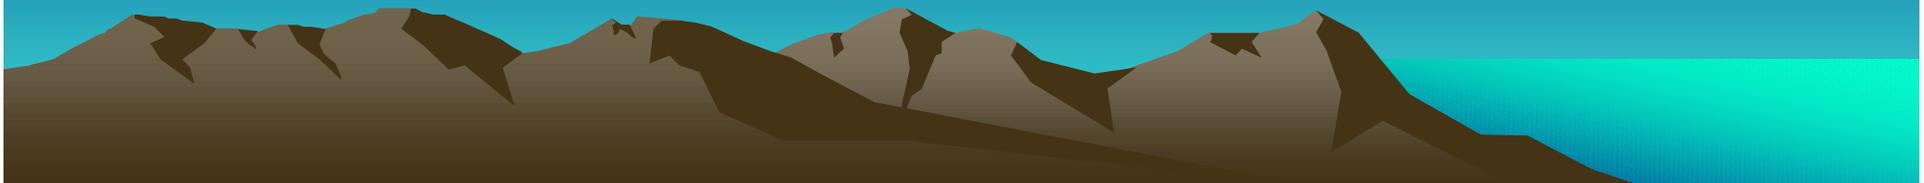
ML 988

Gullying at ML988

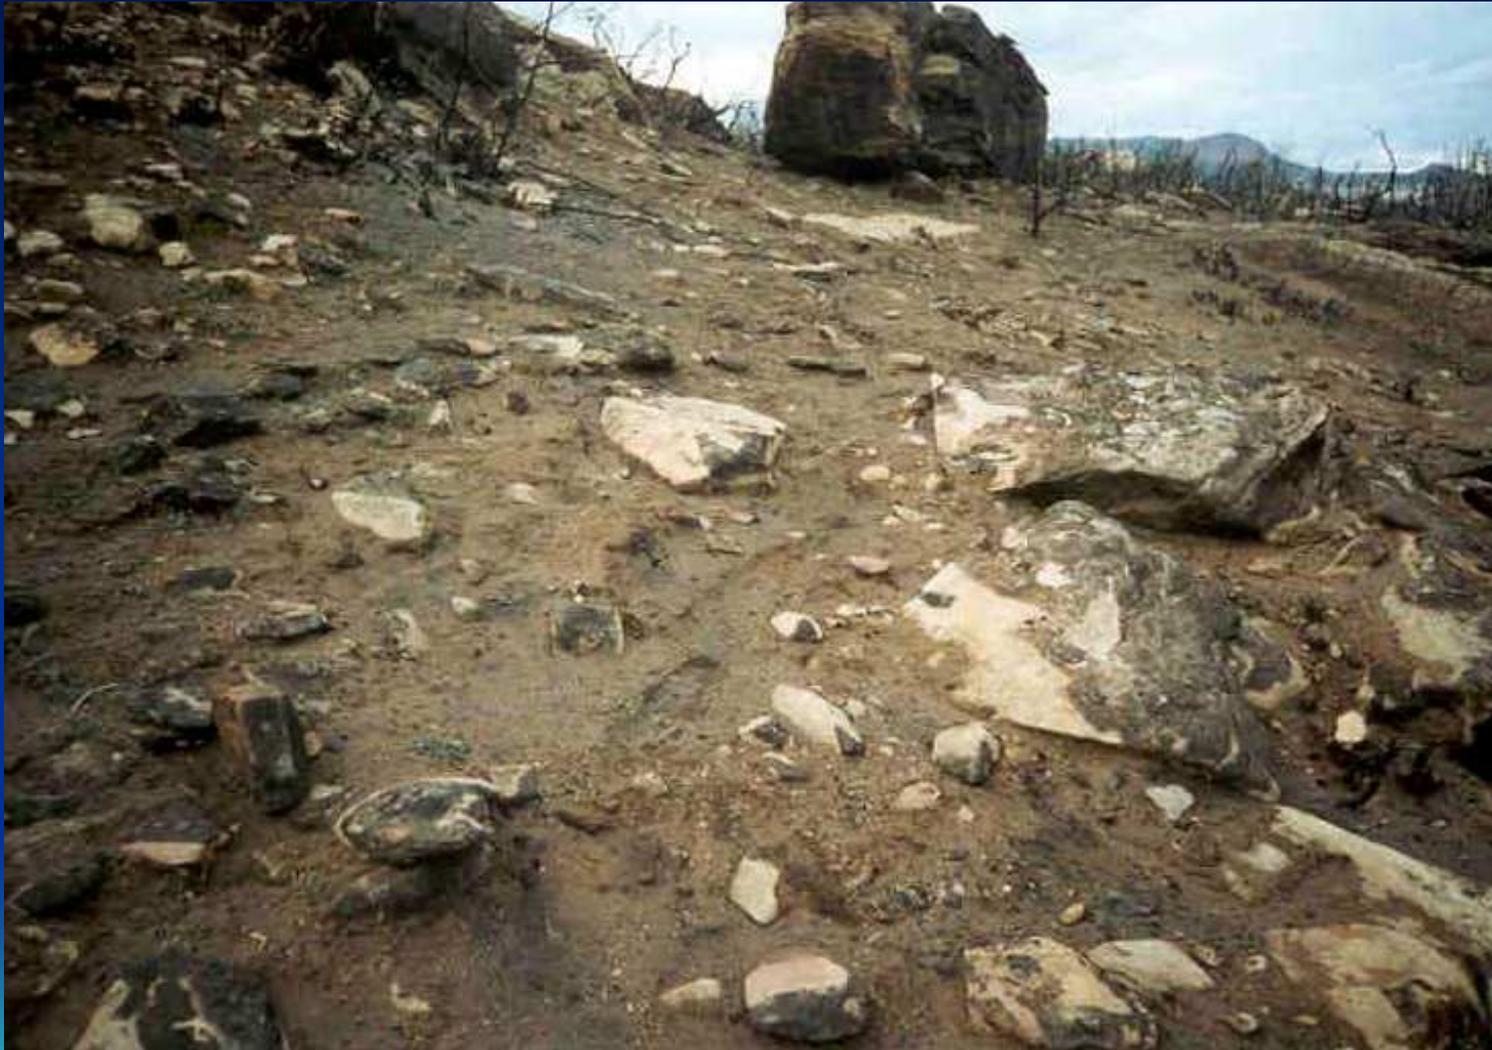
Deflation from sheetwash
